Orion P. Keifer  
Peter D. Layson  
Charles A. Wensley

# Investigating Absorption Refrigerator Fires (Part 2)

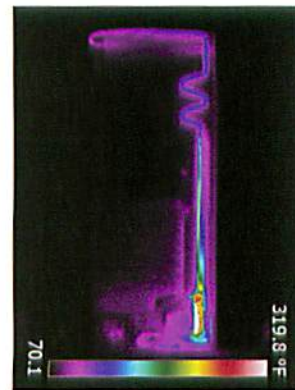
Figure 2 is a Thermograph of the unit while it was operating. Note that the insulation has been removed from the boiler and gas flue to image that area. As can be surmised, the hottest area of the cooling unit is in the boiler region.

**FIGURE 2—Thermograph of absorption refrigerator with boiler insulation removed. Note evaporator coils are not visible because they are cold and located in the freezer/refrigerator compartments.**

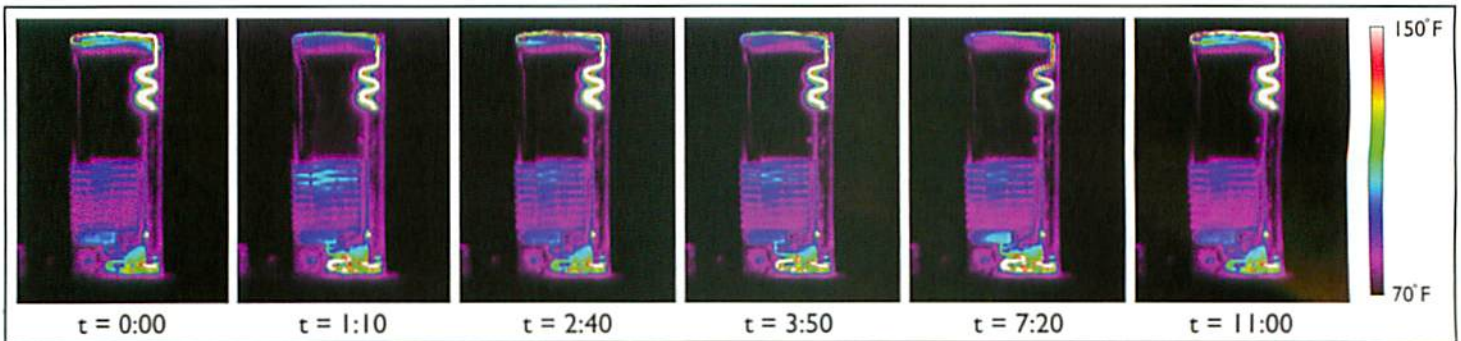
The thermal imaging also shows that the temperatures are not steady state, but are cyclic. Much like an old style percolating coffee pot, it takes time to heat up the ammonia-water solution and get percolation from the ammonia gas bubbles forming and combining in the percolating tube. After the percolation event, the released hot ammonia gas travels up to the condenser and the water in the percolation tube goes into the annulus around the percolating tube, causing the hot water in the annulus to travel toward the return tube. Water from the reservoir gets preheated by the return water and goes into the percolation tube, for another heating cycle. The series of thermographs in Figure 3 show temperature variations at different times in the cycle. Interestingly, the cycle progresses relatively slow, with a period of several minutes.

FIGURE 3—Series of thermographs showing temperature variation.

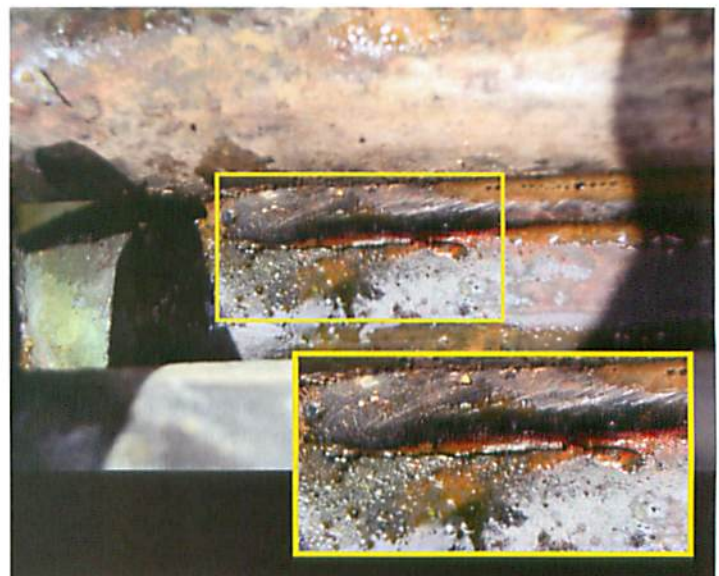
Evidence of boiler failure was discussed extensively in the previous article<sup>(1)</sup>. Evidence of sodium chromate, scaling, cracking, and heat patterns on the galvanized steel sheet metal should be documented. Figure 5 depicts a crack along the electric heater tube weld of an absorption refrigerator involved in a fire.

FIGURE 5—A crack on the edge of the weld between the electric heater and boiler tubes of a Dometic RM2862.

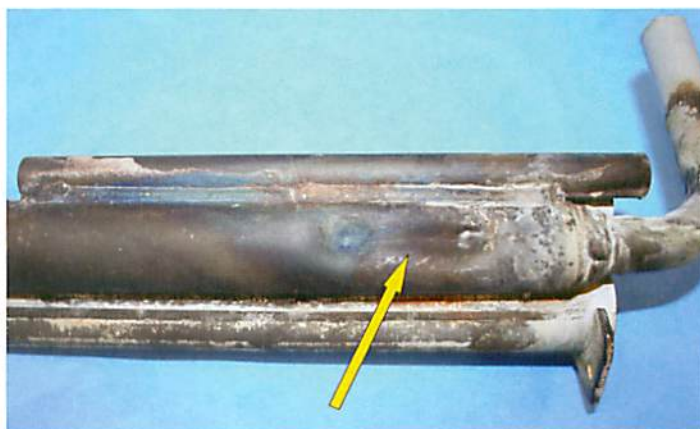
Check for scaling, sodium chromate, and evidence of bluing. Steel can exhibit a blue color if exposed to a temperature range from approximately 1112-1472° F (600-800° C)<sup>[7]</sup>. The color is dependent upon the thickness of the iron oxide ( $Fe_3O_4$ ) layer formed on the surface, which is a function of the temperature to which it was exposed. See Figure 6 for an example of bluing.

**FIGURE 6—Bluing on a removed boiler from a Dometic RM2852 which shows the steel experienced higher than normal operating temperatures. Note the axial indentation in the tube, commonly called a dimple.**

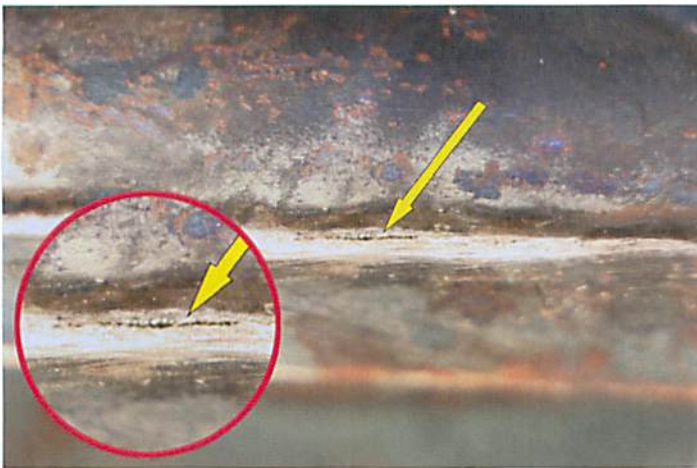
Visual and optical microscopy analyses should be considered first when observing the failure. If the failure is difficult to see, liquid dye penetrant testing (PT) can be used on the exterior surfaces to elucidate the location and size of the failure on the exterior wall of the boiler tube. Figure 7 is an example of a crack found on visual inspection.

**FIGURE 7**—Macrograph of a boiler tube crack adjacent to a heater tube weld.

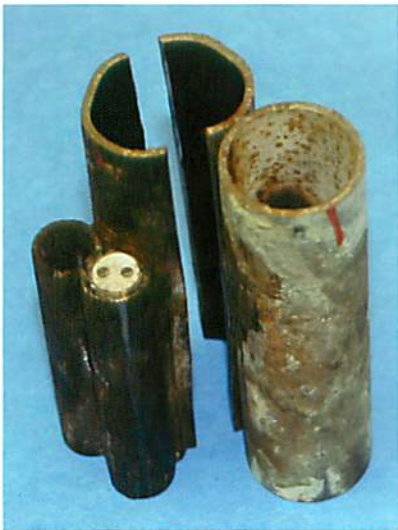
**FIGURE 8**—Upper portion of a boiler which has been sectioned axially to view inner surfaces.

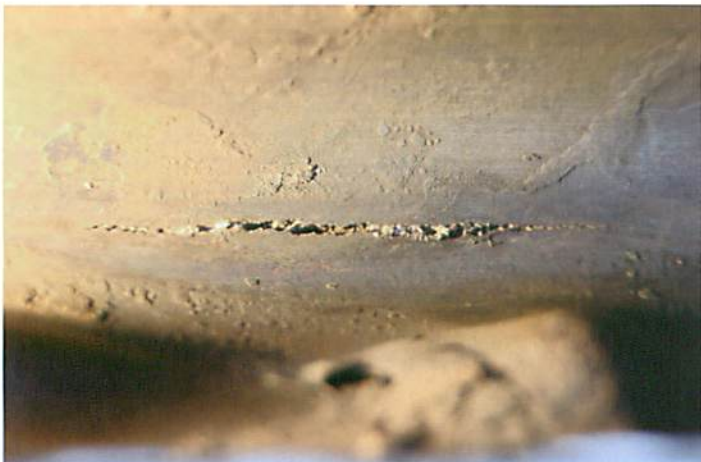
**FIGURE 9**—Crack revealed on the inside of a boiler after axial sectioning.

The previous steps should reveal the location of the failure, and conversely areas that don't contain the failure. To determine the mechanism of failure, it is often necessary to view the *interior of the tubing*. To achieve the best view, the sample can be sectioned. It is desirable to select an axial cut plane which will avoid all areas of interest. Non-destructive analysis can be repeated for the inside of the tubing once the axial sectioning is complete. The nature and location of the breach should be determined. Figure 8 is an example of an axially sectioned boiler, while Figure 9 shows a view of a boiler crack revealed after the axial cut.

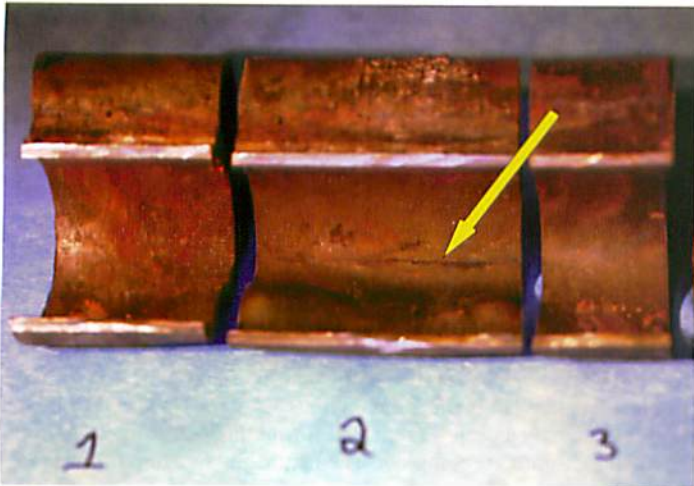
**FIGURE 10**—Sample trimmed just past the edges of a crack on the interior of a boiler.

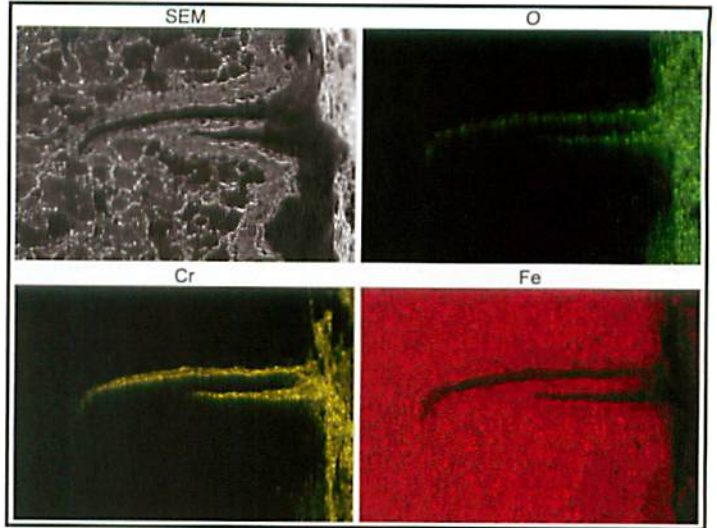
EDS can be useful in confirming elements present in the alloy, oxide layers, and/or corrosion products. Figure 13 shows an EDS mapping of a cross-sectioned boiler specimen with independent elemental graphs created from a region analyzed with SEM.

**FIGURE 13**—EDS map of a cross-sectioned boiler specimen showing regions where oxygen (green), chromium (yellow), and iron (red) were detected.

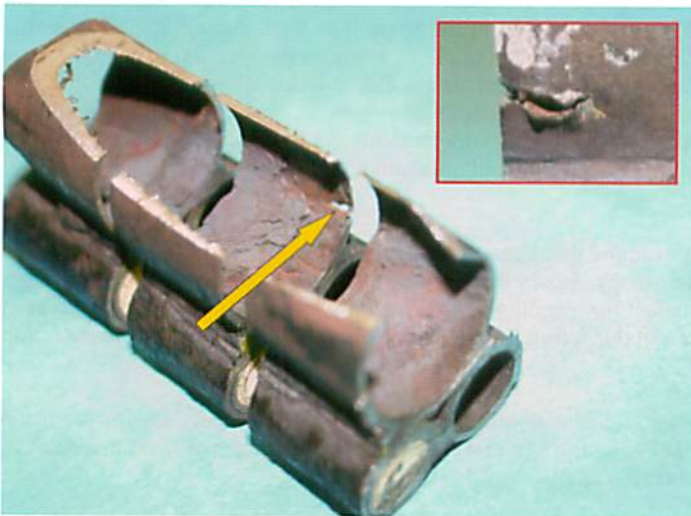
**FIGURE 11**—Corrosion in a Norcold 6162 thinned the sidewall of the boiler to the point it ruptured with a lip. Inserted photograph in the upper right corner is an exterior view of the rupture.

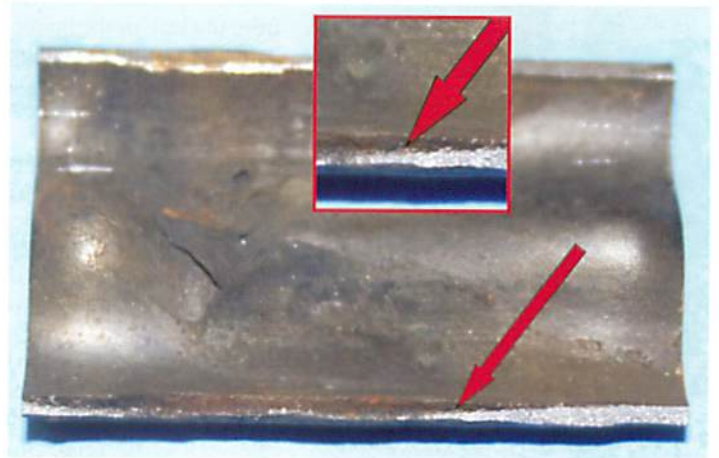
**FIGURE 14**—A crack surface on a boiler tube exposed after being embrittled with liquid nitrogen. Note the color difference between the corroded portion and the fresh fracture. The interior of the dimple is present. The line at the dimple is shadowing from scale buildup.

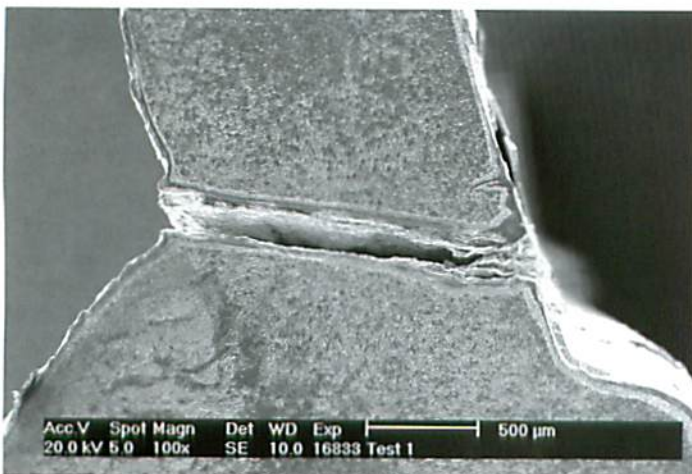
Visual means can be used to examine the defect surface and/or cross-section. Metallography as well as electron and optical microscopy should be considered. It may also be desirable to make a cross-sectional cut through the defect for metallography of mating edge surfaces of the defect, even though it limits other observations of the defect. Figure 12 shows a polished and etched cross-section of a crack at the edge of a weld.

**FIGURE 12**—Scanning Electron Microscope (SEM) micrograph of a cross-sectioned crack at the edge of the electric heater weld.

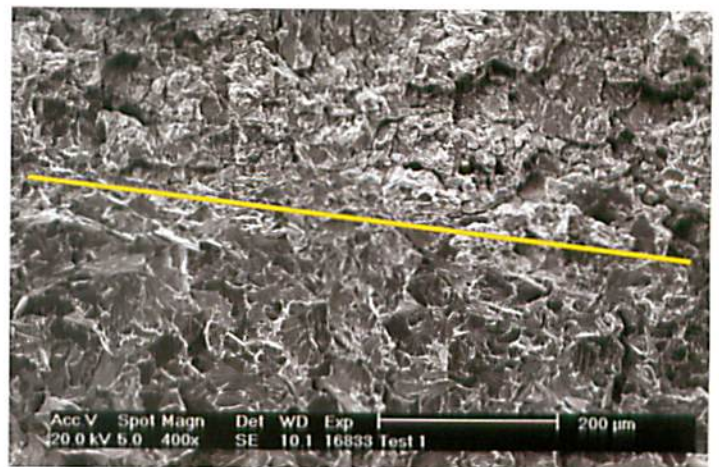
**FIGURE 15**—SEM micrograph of the mating crack surface to Figure 14. The top portion shows corrosion while the bottom portion shows cleavage fracture from the liquid nitrogen embrittlement.

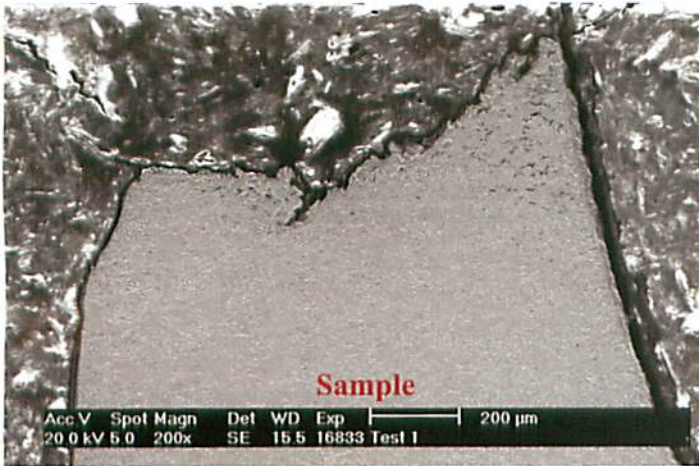
**FIGURE 16**—SEM micrograph of a cross-sectioned crack surface. The right side is the interior surface of the tube and the left side is the exterior. The crack, top, progressed from interior to exterior.

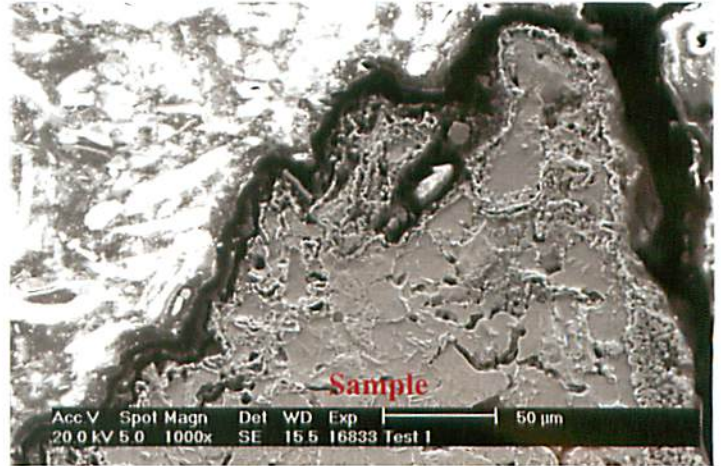
**FIGURE 17**—Magnified view of the crack origin in Figure 16. The right side is the interior tube surface. Note the corrosion and intergranular (between the grains) separation.
