## Case Study: Failure Analysis of Diesel Engine Cylinder Liners

*By Nagesh Goel  
Technical Director*

*Three used cylinder liners identified by numbers 277, 1016 and 1076 were submitted for failure analysis. The liners were pitted on the outside surface. Liner 277 had a crack under the flange, additionally. An unused liner was also submitted for reference. The following mileage information was provided*

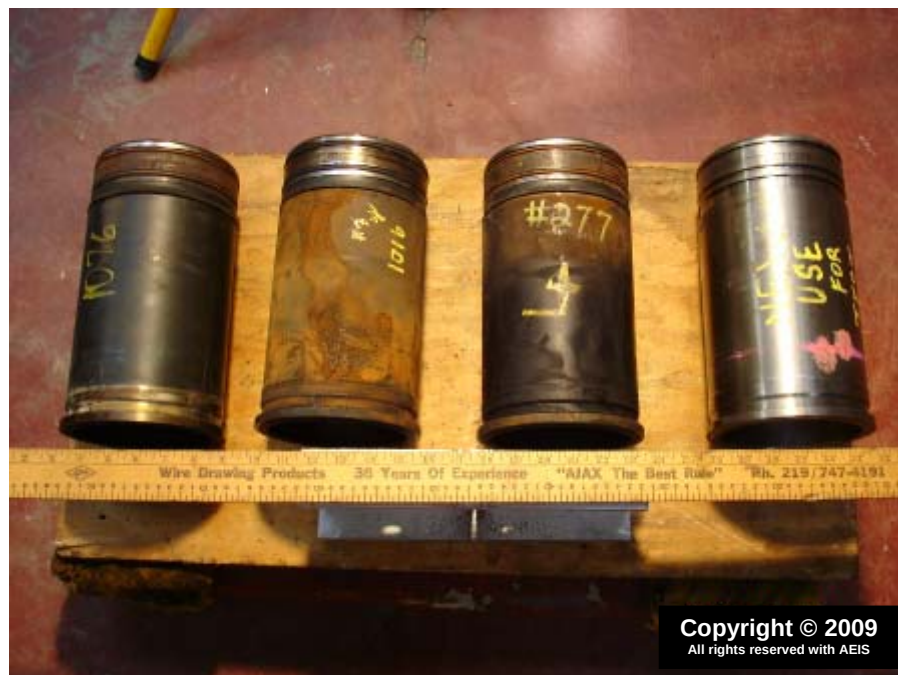
**Visual  
Examination  
of General  
Feature** Cylinder Number 277 showed pitting and erosion on the outside surface. No pitting was observed below the seal region. The metal loss was defined to distinct patches suggesting a perpetual flow pattern over a finite length of time. Cavitation was also observed in isolated regions in the cooling channel. Approximately 1/16 inch deep grooving immediately below the flange was observed. Attack was also observed on the lower face of the flange. A crack on the other side of the wall i.e. on the internal surface was apparent. The crack covered approximately half the circumference and had an opening approximately 1/32 of an inch in its widest spot; in the middle. Some scoring was observed in a band approximately 1/8 inch at the upper edge of the crack. A slight difference in surface level was felt by touch. The crevice seal, though slightly compressed, was found to be intact. The surface underneath was clean and free of any damage. Both the sealing O-rings were found to be intact and without any noticeable damage. The surface underneath was clean and free of any damage.

Figure 1: Cylinder liners in as received condition

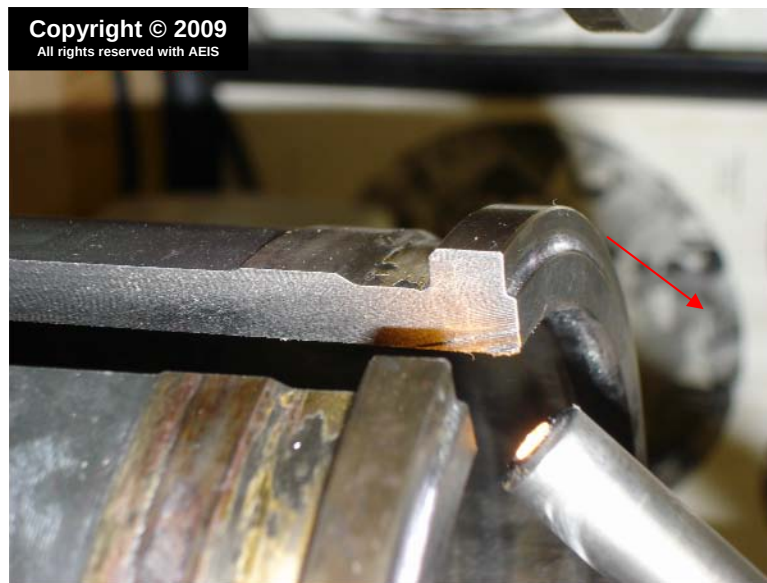
Cylinder liner Number 10076 was found to be generally free of cavitation, both on the general outside surface as well as under the flange. A small patch with a cumulative area of about one and a half square inch was found on the upper half of the liner. The cooling channel had some golden colored patches which appeared to be remains of an adhesive. Rectangular marks suggesting that the surface was covered by some strip was observed. The flange had a straw coloration apparently from an oxide film. The crevice seal was chipped at the upper edge. The damage did not spread across the width. The surface underneath was clean and free of any damage. Both the bearing shells were found to be intact and without any noticeable damage. The surface underneath was clean and free of any damage on cylinder liner 1076. The radius under the flange was recessed into the corner, Figure 2 unlike the new liner, Figure 3.

Figure 2: Profile of flange radius in cylinder liner 1076

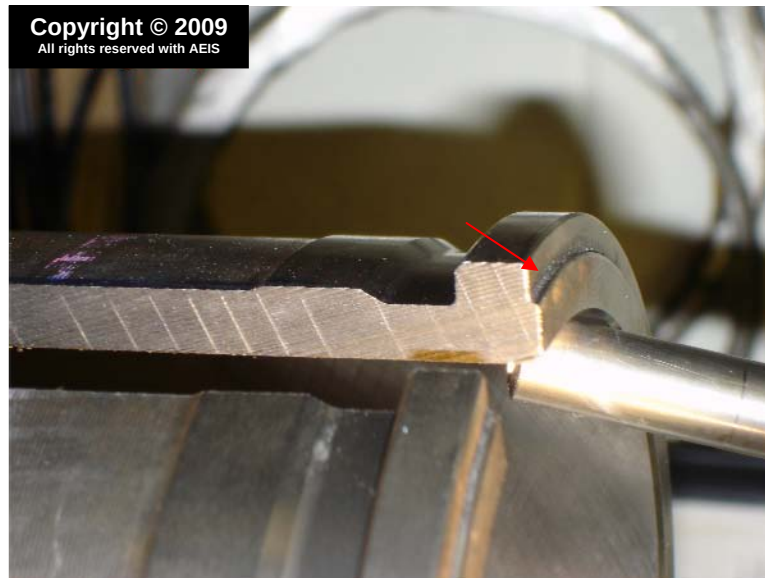
Figure 3: Profile of flange radius in new cylinder liner

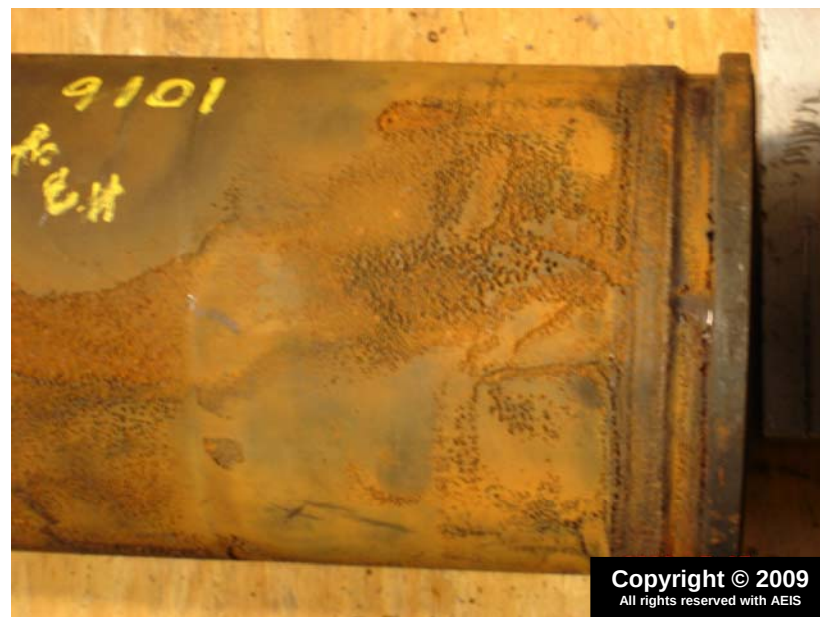
Cylinder liner Number 1016 had similar cavitation patches though deeper than cylinder liner number 277. The metal damage below the flange was observed in this cylinder liner too. The loss appeared to be similar in depth though on a lesser cumulative linear dimension. The crevice seal was found to be intact. The surface underneath was clean and free of any damage. Both the bearing shells were found to be intact and without any noticeable damage. The surface underneath was clean and free of any damage.

Figure 4: Cavitation patches on cylinder liner 1016

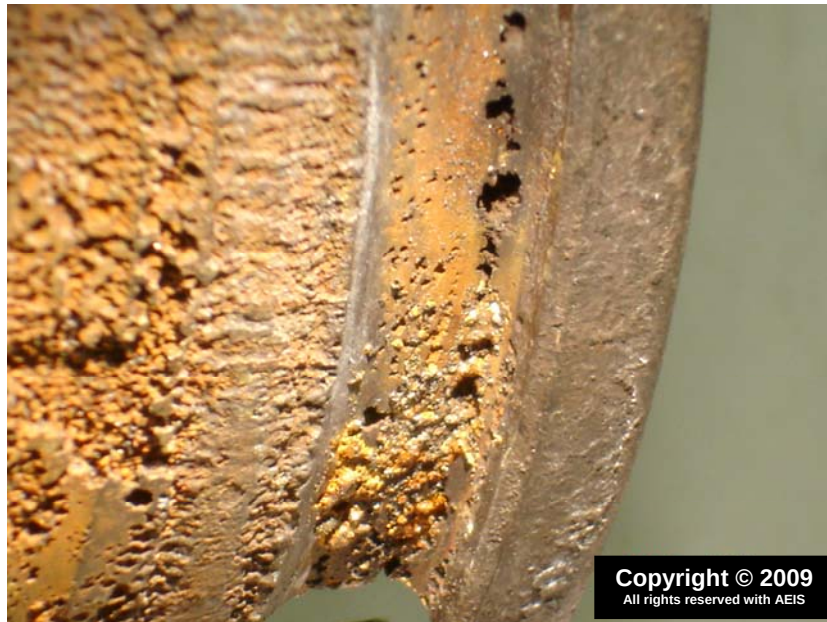
Figure 5: Close up of cavitation damage under the flange on cylinder liner 1016

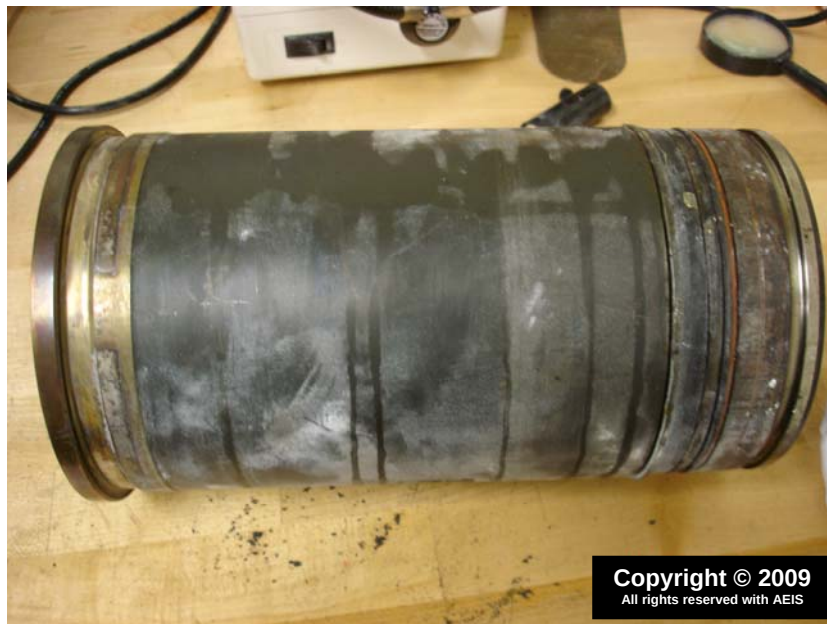
Figure 6: Outside surface of cylinder liner 1076 generally free of cavitations.

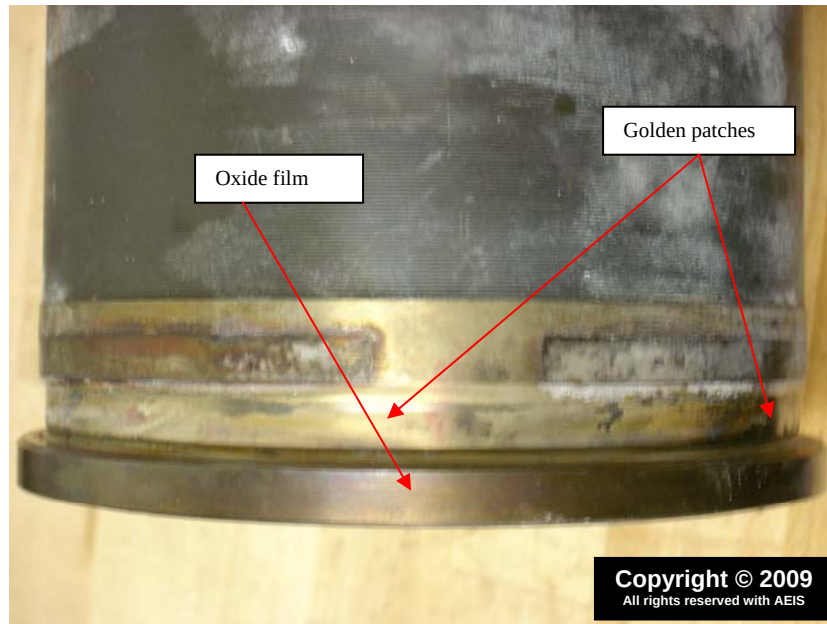
Figure 7: Close up of cooling channel area of cylinder liner 1076

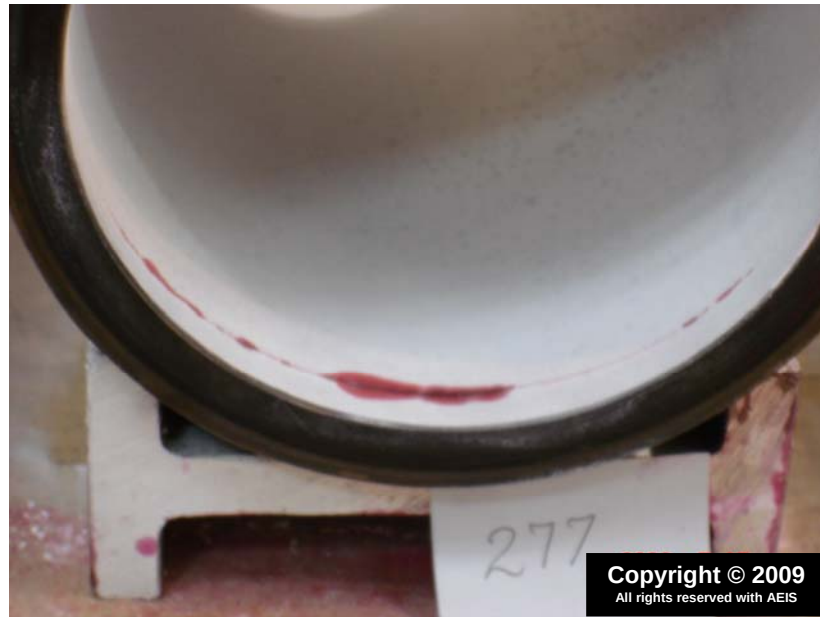
The cracked area on the cylinder liner number 277 was examined under low powered optical microscope. The observations made in the visual examination were confirmed. Figure xx and Figure XX shows the cavitation loss under the flange. The crack surfaced along a circumferential mark approximately 3/16 inches from the upper surface of the flange. The outside opening coincided with the eroded corner of the flange. The crack on the cross section at one end was observed to be having a profile of an arc with an approximately 1/4 inch radius. The difference in surface level across the crack is obvious in figure.

Figure 8: Crack in Cylinder liner 277

It may be observed that the crack in liner is circumferential in morphology and does not cover the entire circumference. Such a crack can result from an axial force that is not uniformly distributed on the entire periphery or a weakness in material at the crack initiation point. Had an inherent weakness in the cylinder liner been of sufficient magnitude the liner would have failed before the recorded 156,829 miles. The force exerted by the firing stroke however could exert an unbalanced and increased pressure around the periphery because of randomly reduced cross section and the stress concentration occurring because of very small size of pits. The crack initiation was from such a grooved area. It is noteworthy that graphite flakes in cast iron are in fact tiny lamination in themselves and are a cause of stress concentration. Should an excessive force be exerted across its plane, it can open up along its surface. Microstructure shows the propagation of crack along such planes. Visual observations and macroscopic examination showed that cavitation was present on a well spread area on the upper half of the cylinder liner 277, including area on the under side of the flange. It had cut a groove into the lower corner of the flange. This suggests that the coolant had access to these surfaces including the surfaces governing the critical dimensions. This could misalign / cause a play in the liner. Such a condition could raise the stress to a damaging level.

All the used liners suffered from cavitation damage. In our opinion the metallurgy of the liners did not have any significant bearing on the extent of damage. In absence of that, the cooling environment was the major single factor for causing pitting. It is also our opinion that cavitation under the flange was primarily responsible for cracking of cylinder liner 722.

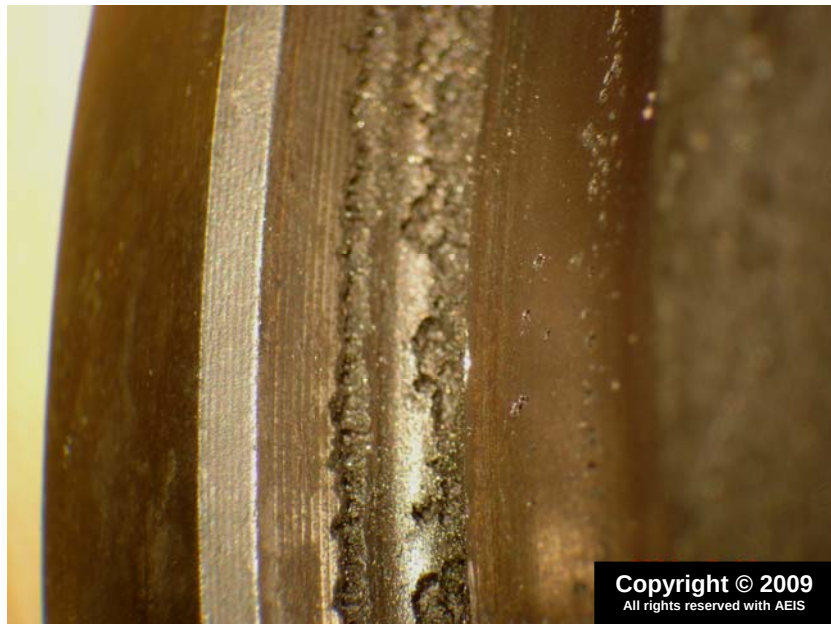
Figure 9: Cavitations immediately under the flange

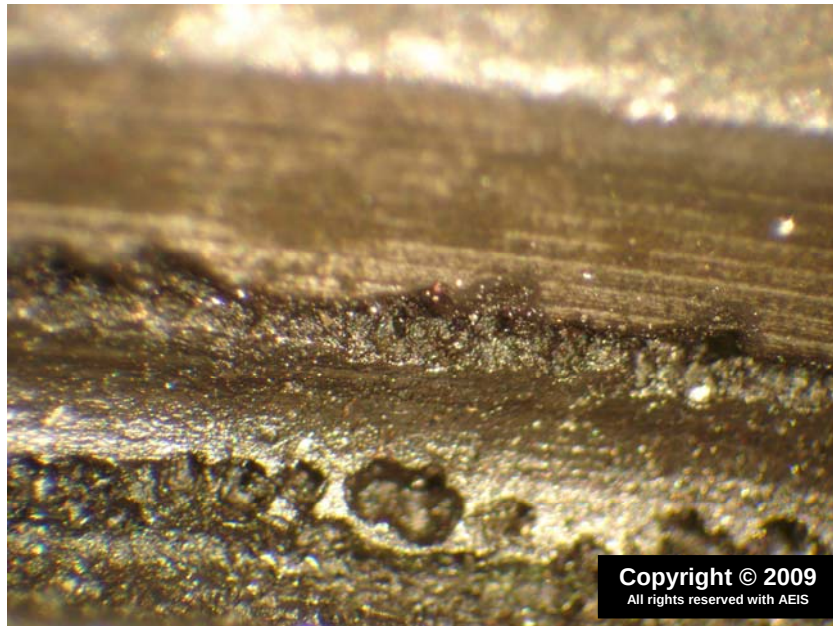
Figure 10: Close up of the cavitations immediately under the flange

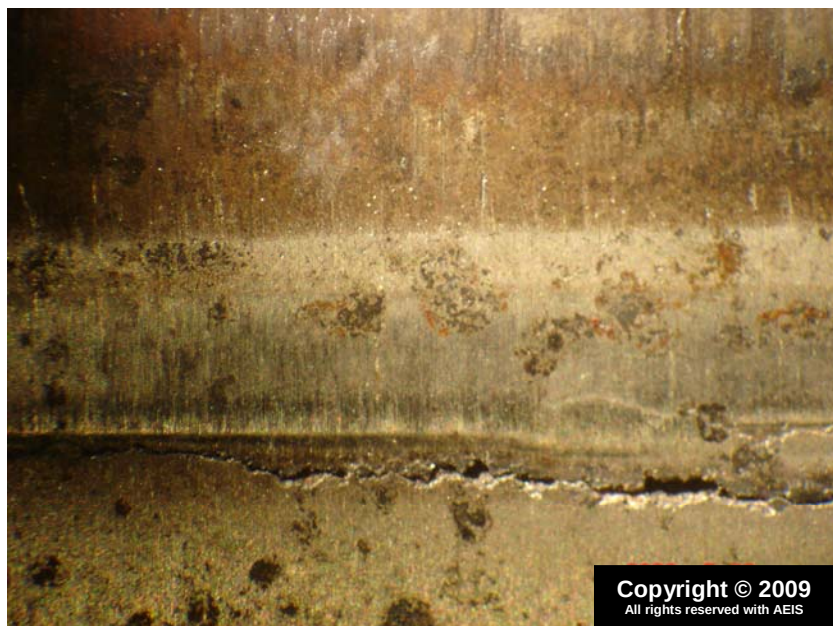
Figure 11: The crack and the scored band on the inside surface

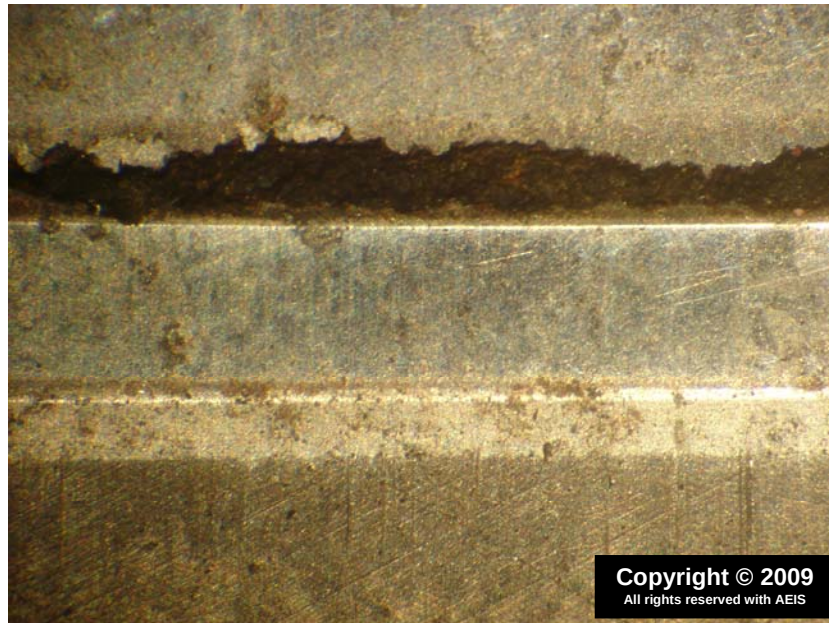
Figure 12: Damage on the inside surface in the middle of the crack length..

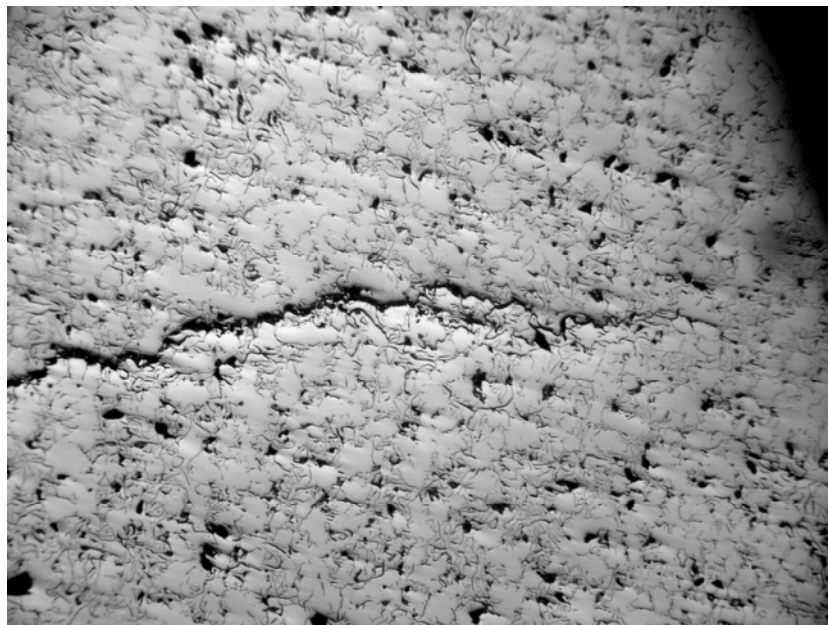
Figure 25: Crack propagation profile in liner 277 100X Magnification

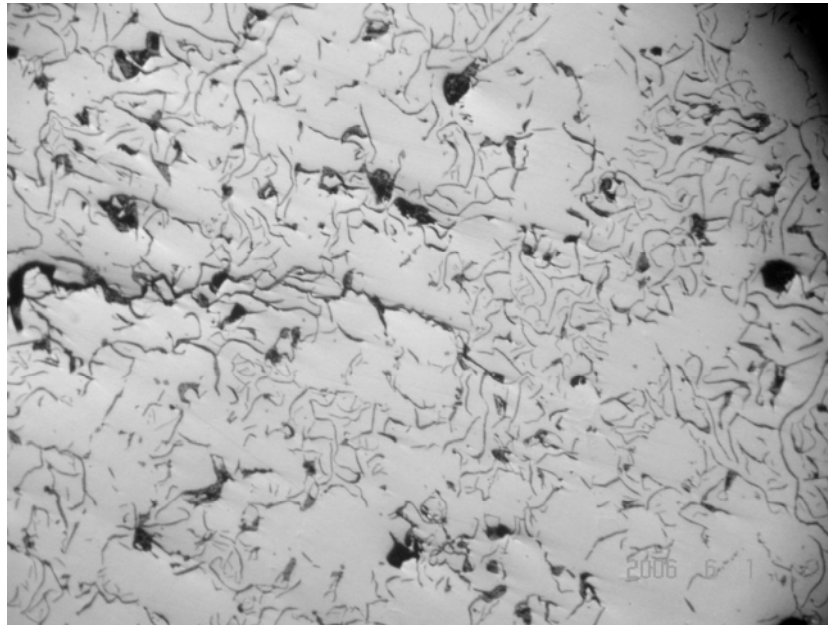
Figure 26: The crack propagation in liner 277 along the graphite flakes. 150X Magnification

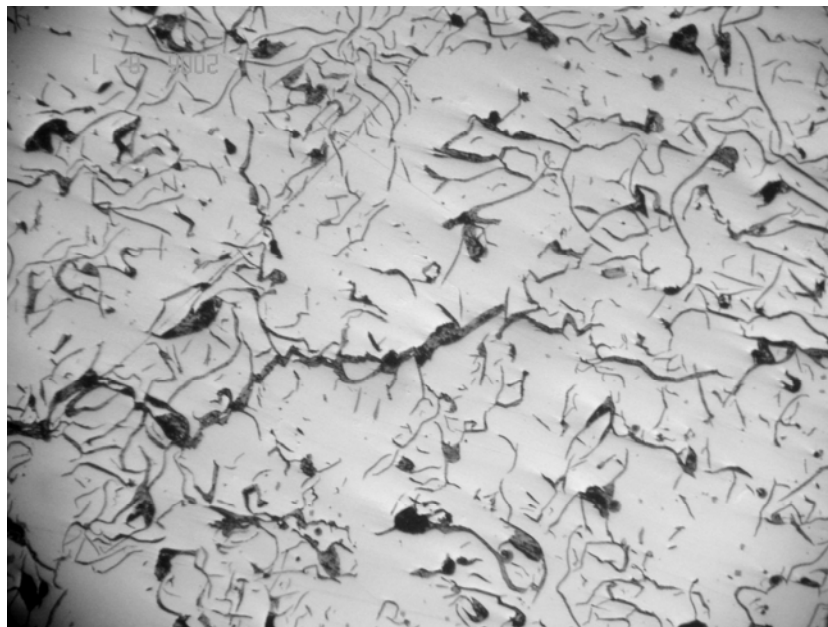
Figure 27: The crack propagation in liner 277 along the graphite flakes. 200X Magnification

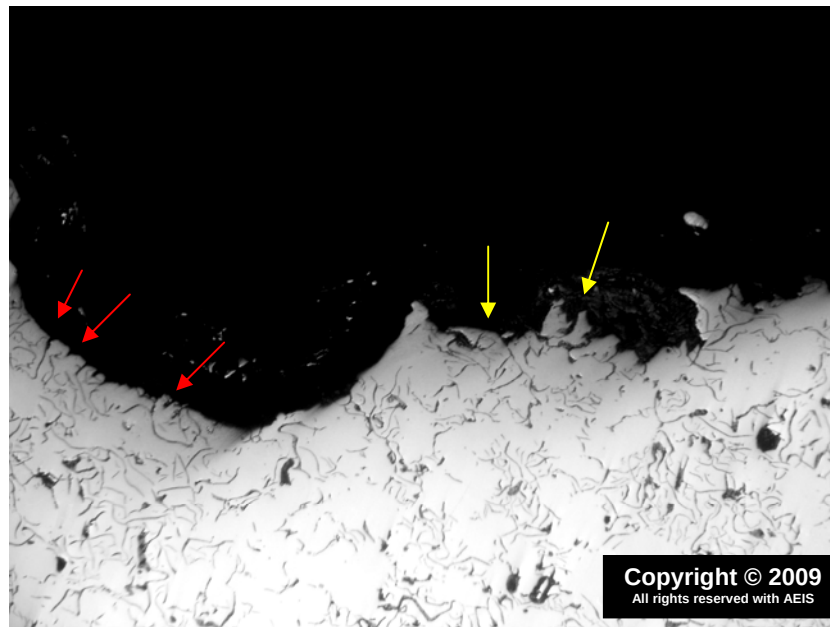
Figure 28: Stress points and attrition at the bottom of the cavitation pit. 100X Magnification

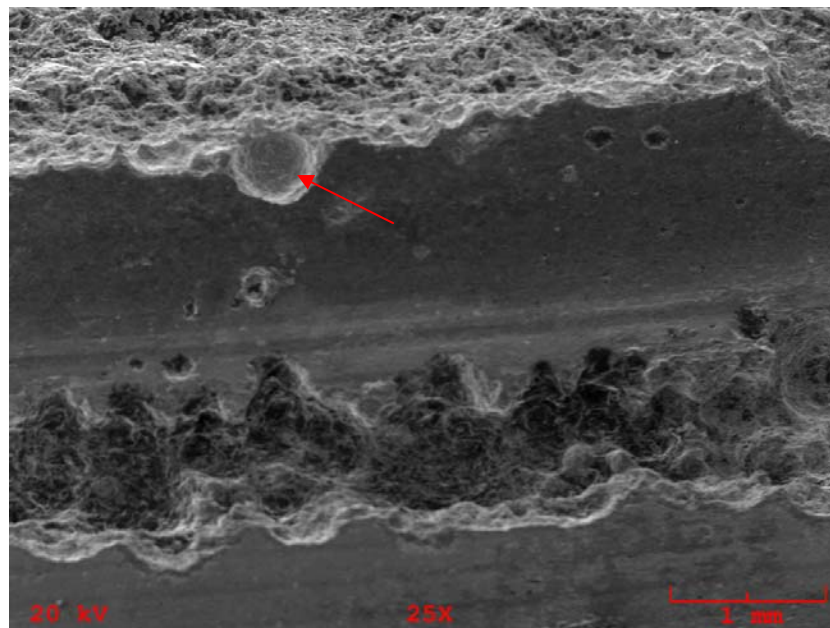
The fracture surface was examined under a scanning microscope. Cavitation pits were observed on the fracture surface.

Figure 29: SEM photograph of fracture surface showing a pit profile

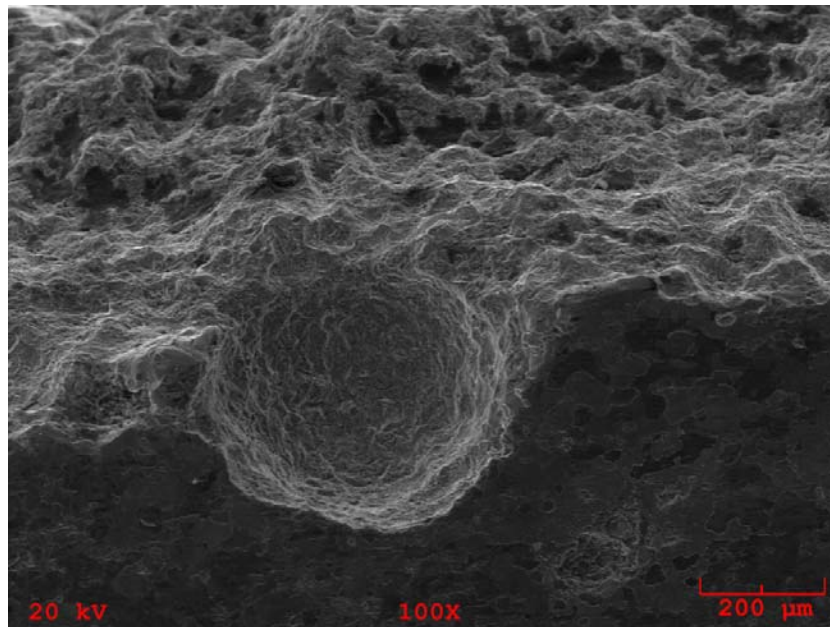
Figure 30: SEM photograph of close up of the pit

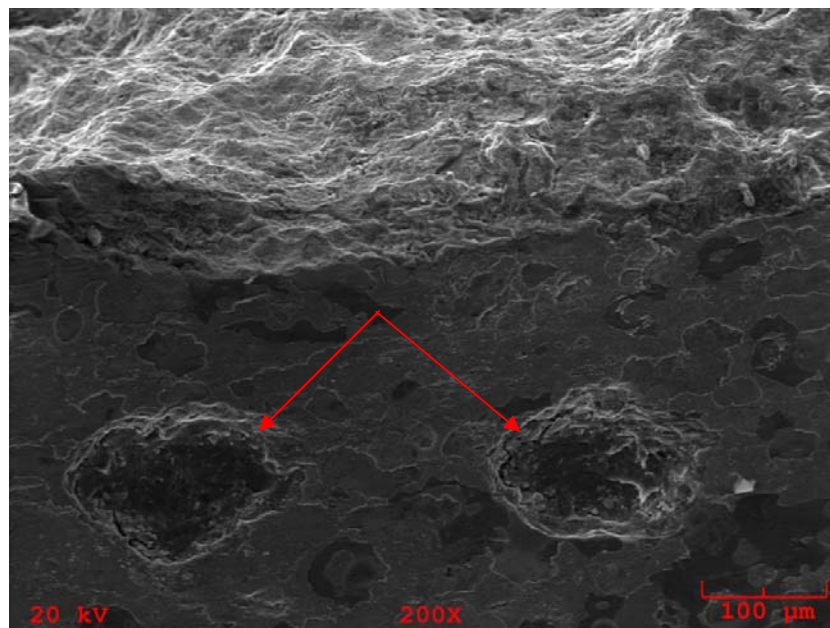
Figure 31: SEM photograph of pits on the fracture surface
