Orion P. Keifer  
Peter D. Layson  
Charles A. Wensley

# Investigating Absorption Refrigerator Fires (Part I)

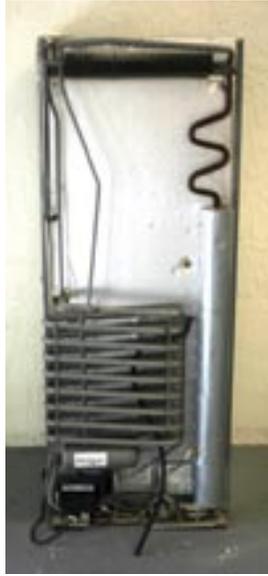
**FIGURE 2—Rearview of a recalled Dometic RM 2852 absorption refrigerator.**

The boiler region, as seen in Figure 2, is surrounded by fiberglass insulation and galvanized steel sheet metal. This enclosure most often prevents a visual inspection of the subject area. It is recommended that proper notification, in accordance with ASTM E 860 *Examining And Preparing Items That Are Or May Become Involved In Criminal or Civil Litigation*<sup>[5]</sup>, be sent to potential parties before this inspection is performed.

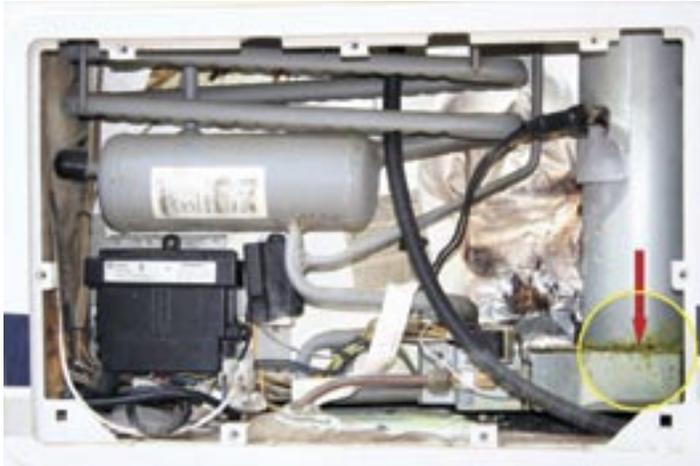
Another indicator of a refrigerant leak is the presence of sodium chromate on the exterior of the sealed system. Sodium chromate is a yellow crystalline compound which is very soluble in water. While water and ammonia are normally colorless, the sodium chromate imparts a yellow tint to the water solution. Evidence of yellow residue in the area of the boiler region of the cooling unit before or after a fire

event indicates a loss of refrigerant as well as partial de-pressurization of the system. Figure 3 shows the presence of sodium chromate on a recalled Dometic RM 2662.

**FIGURE 3**—Rear view of a refrigerator in an RV after the refrigerator access panel was removed. Note the yellow residue on the galvanized steel sheet metal and below the incoming propane gas line.

Care must be taken while looking for sodium chromate, as it can be blown and/or wicked away from the original leak site. It has been suggested during some inspections that the yellow residue at the back of the refrigerator could be from other sources, such as a fire extinguisher. At some point in the investigation it may be necessary to have the residue tested for the presence of sodium chromate.

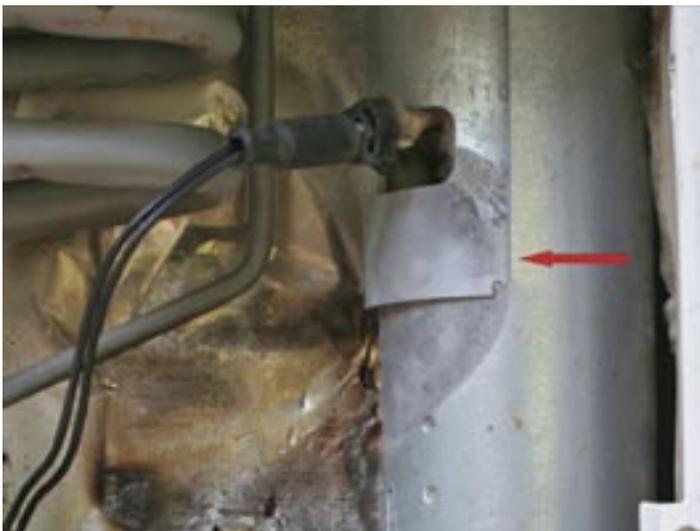
Evidence of isolated thermal stress to the galvanized steel sheet metal in the area of the boiler indicates an abnormal thermal event. Closer examination of the heat affected area normally reveals a radial heat pattern. See Figure 4 for an example of localized zinc discoloration.

**FIGURE 4**—Note the discoloration and radial heat pattern of the zinc coating on the steel sheet metal.

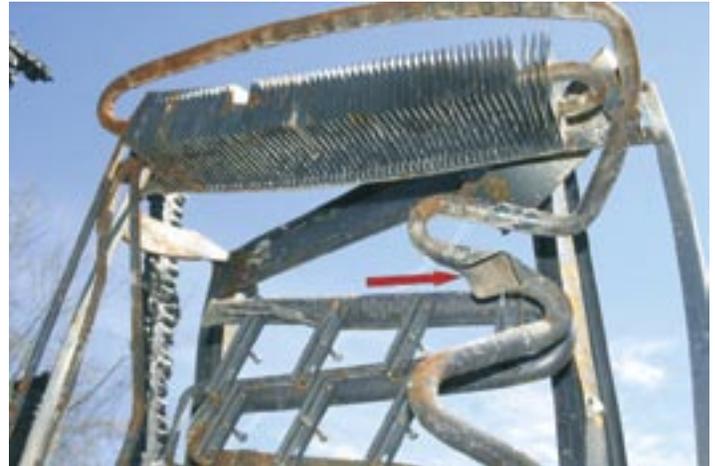
If the cooling unit exhibits a rupture at a location where it does not have a known heat source, this indicates an external fire was the cause of that damage. Importantly, the entire cooling unit is under the same pressure: however, metals lose yield strength with increasing temperature. A rupture that occurs at a site without a known heat source indicates an external fire caused the steel in that location of the cooling unit to rise in temperature and weaken until the pressure inside the cooling unit exceeded its wall strength. Figure 5 shows a rupture in the upper portion of a Dometic cooling unit which was caused by an external fire.

**FIGURE 5**—Rupture of the cooling unit involved in a complete RV burn. This unit had maintained pressure up until the point where a fire weakened an area of the cooling unit sufficiently to yield catastrophic failure.

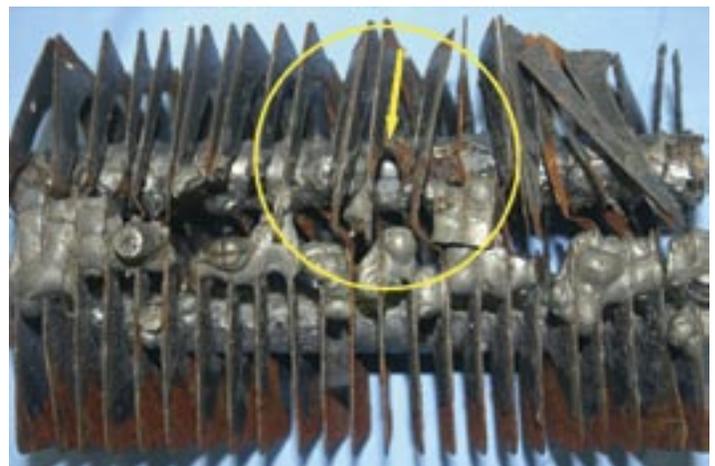
It is common to see the dissolution of steel components when molten aluminum falls on the steel surfaces. The steel surfaces must be at temperatures in the range of the molten aluminum for the dissolution process to occur. This has been observed many times on the condenser fins and coil of cooling units as seen in Figure 6. This can occur with or without pressure in the system reducing its helpfulness

**FIGURE 6**—Leak site created in a cooling unit condenser due to dissolution of the steel tubing wall in molten aluminum.

in determining whether the refrigerator caused the fire. It can, however, be misleading to a fire investigator unfamiliar with this interaction.

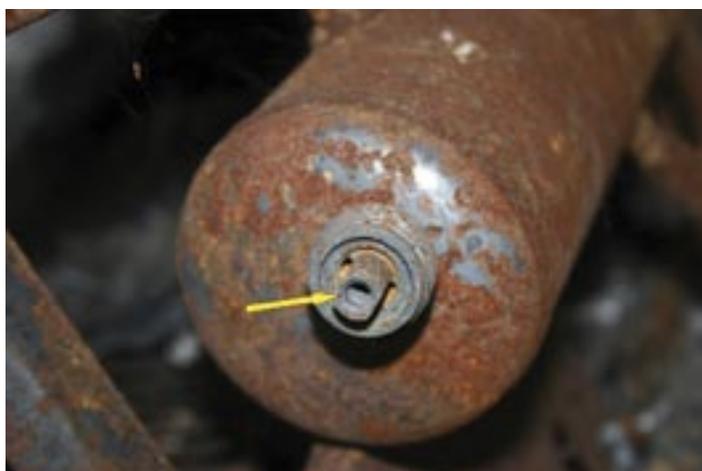
Absorption refrigerators have a built-in temperature relief plug made of a tin-bismuth alloy. The purpose of this plug is to blow out if exposed to abnormally high temperatures, causing the cooling unit to depressurize instead of undergoing a catastrophic rupture in an unknown area. This particular alloy is used because it has a low melting temperature, with a eutectic temperature of 281° F (138° C)<sup>[7]</sup>. On Dometic units, this plug is located on the absorber vessel and oriented away from the boiler region of the cooling unit, as in Figure 7. Figure 8 shows the Norcold unit design, and the plug is located higher up on the absorber coils and is also oriented away from the boiler region of the cooling unit. If the plug is observed to be “blown out”, with little heat/fire damage in the area of the plug, then it was likely exposed to temperatures higher than normal operating temperatures produced by an attacking fire. Fire patterns must be analyzed to determine how an attacking fire reached the blow plug.

FIGURE 7—Shows the relief plug on the absorber vessel of a Dometic RM 3862 refrigerator unit which has been “blown out.”

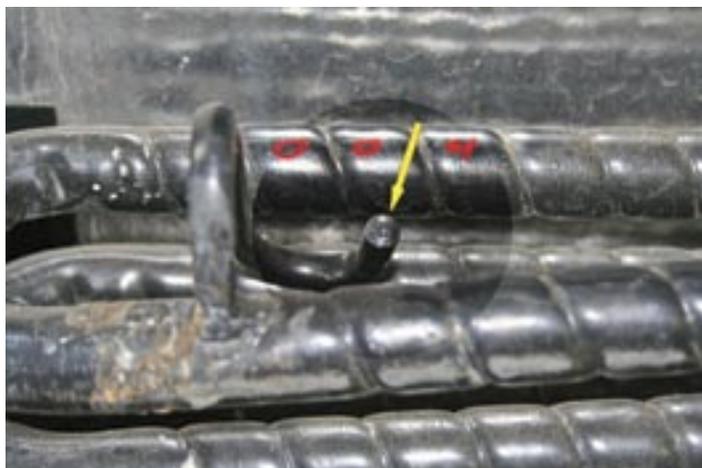
FIGURE 8—Shown is the still intact relief plug of a Norcold N621 refrigerator unit which is located at the top of the absorber coils.
