FIRE INVESTIGATIONS

WHY MOTORCOACHES MAY BURN

(A MECHANICAL ANALYSIS)

A CVSA SPECIAL REPORT

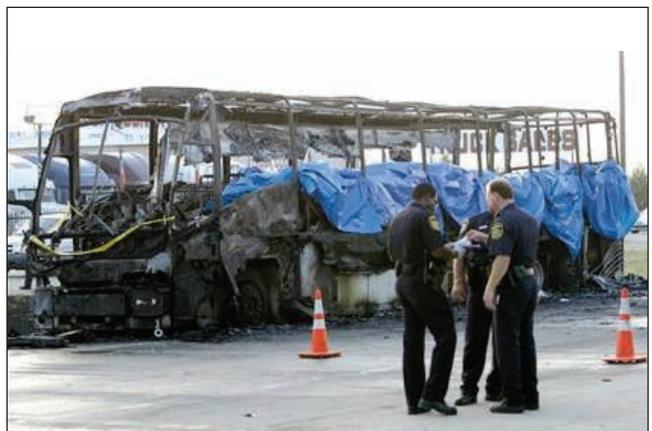
As simple as it appears, if the vehicle is in motion certain items are valid as possible causes. Likewise, if the vehicle is stationary with the engine on or off other items become potential causes. In either case, the situation is dangerous and costly in both human life and property (Photo 1).

Photo 1: Motorcoach involved in fire during Hurricane Rita evacuation (September 24th 2005)

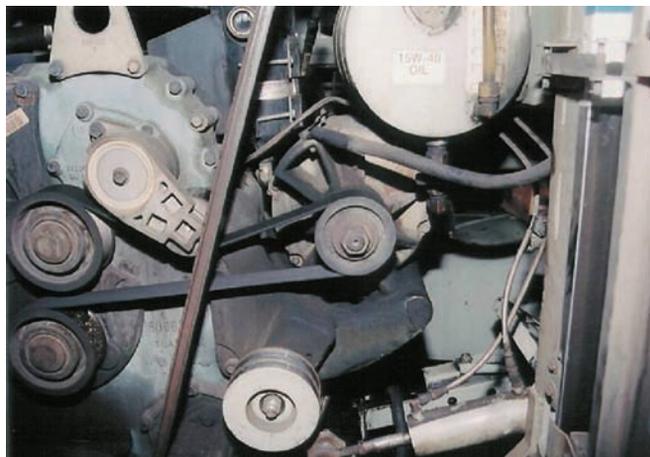
nator similar to an automotive application; but larger. The typical varieties are a Delco 50-DN (Photo 3a) or an air cooled dual Bosch T1 (Photo 3b) configuration. The author must stress that these manufacturers are not being singled out for any particular reason; however, they are the most commonly found units within this type of vehicle. For most applications, the charging system for the motorcoach produces 275 amperes or more — as much amperage as a typical single family home may have. With this, the alternator (and system) carries great potential as an ignition source.

Typically with a 50-DN installation (Photos 3a & 3c), the B+ (direct battery feed) cable is routed to a large stud on the back of the alternator. This in turn is held in place with a nut (to the stud) along with various clamping methods to secure the cable end from any movement (Photo 4).

Photo 3A: 50-DN, Series 60

These connections must be quality checked after the alternator has been installed and inspected periodically as well as to ensure there is no movement. *It is noteworthy to point out that with some applications, these cables may need to be temporarily removed to facilitate other non-alternator related repairs. The same care and vigilance should be used whether alternator or other repairs are being made. If the B+ cable is loose, it can, by its own weight either fail the plastic insu-*

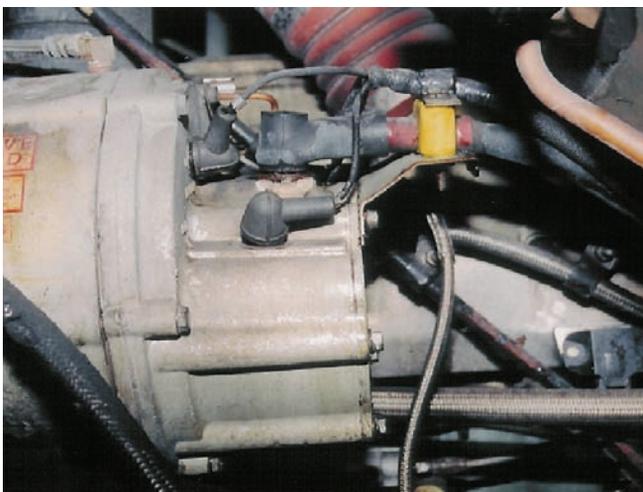
Photo 4: 50-DN, Series 60, MCI Installation

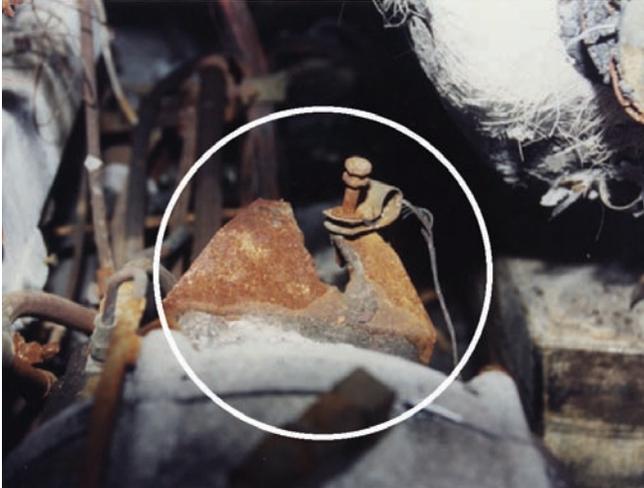
Photo 5: 50-DN, B+ Bracket, Series 60

lator material surrounding the stud at its base, internal to the alternator, or wear through the cable insulation locally and make unwanted contact with the support bracket. When this occurs the cable can act similarly to an arc welding machine and cut its way through the bracket (Photo 5).

Once the B+ cable end is free, the cable can drop, making contact with a ground source, resulting in a sustained duration spark. This is exceptionally critical in that with some engine applications the alternator is installed above and on the fuel side of the engine.

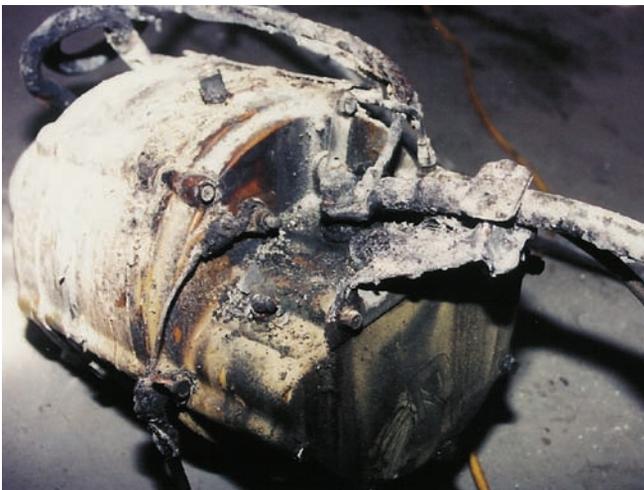
Photo 6B: 50-DN, Result of Failed B+ Stud Insulator

In addition to the cable and its' mounting system there is another potential fire hazard. When installing the B+ cable to the stud (50-DN) the proper torque must be used to ensure that the plastic material (internal insulator) is not broken or compromised in any way (Photo 6a). If this nut is over-torqued, or otherwise installed incorrectly, it could lead to a loose stud subsequently leading to an ignition source and fire (Photo 6b).

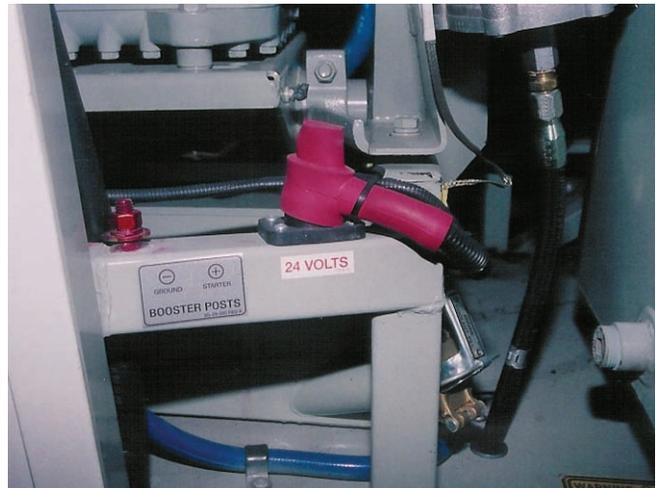
Remote Jump Post: With some applications a convenience feature is provided in the engine compartment for "jumping" a disabled vehicle. This is typically a positive (+) cable running from the starter to an exposed stud. These connections must be inspected and maintained to provide integrity. Additionally, this stud is covered with a flexible rubber boot (Photo 7).

Photo7: Remote Jump Post

This boot must be in good condition and over the positive (+) stud at all times. A loose jumping stud/cable can create a sustained duration spark similar to the alternator B+ cable.

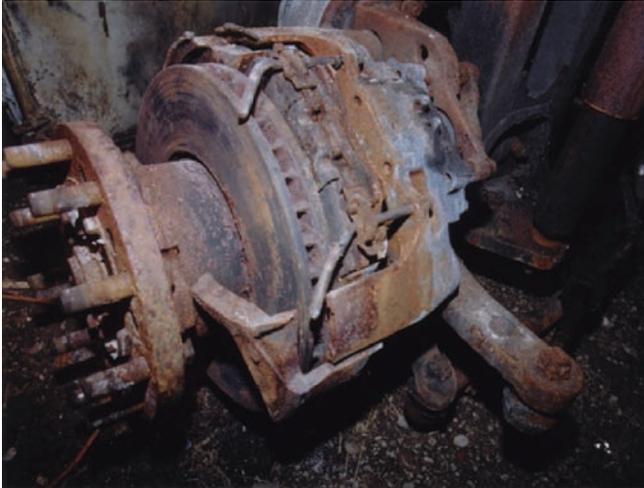
Photo 9: Disc Brake (RH Tag Axle) [Involved]

An additional risk exists, with disc brake applications, during a wheel bearing/hub failure. That is, as the outer bearing begins to fail, the hub load is transferred from the outer bearing to the brake caliper, brake pads and rotor. Once the outer bearing has failed completely, no longer able to support the hub load, the caliper, brake pads and rotor are then supporting that particular wheel end (Photos 9 & 10).

Once the brake caliper begins carrying the load, at that particular wheel end, the surface temperature of the brake pads and rotor (or drum) rise well above the auto-ignition temperature of the surrounding combustibles (due to friction) and eventually igniting them. The combustible material typically ignited by this failure mode is the tire(s). Tires generally revert (melt) at approximately 250°F and catch fire over the 600°F mark. It is common, although not mandatory, for the tire fire to occur when the vehicle comes to a stop. This is the condition with the least amount of air flow circulating around the brake rotors, brake drums and tires. Without air flow around these items, their temperature rises rapidly and is transmitted to the tire—subsequently igniting it. This concept of brake caliper/pad/rotor supporting the hub load can typically be seen by a thinner more worn outside brake pad as compared to the inner pad. This is due to the hub moving outward, away from the spindle. As a result of this temporary load support from the caliper, the

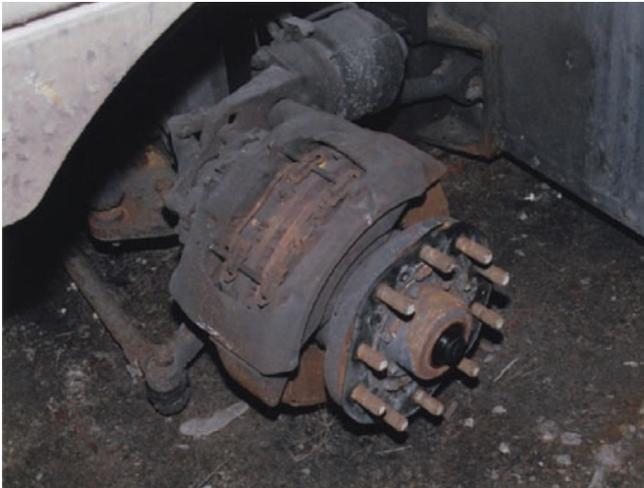
Photo 10: Disc Brake (LH Tag Axle) [Not Involved]

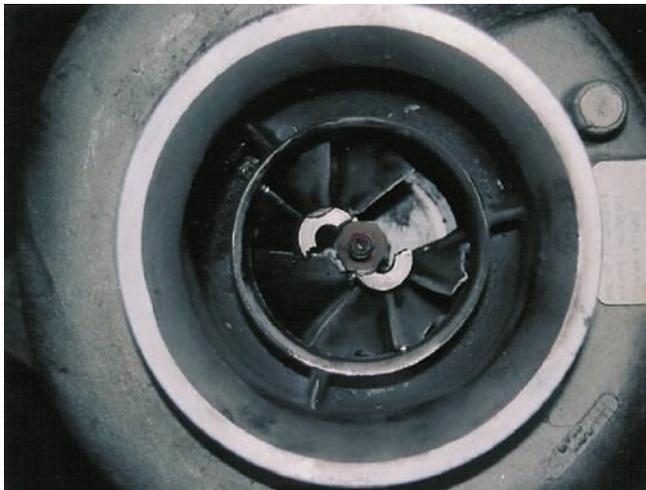
Upon a failure of this bearing system or an imbalance of either the turbine or compressor wheels contact is made within the turbocharger housing causing a rapid deterioration of the compressor and turbine (Photos 12 & 13).

Once the shaft has been re-oriented as a result of any one of the aforementioned failure modes, the shaft seal(s), which controls the lubrication oil within the bearing cavity, subsequently fails allowing oil to enter directly into the hot side (turbine) of the housing and then directly into the exhaust system (Fig. 8). This can create an auto-ignition fire within the turbocharger itself or exhaust system.

Photo 12: Failed Compressor, Series 60

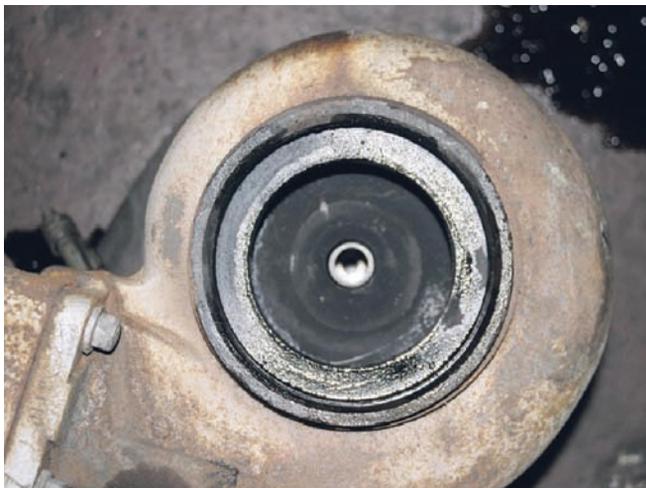
Photo 13: Failed Turbine, Series 92

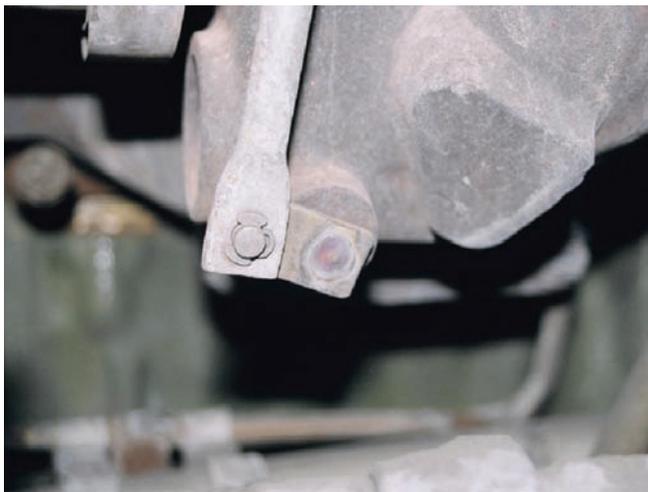
used to detect the onset of an internal turbocharger failure. If the turbocharger has experienced an internal failure the performance of the engine is compromised. Specifically, blue smoke, due to oil consumption along with reduced engine torque will be noticed. Also a specific oil leak, from the waste gate pivot point, can be observed (Photo 14). Once oil has begun to leak from this point on the tur-

Photo 14: Waste Gate Pivot, Series 60

bocharger it should be removed from service and the exhaust system should be thoroughly cleaned. To assist in preventing this failure mode; the turbocharger waste gate or variable geometry function (V.G.T.) must be confirmed. Additionally, the shaft free play, both axially and radially, must be inspected by a mechanic.

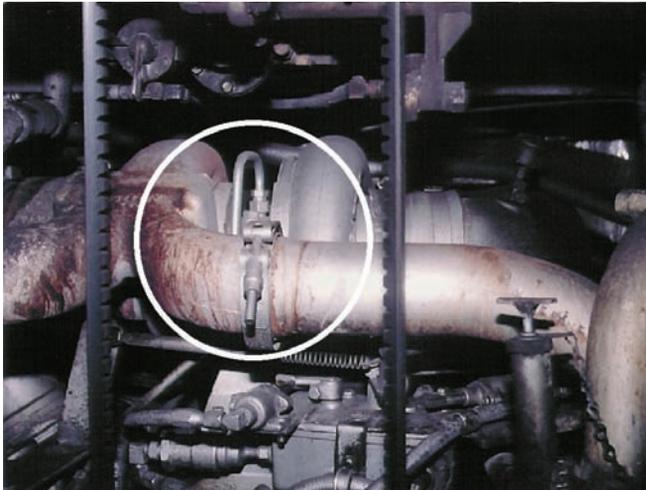
External Turbocharger Oil Lines: With the Detroit Diesel Series 92 application, there is only one external oil line. The oil supply line is positioned on top of the turbocharger and must be inspected periodically for leaks (Photo 17).

Photo 17: Turbocharger Oil Inlet Line, Series 92

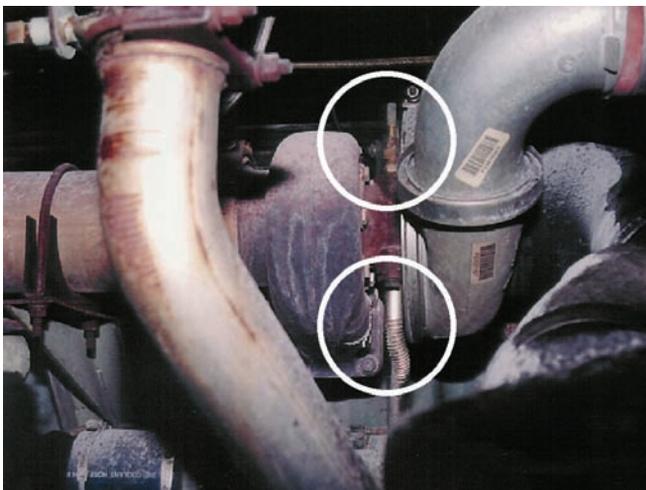
Photo 18: Turbocharger Oil Inlet and Outlet Line, Series 60

inspected (Photo 18). These turbochargers have an external supply and return oil line. In either case, a leaking oil line must be repaired to prevent an auto-ignition fire.
