National Highway Traffic Safety Administration

2009 SAE Government Industry Meeting

# Motorcoach Roof Crush/Rollover Testing

February 2009

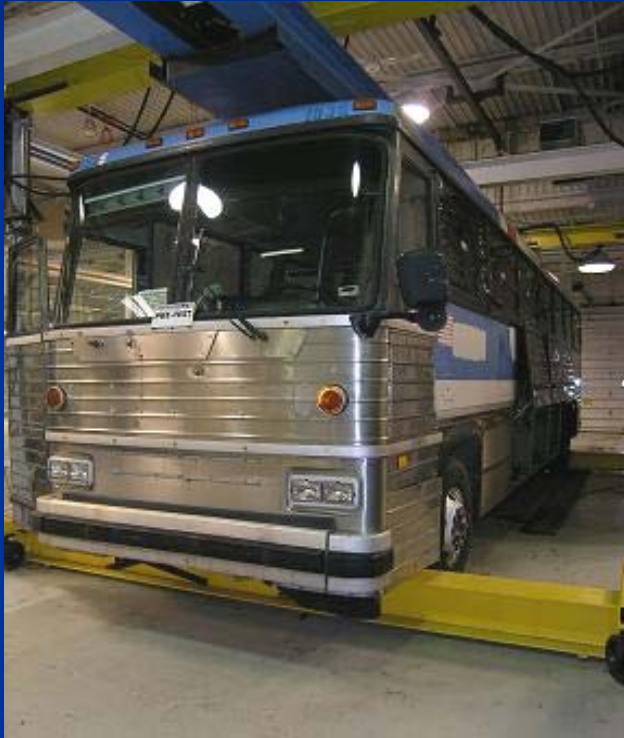
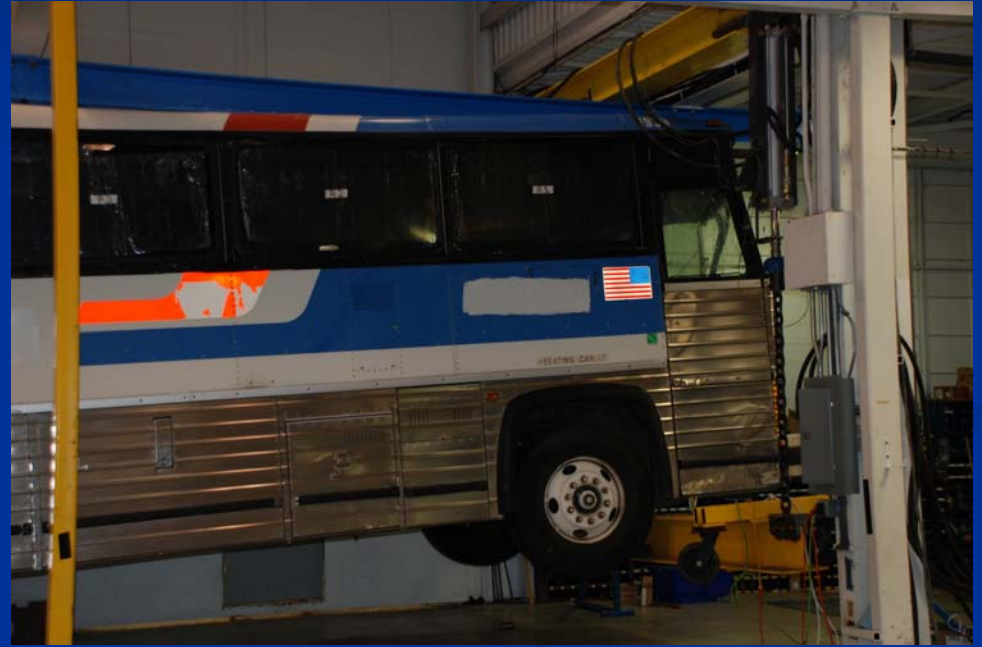
# FMVSS No. 220 Test setup

- Uniformly distributed load equal to 1.5 times the unloaded vehicle weight (UVW)
- 36 inch wide plate, one foot shorter than the bus length, placed along the longitudinal centerline of the roof
- Maximum crush  $5 \frac{1}{8}$  inches
- Emergency exits remain operable during and after the test

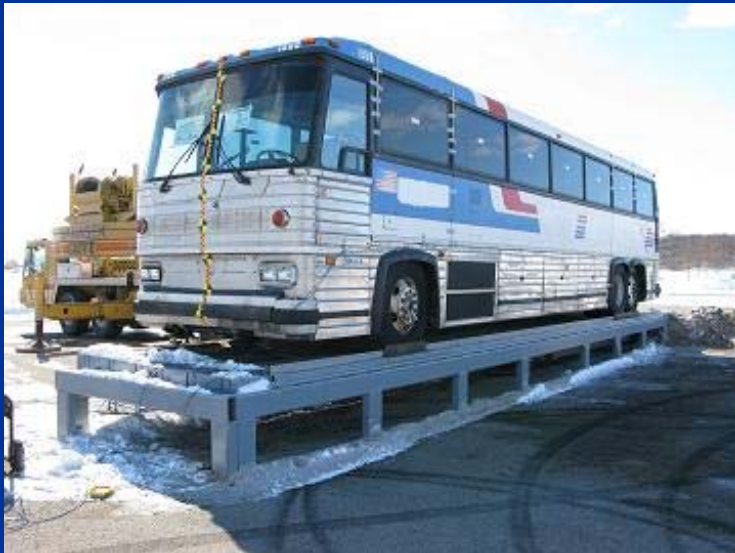
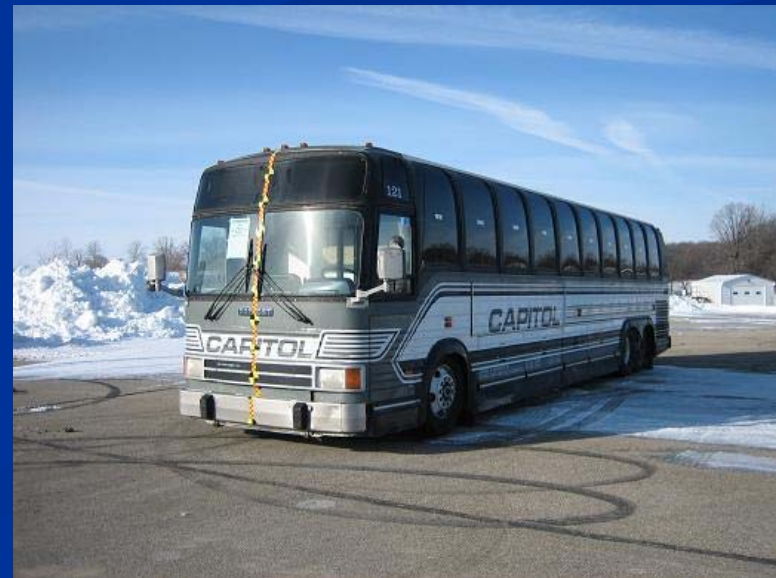
# Test Vehicles

- 1992 MCI MC-12 40’ coach
- Weight: 27,853 lbs UVW
- Window spacing: ~58” CTC
- 1991 Prevost LeMirage 40’ coach
- Weight: 29,270 lbs UVW
- Window spacing: ~40” CTC

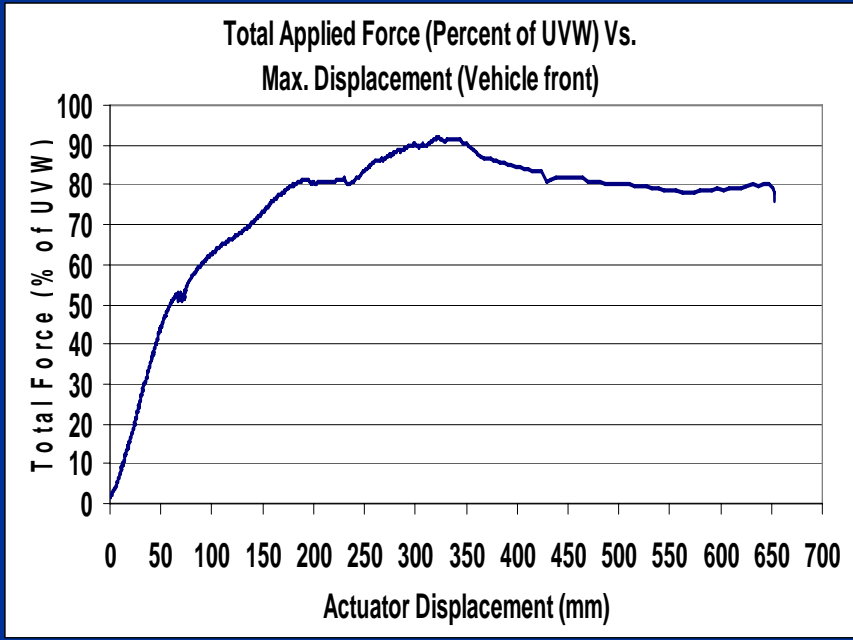
MCI – MC12

- MCI bus reached a maximum of 0.91 UVW
  - Reached FMVSS No. 220 limit ~ 0.7 UVW
- Prevost bus reached maximum of 1.31 UVW
  - Reached FMVSS No. 220 limit ~ 1.0 UVW
- Emergency exits remained operable during and after the test

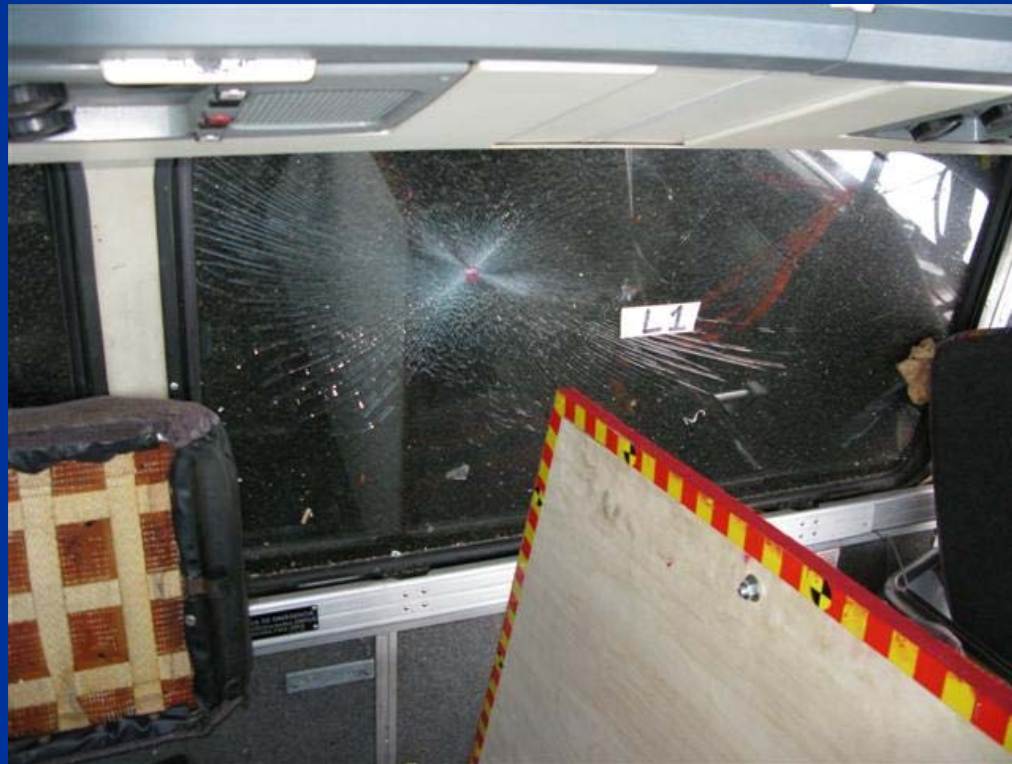
## Test Results – ECE r.66

- Both buses the front residual space template struck the side window in the front

- The front of these two buses is weaker than the back - Contact between the front residual space template and side window
- The roof emergency exits opened when the roof of the bus impacted the ground - provides a potential ejection portal
- MCI bus, the unrestrained ATD, one IAV (Nij (compression-extension) 1.10) that was slightly over the acceptable limit.
- Prevoost bus, the ATD fell across the bus head first on to the side window on the ground, resulted in multiple IAVs that were well above the acceptable limits
- Average accelerations from the roof accelerometers when the buses impacted the ground ranged from 7.59 to 8.2 g's
