Subject: Motorcoach Safety Research

Motorcoach Roof Crush/Rollover Testing Discussion Paper, March 2009

Motorcoach Roof Crush/Rollover Testing

Discussion Paper

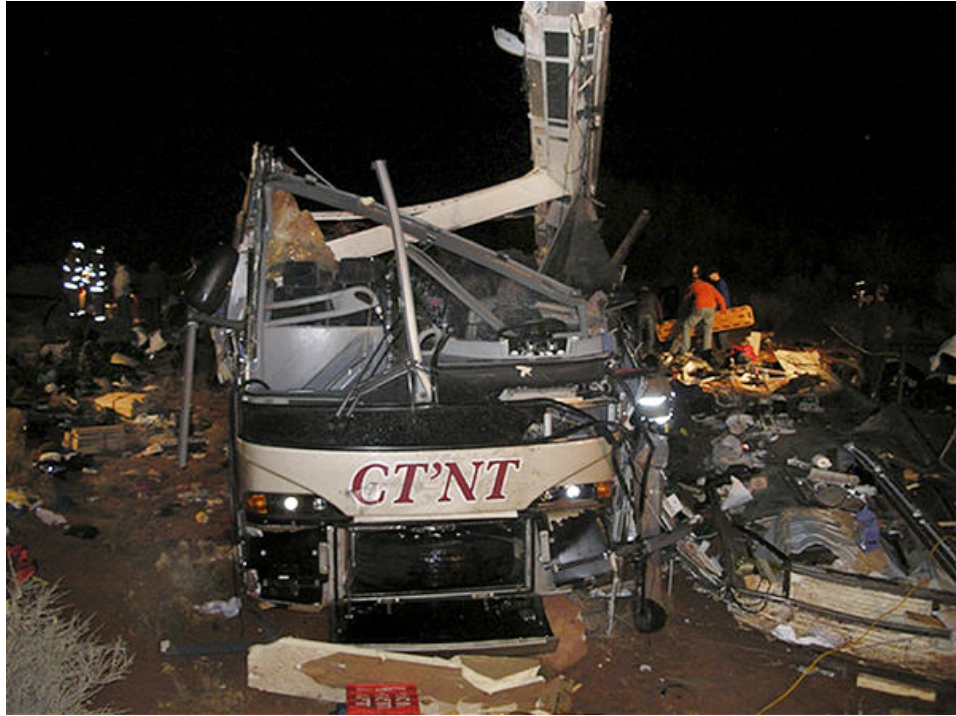
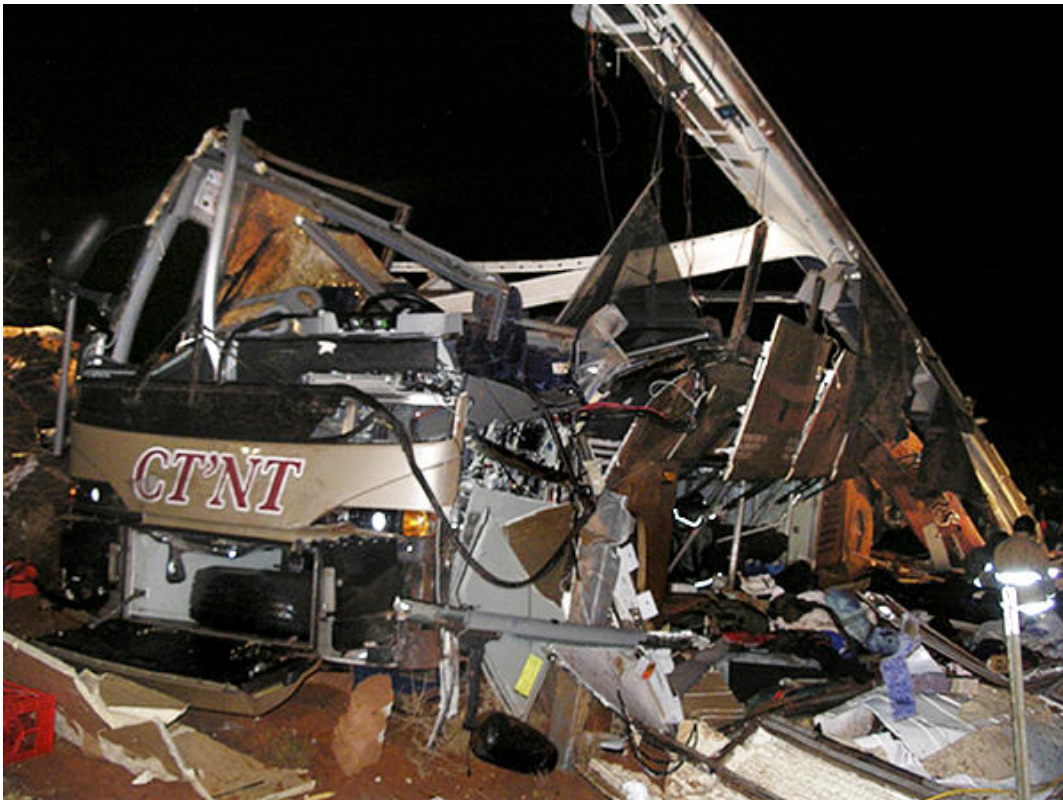
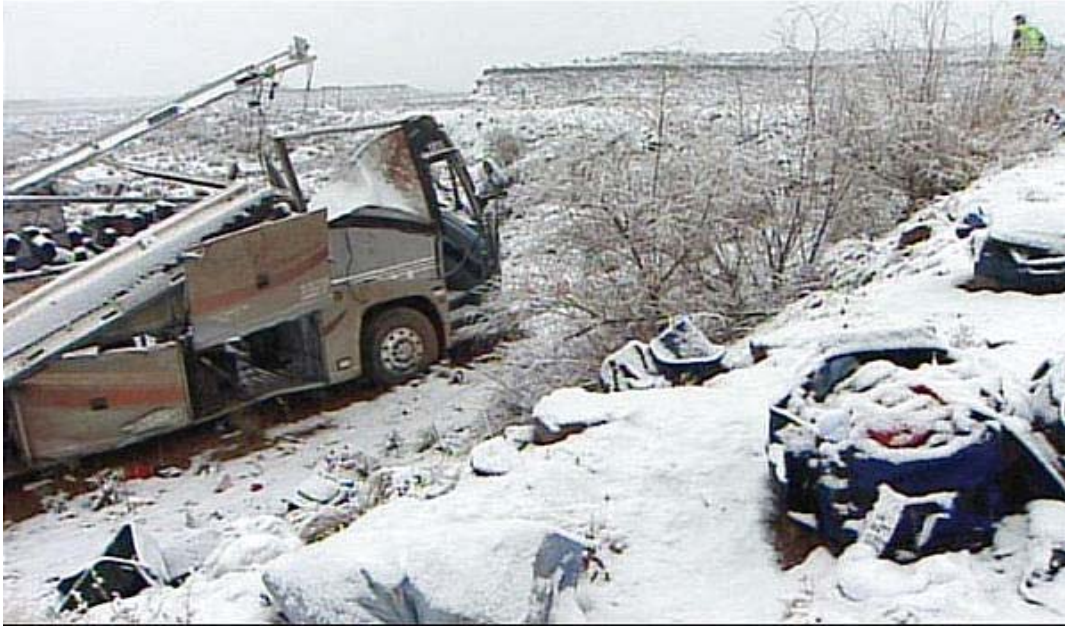
Figure 1: Mexican Hat Bus Rollover, Front View

Figure 2: Mexican Hat Bus Rollover, Oblique Left Side

Figure 3: Mexican Hat Bus Rollover, Side View Looking Down Embankment

In the 1999 report, NTSB cited an October 1971 rollover of a 1970 Motor Coach Industries (MCI) motorcoach to justify a roof crush safety recommendation. However, recent events involving motorcoaches also indicate that roof strength may continue to be an area which could provide improved occupant protection. In January 2008, there was a rollover incident involving a 2007 MCI motorcoach near Mexican Hat, Utah that, according to newspaper and media reports, rolled down (one complete 360 degree roll) a 12.2 meters (40 feet) embankment. As a result, the entire roof of the motorcoach sheared off and 50 of the 52 occupants were ejected. There were nine fatalities and a number of occupants sustained serious injuries. NTSB is currently investigating the incident. Below are pictures of the bus:

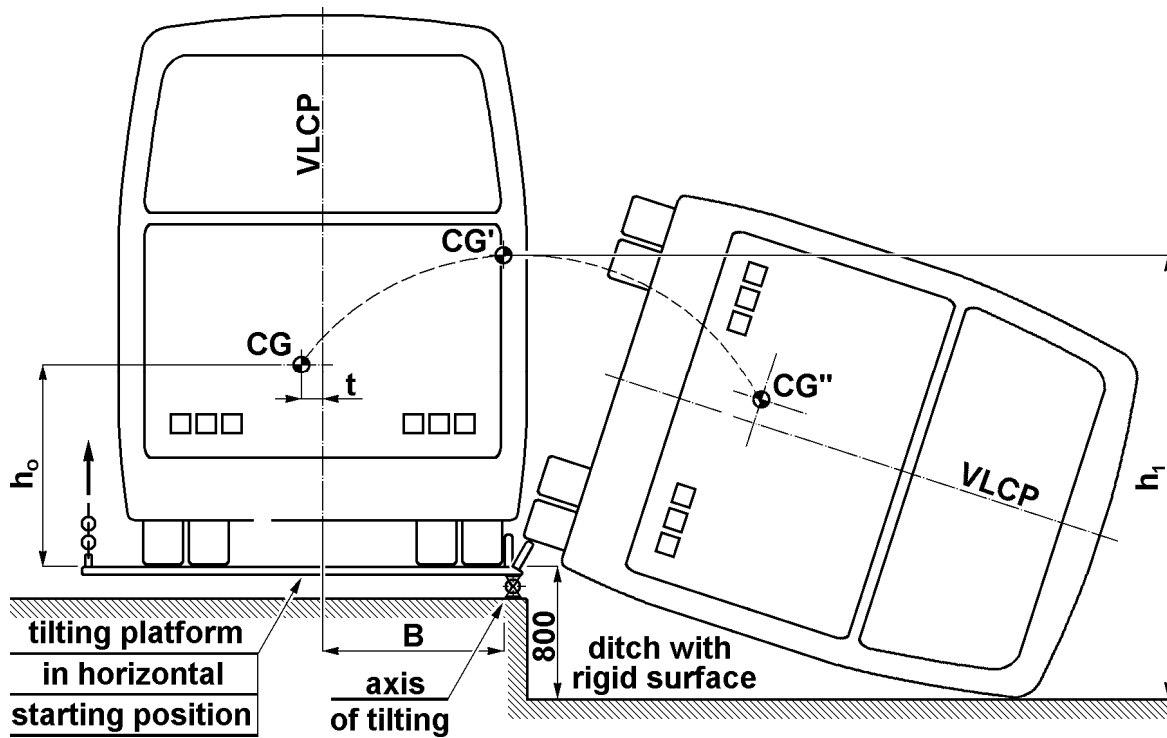
In the complete vehicle test, the vehicle with suspension blocked is placed on a tilting platform and is slowly raised to its unstable equilibrium position (Figure 4). The vehicle is tipped over from a raised platform with a nominal depth of 800 mm (31.50 in) into a ditch, having a horizontal, dry and smooth concrete ground surface. If the bus is not fitted with occupant restraints it will be tested at unloaded vehicle weight. If the bus is fitted with occupant restraints it will be tested at total effective vehicle mass which includes half the total weight of the occupants.

Figure 4: ECE r.66 Rollover Test

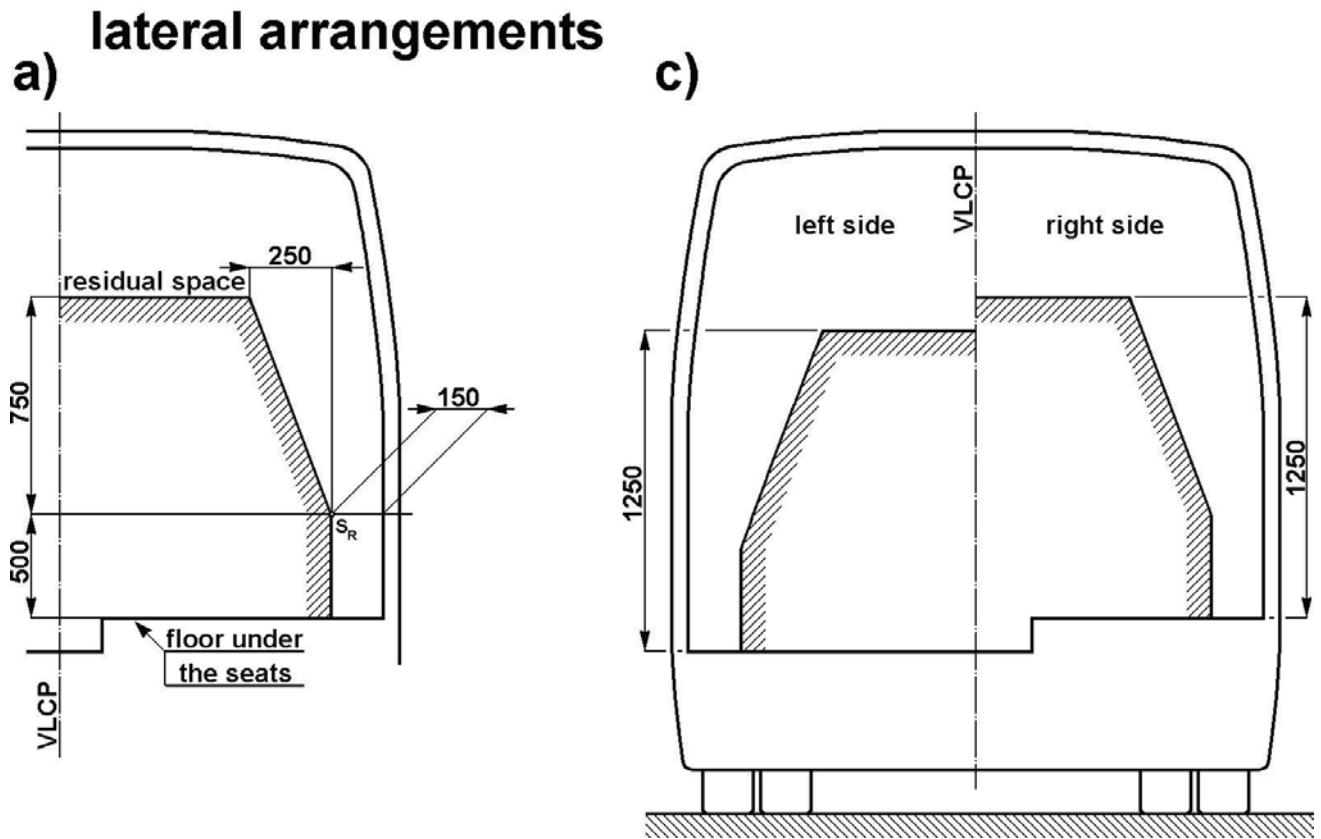
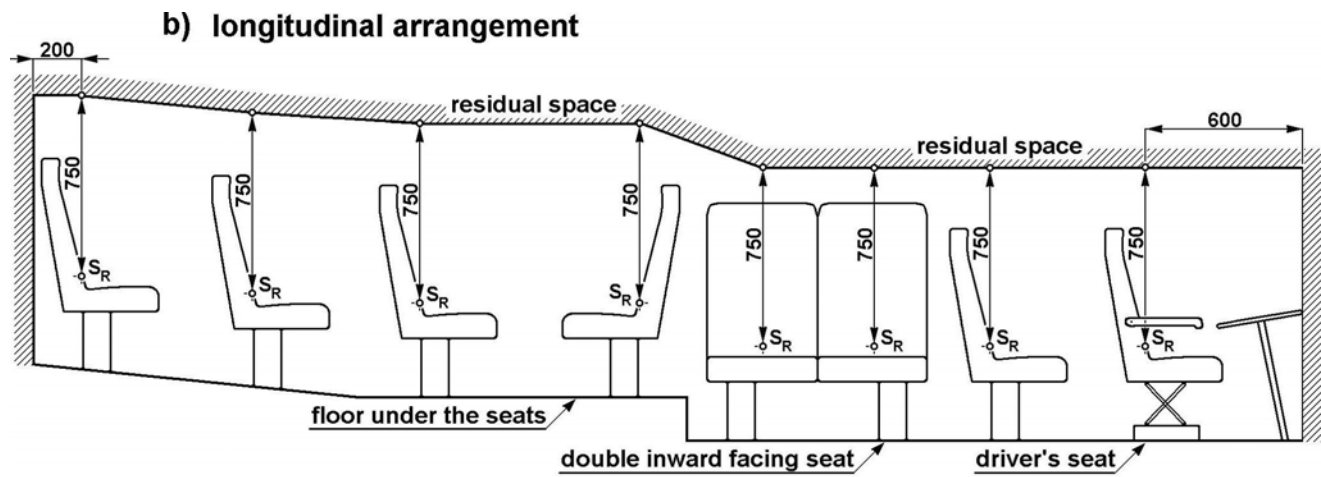
The performance specifications of ECE R.66 requires that the superstructure of the vehicle has sufficient strength to ensure that the residual space during and after the rollover test on the complete vehicle is unharmed. Templates for residual space are placed inside the vehicle at a minimum in the front and rear of the bus. No part of the vehicle which is outside the residual space at the start of the test (e.g. pillars, safety rings, luggage racks) shall intrude into the residual space during the test. The envelope of the vehicle's residual space is defined by creating a vertical transverse plane within the vehicle which has the periphery described in Figures 5 and 6.

Figure 5: Residual Space Template End View

Figure 6: Residual Space Template Side View

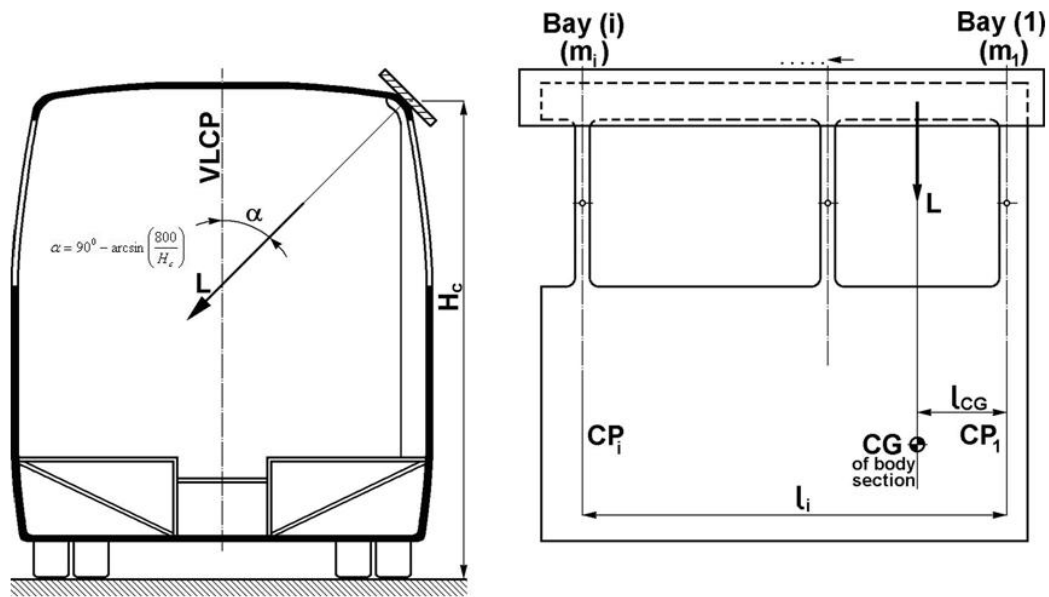
Under this option a quasi-static loading test is conducted on a body section of the bus. The body section includes at least two windows or doors. The body section is securely attached to the test bench through a rigid under frame. A uniformly distributed load is then applied to the body section with a rigid beam which is longer than the body section to simulate striking the ground in a rollover test as shown in figure 7.

Figure 7: Application of load to body section

The load is increased gradually, taking measurements of the associated deformation until the residual space is invaded by one of the elements of the body section. This option specifies that the energy absorbed by the body section is at least 75 percent of the estimated energy absorbed by the body section in the complete vehicle rollover test.

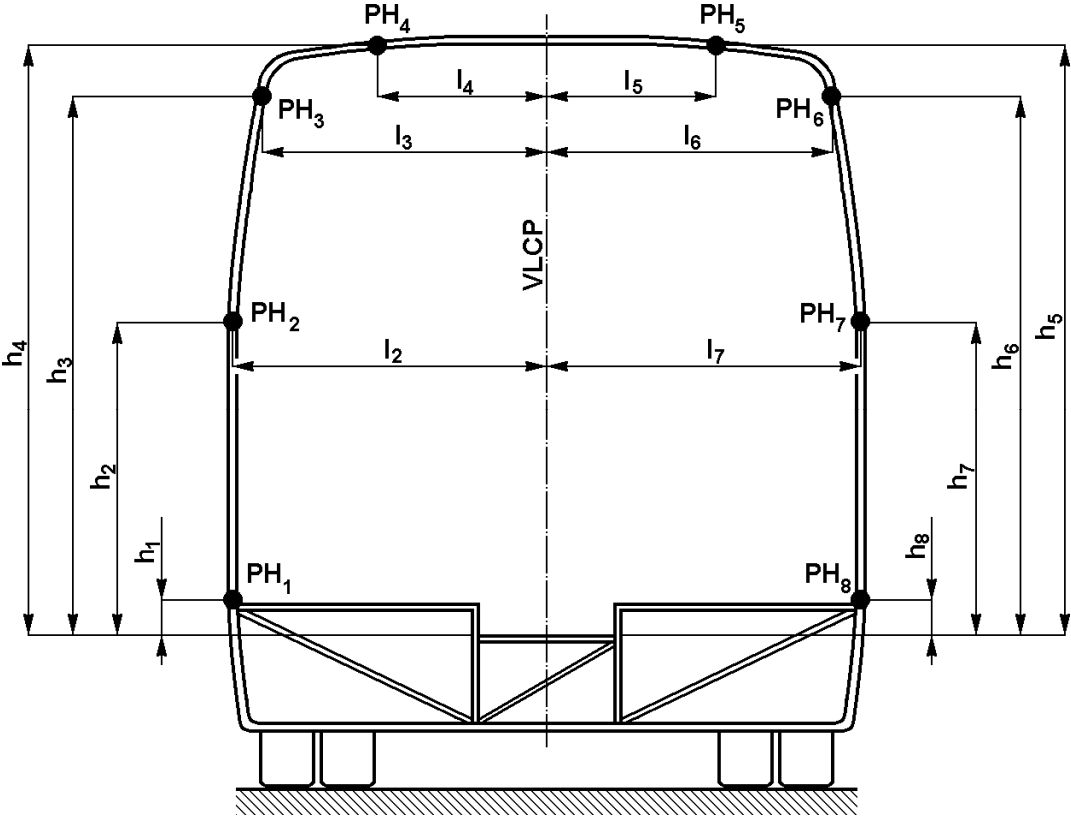
Under this option, the manufacturer calculates the deformation with a computer algorithm to determine the amount of energy absorbed in the quasi-static test. The manufacturer must determine the plastic hinges (PH) and/or the plastic zones (PZ) of the bus structure and shown in figure 8. The algorithm must contain at least 100 incremental “quasi-equal” steps when making the calculation. The load application is applied as shown in figure 9. As in the quasi-static test,

Figure 8: Geometrical parameters of plastic hinges on a bay

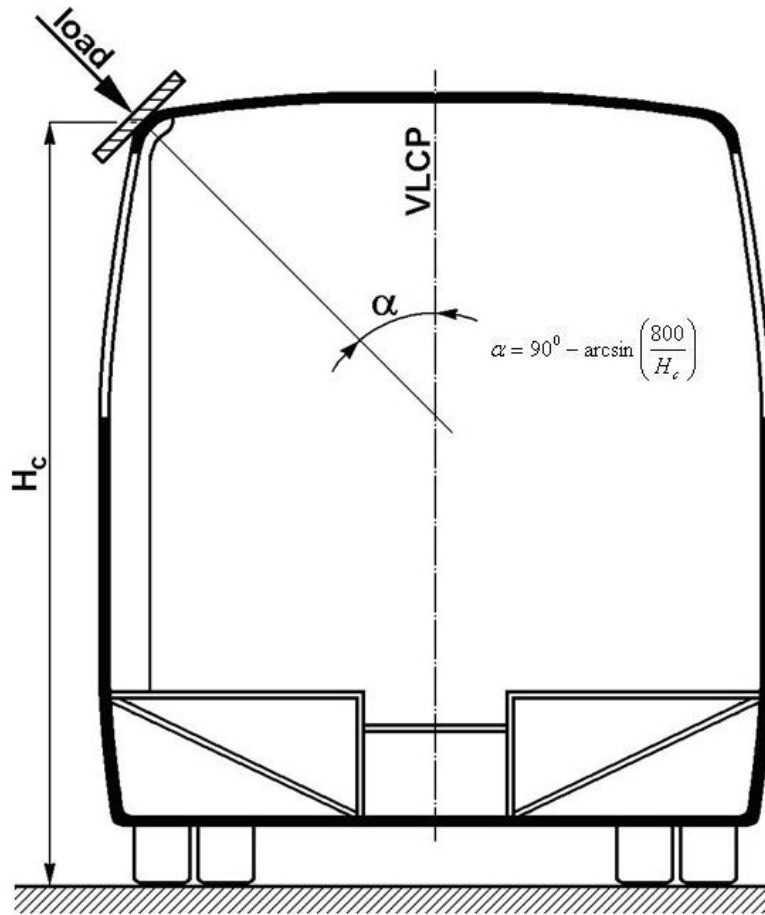
Figure 9: Load application to the superstructure

the absorbed energy of the body section must be at least 75 percent of the amount of energy it would have received in the complete vehicle rollover test.

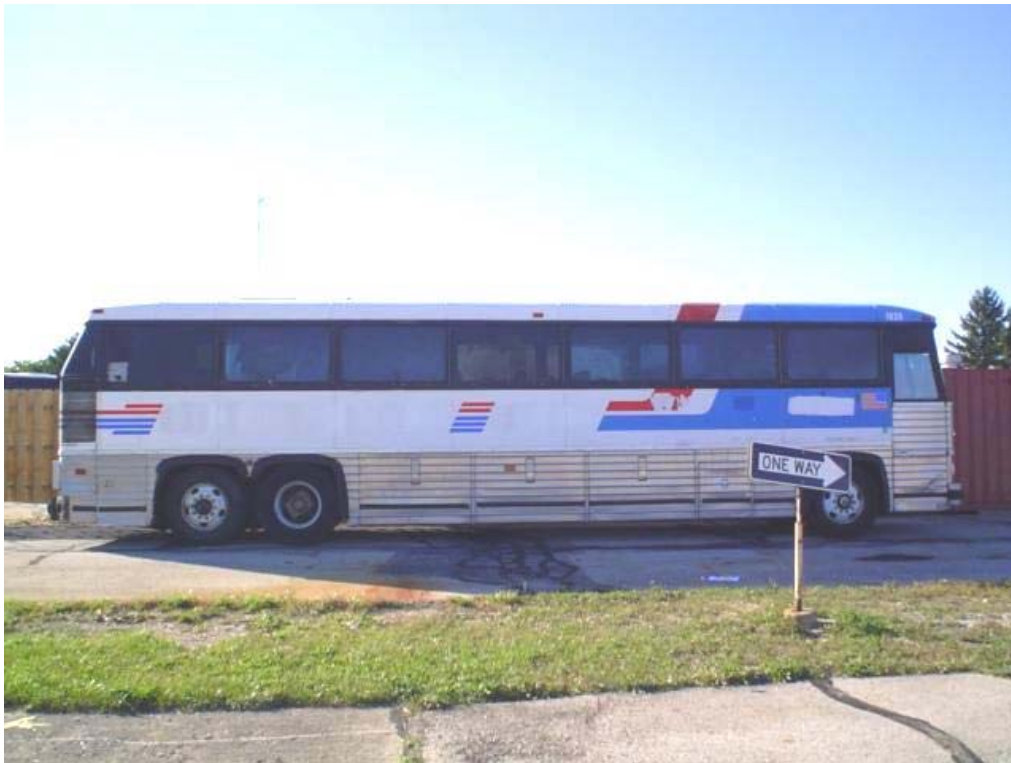
Figure 10: 1992 MCI, MC-12

MCI and Prevost vehicles were selected for roof strength and occupant survivable space research assessment using the FMVSS No 220 and ECE r.66 test protocols because they were similar in size and weight but exhibited visible differences in construction. The most discernable difference between these two models was that the Prevost LeMirage had smaller side windows and more roof support pillars. Table 1 presents selected information about each of the buses. Figures 10 and 11 are photographs of the test buses.

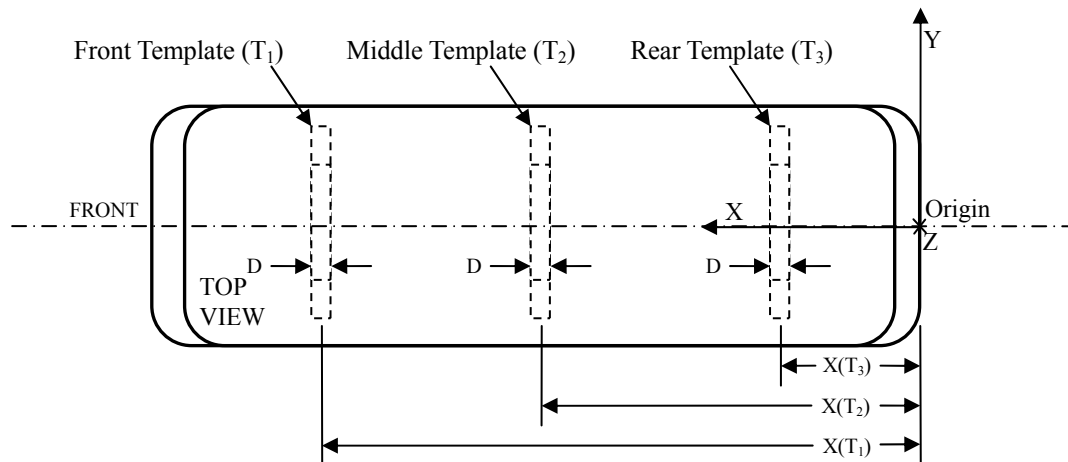
Each of the buses was outfitted with residual space templates as specified in ECE r.66 as shown in Figure 12. The location of the residual space templates is presented in Table 2.

Figure 12: Residual Space Template Locations

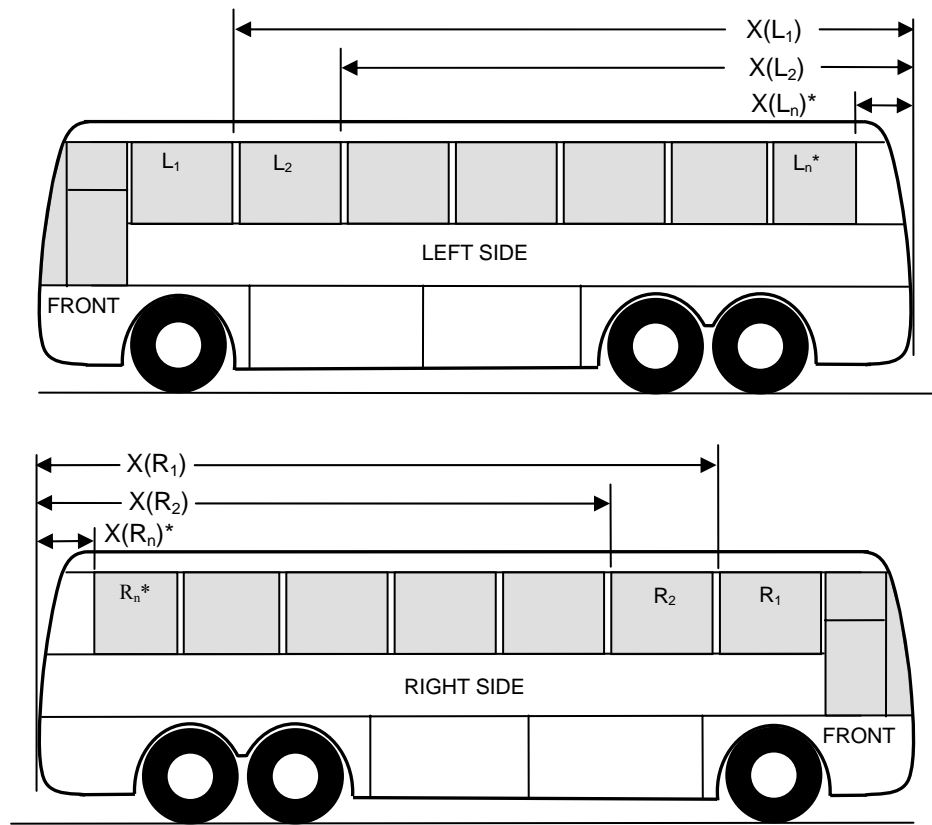
The location, size and type of side windows were measured as shown in Figure 13 and are presented for each bus in Tables 3 and 4.

Figure 13: Bus side window locations

* n = Side window number

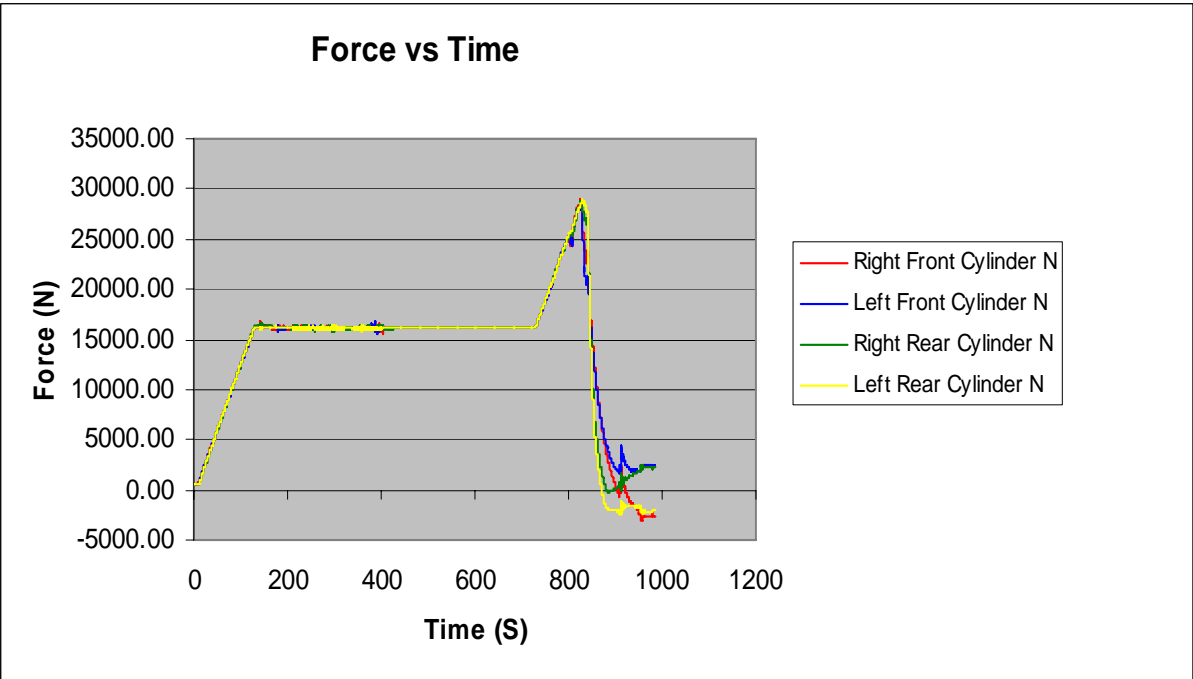
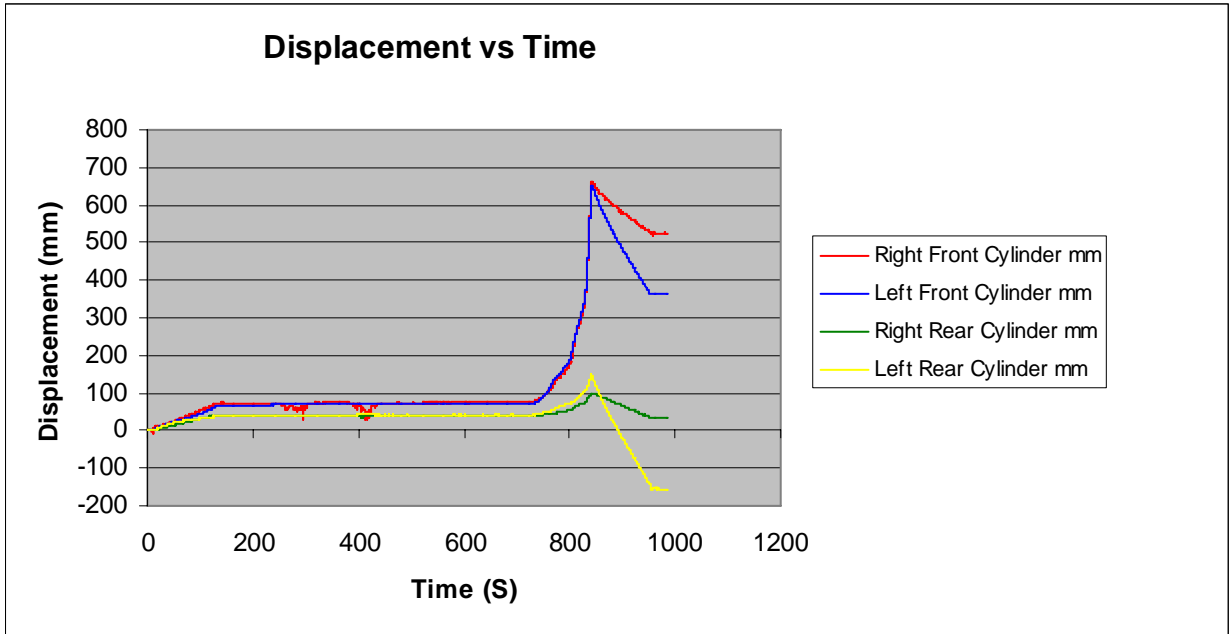
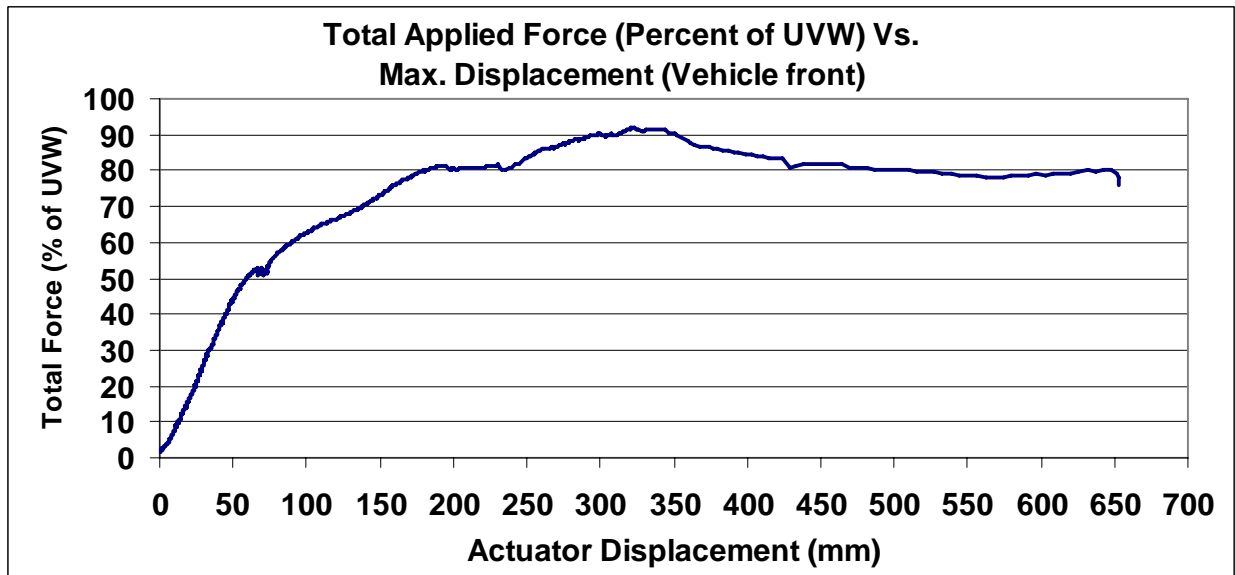
Figures 14 and 15 present the force and displacements of each of the four hydraulic actuators versus time. Note that the force applied by the four actuators is equal during the test by design to provide uniform loading on the roof. However, the displacement at the front of the bus is significantly greater than that at the rear of the bus. The total force applied is the sum of the forces from each actuator and the maximum displacement is that measured at the front of the bus. Figure 16 is a plot of the total applied force (presented as a percentage of the unloaded vehicle weight) versus the maximum actuator displacement.

Figure 14: Actuator Force vs Time

Figure 15: Actuator Displacement vs Time

Figure 16: Applied Force in Percentage of Unloaded Vehicle Weight (UVW) vs Displacement

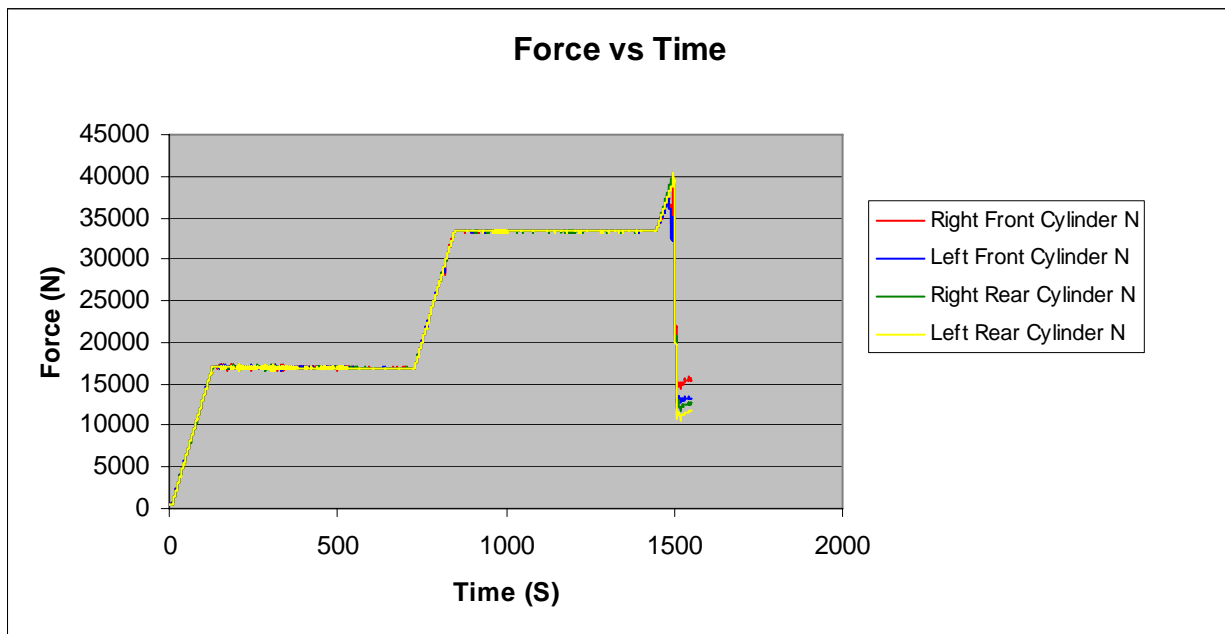
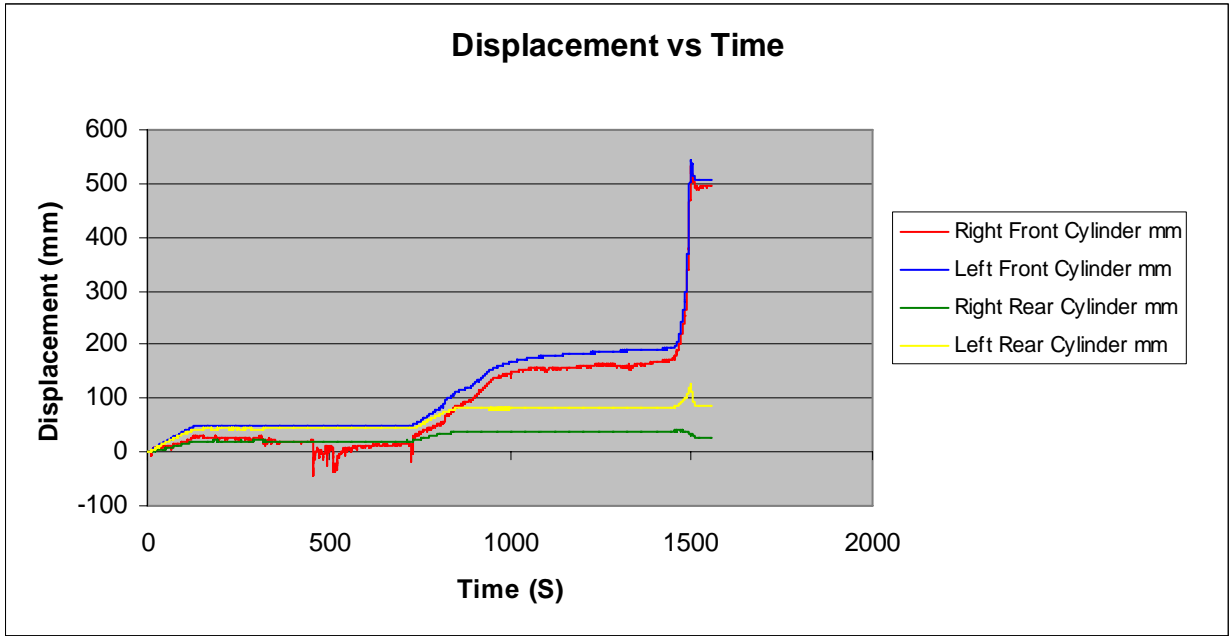
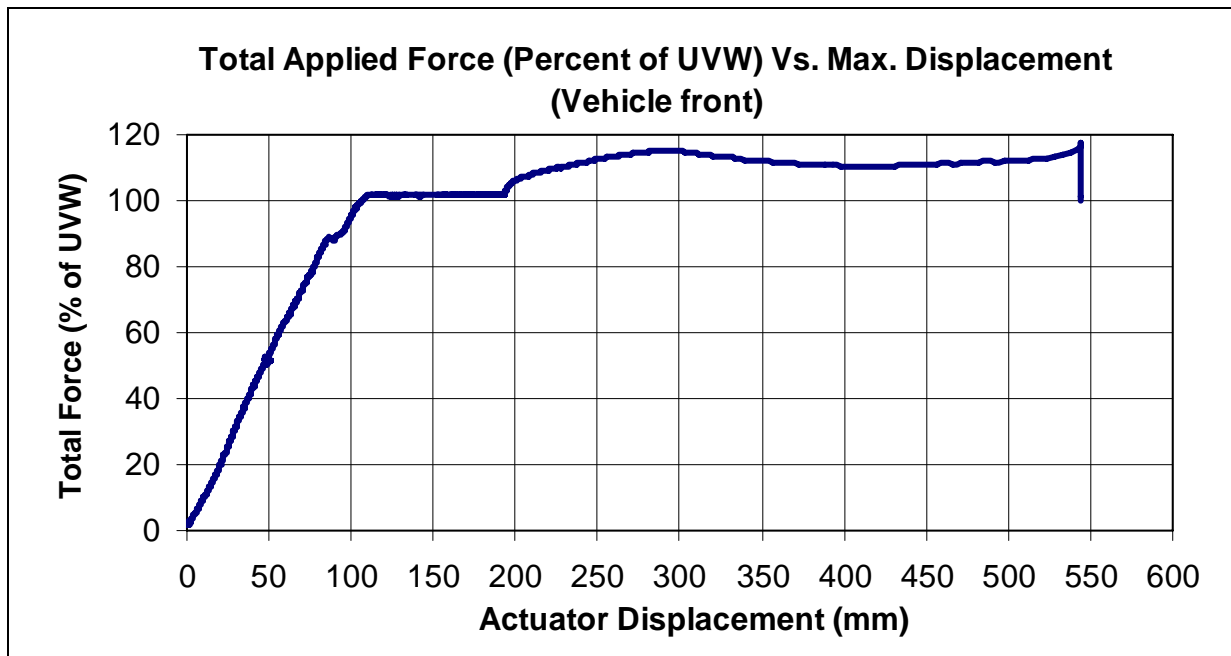
Figures 17 and 18 present the force and displacements of each of the four hydraulic actuators versus time. Note that the force applied by the four actuators is equal during the test by design to provide uniform loading on the roof. However, the displacement at the front of the bus is significantly greater than that at the rear of the bus. The total force applied is the sum of the forces from each actuator and the maximum displacement is that measured at the front of the bus. Figure 19 is a plot of the total applied force (presented as a percentage of the unloaded vehicle weight) versus the maximum actuator displacement.

Figure 17: Actuator Force vs Time

Figure 18: Actuator Displacement vs Time

Figure 19: Applied Force in Percentage of Unloaded Vehicle Weight (UVW) vs Displacement

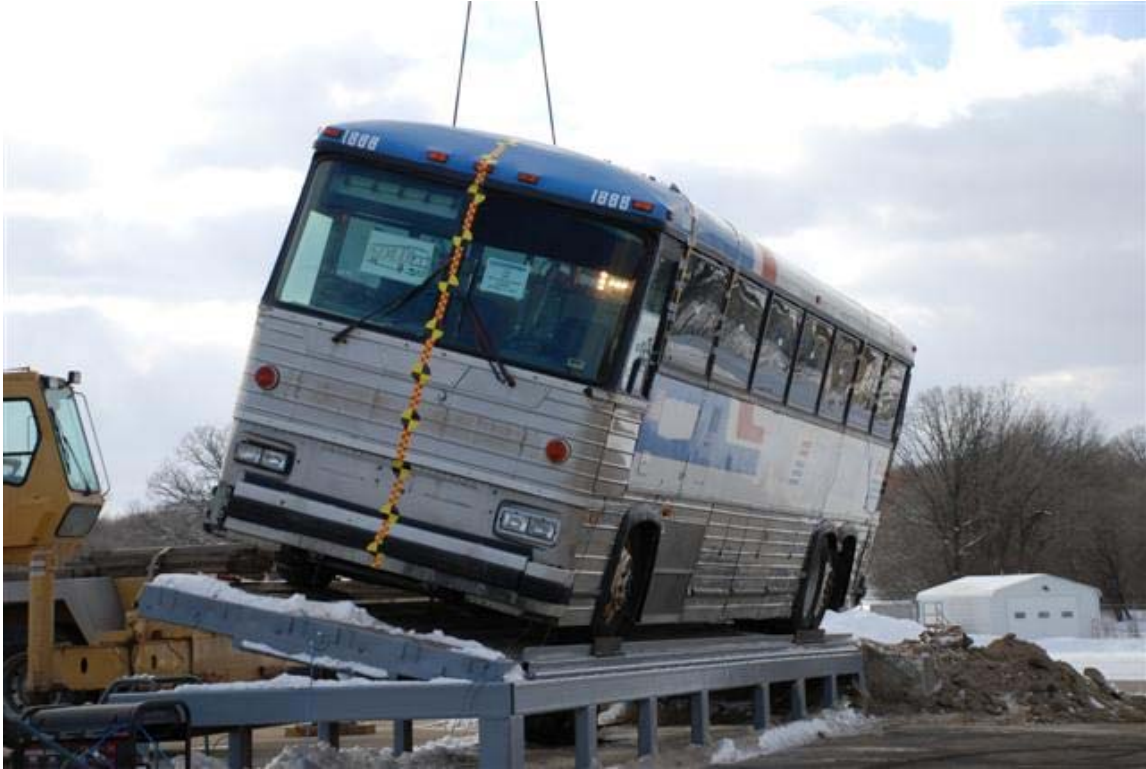
Figure 20: MCI Pretest photograph

The motorcoach was positioned on the tilting platform with the driver's side (left) adjacent to the platform's hinge. The platform was raised at a steady rate of not more than 5 degrees/second until the vehicle reached its unstable equilibrium when the platform was approximately 48 degrees from the horizontal and it commenced its roll. The bus then struck the ground near the left upper edge of the vehicle just above the windows. After the bus impacted the ground both sides of the windshield lost retention and fell from its supporting structure. Transfer marks showed that the front template struck the left side window (L1). During impact the emergency exit windows on the side opposite impact remained latched and the windows on the impact side remained intact but cracked. However, the emergency roof exit came open during the impact event. All left side luggage rack inboard hangers rearward of the front two hangers broke during the impact, leaving exposed sharp metal edges. Figure 20 presents a photograph of the bus being raised on the tilting platform. Post-test photographs of the bus are shown in Figures 21, 22 and 23. The test results are summarized in Table 7.

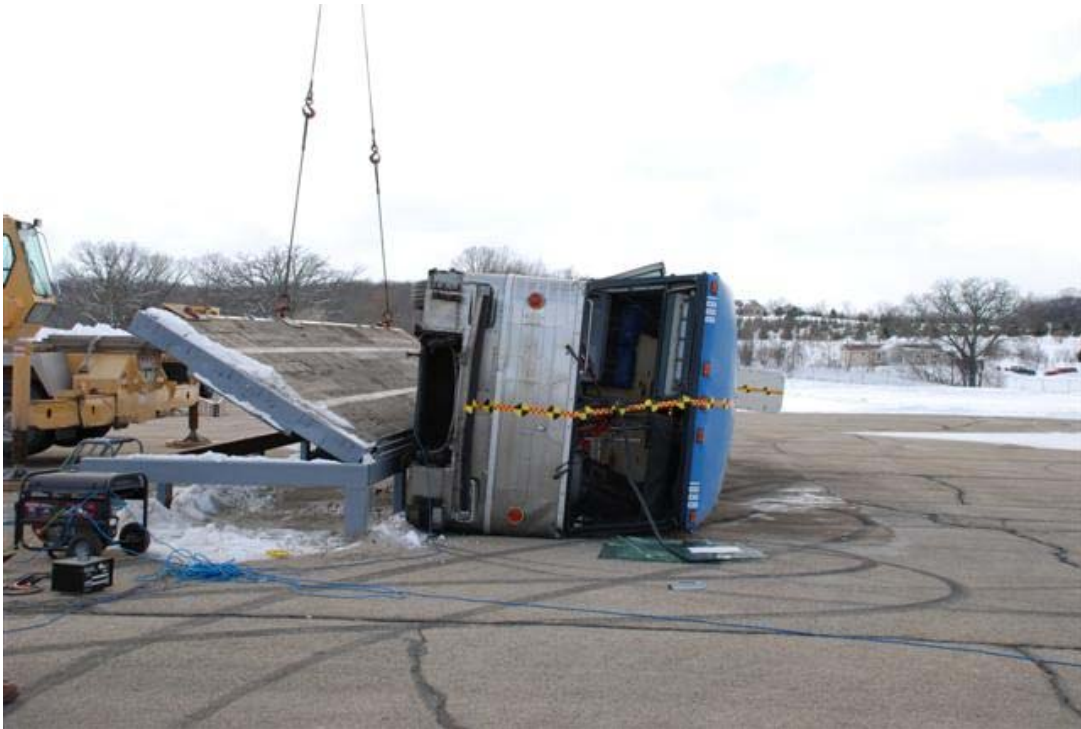
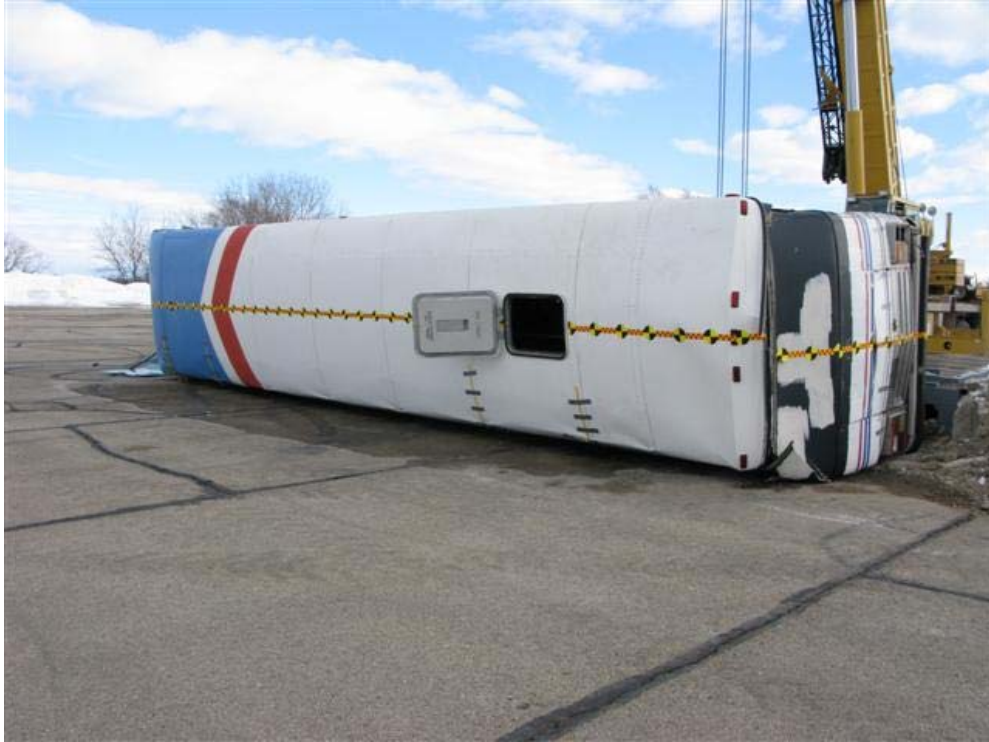
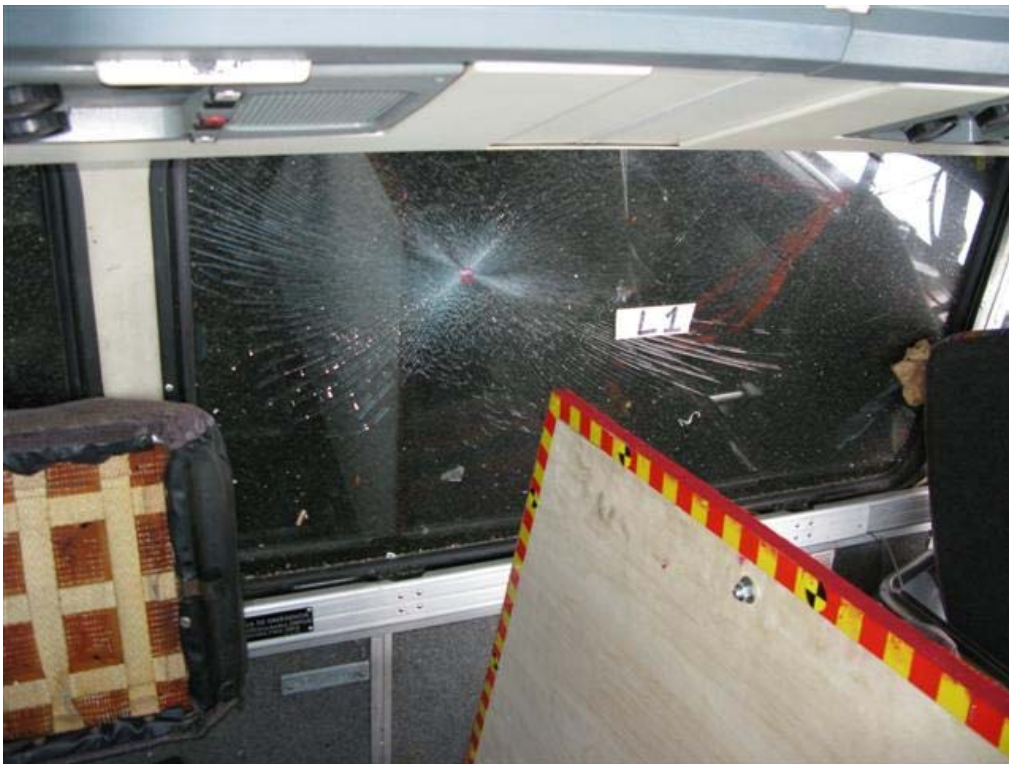
Figure 21: MCI Post-test photograph front view

Figure 22: MCI Post-test photograph side view

Figure 23: MCI Post-test photograph front template transfer mark

| | Observation |
|---|---|
| Residual Space Template Contact: | <p>The left interior sidewall made contact with the front residual space template (T₁) leaving a transfer mark and cracks on window L1 and a transfer mark on the sidewall beneath window L1.</p> <p>There was no evidence of the interior contacting the middle (T₂) or rear (T₃) residual space templates.</p> |

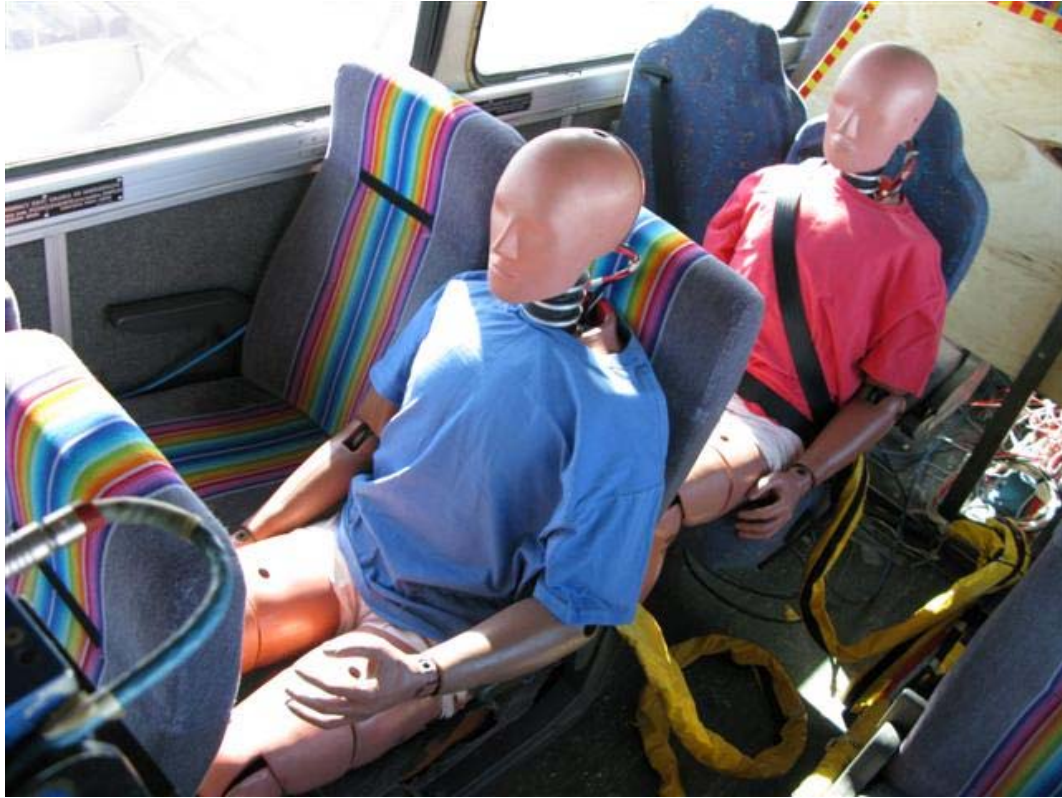
Figure 24: MCI pretest ATD placement

During the rollover event the restrained ATD was kept in its seat by the lap/shoulder belt restraint system and its left leg struck the aisle seat directly across from it. The unrestrained ATD slumped over the armrest into the aisle when the bus was raised on the tilting platform. It fell from this position when the bus struck the ground. All of the injury assessment values (IAV) were within acceptable limits with the exception of the Nij (compression-extension) which was 1.10. Figure 24 presents a pretest photograph of the ATDs positioned in the bus. Figures 25 and 26 present photographs of the ATDs in their final resting position. Table 8 presents observations to the ATD performance and Table 9 presents a summary of the IAVs for the ATDs.

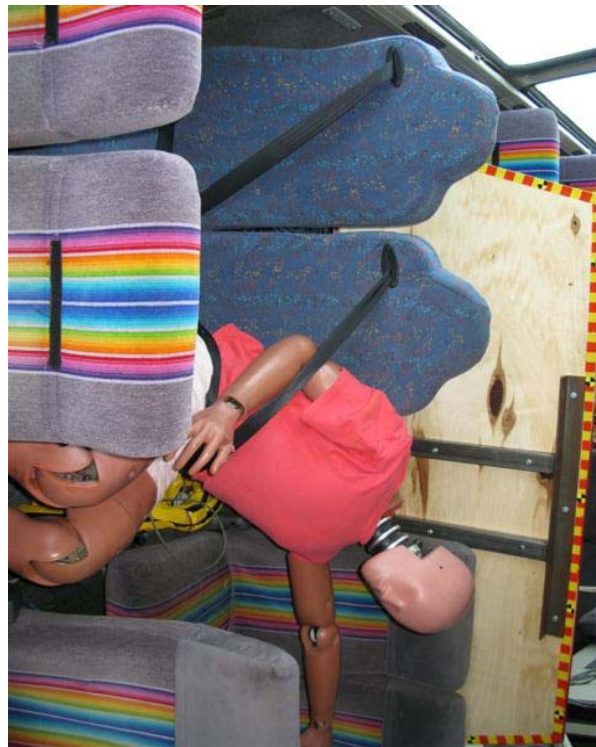
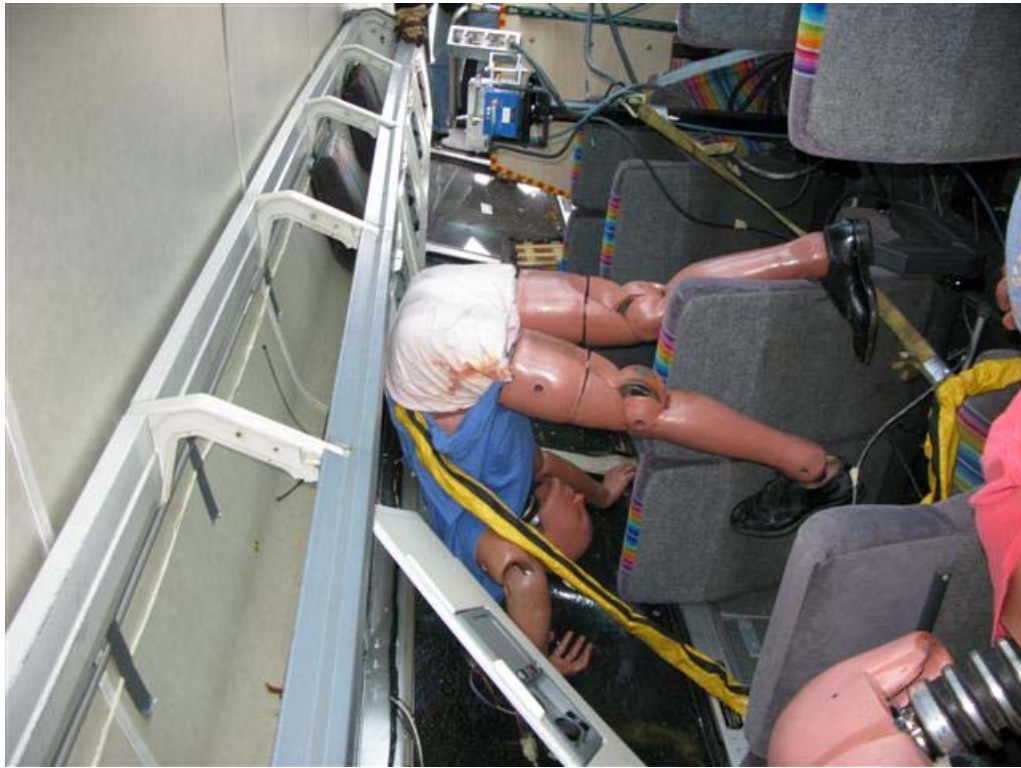
Figure 25: MCI post-test restrained ATD

Figure 26: MCI post-test unrestrained ATD

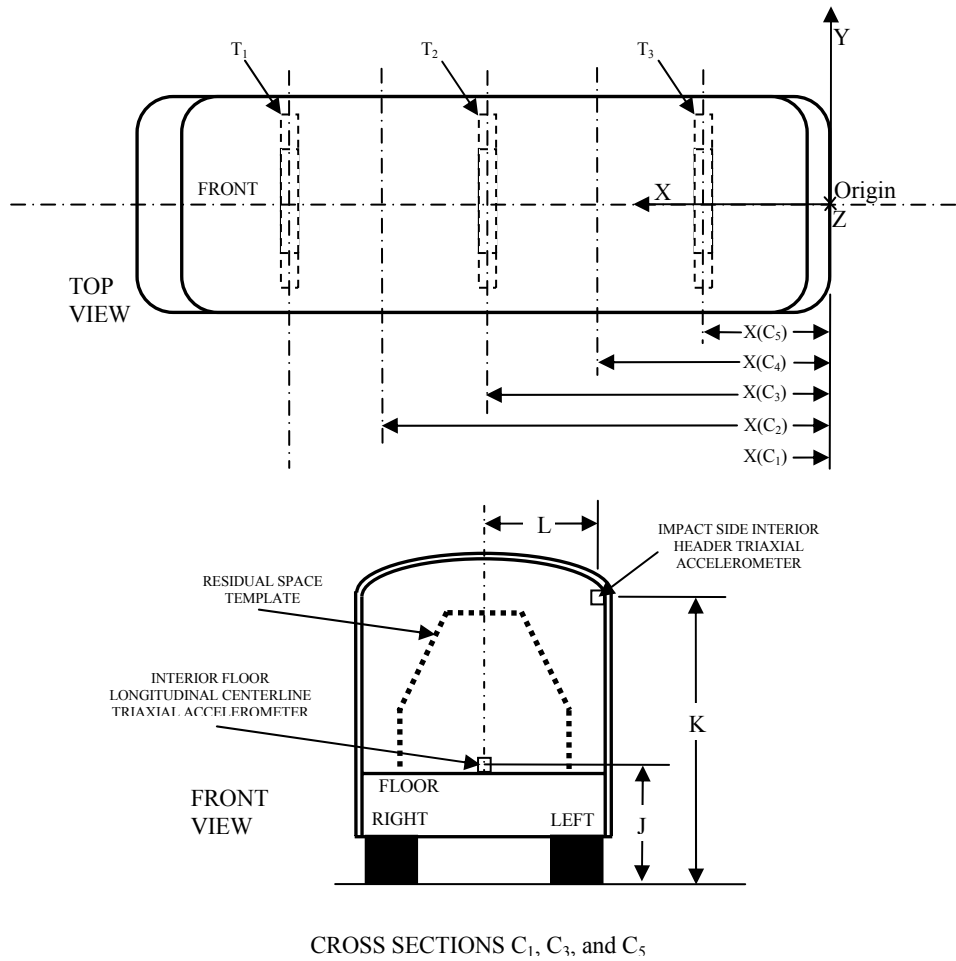
The data from the three tri-axial accelerometers that were mounted on the impact-side interior corner of the roof were filtered using a channel frequency class (CFC) 60 (100 Hz) digital filter. Figure 27 and Table 10 present the location of the accelerometers on the vehicle. Data plots of the X, Y and Z acceleration at each roof accelerometer location are presented in figures 28, 29 and 30. Figure 31 presents a data plot of the resultant roof accelerations at each template location. The peak accelerations for the Y and Z axis, the peak resultant acceleration, and average accelerations were calculated and are presented in Table 11. The average acceleration is the area under the resultant acceleration time history (from the start of deceleration until the resultant acceleration is effectively zero) divided by the associated time duration. The average acceleration along the top of the bus roof when the bus struck the ground surface is 7.59 g's (computed as the average of the average acceleration at each template location). The peak resultant roof acceleration is at the

Figure 27: MCI Accelerometer Locations
