Subject: Motorcoach Safety Research

Motorcoach Roof Crush/Rollover Testing Discussion Paper, March 2009

Motorcoach Roof Crush/Rollover Testing

Discussion Paper

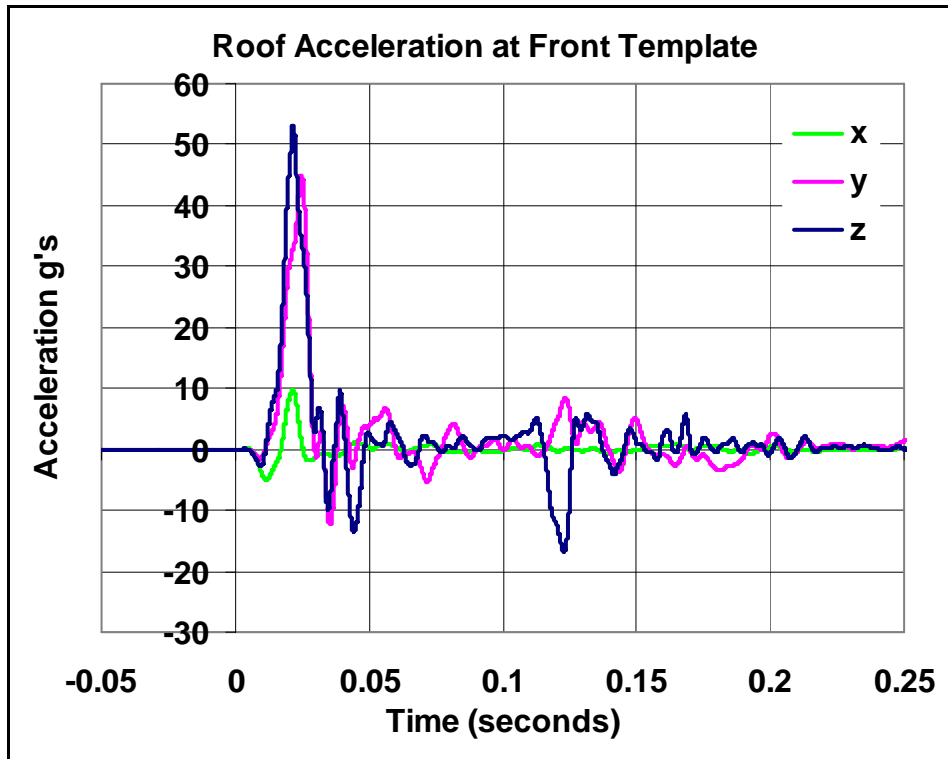
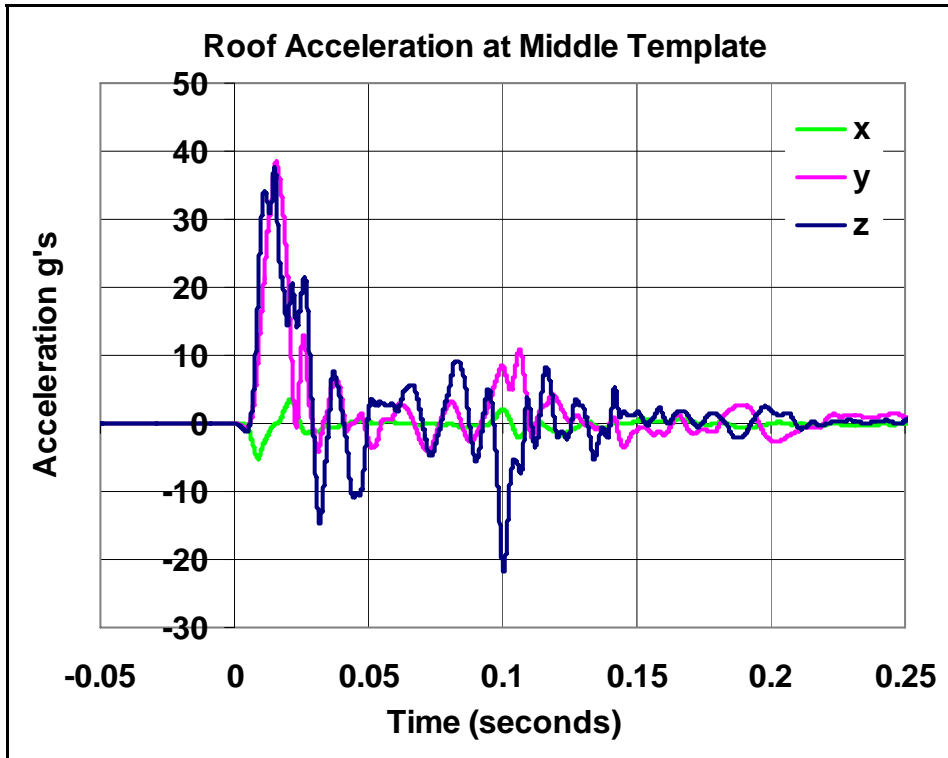
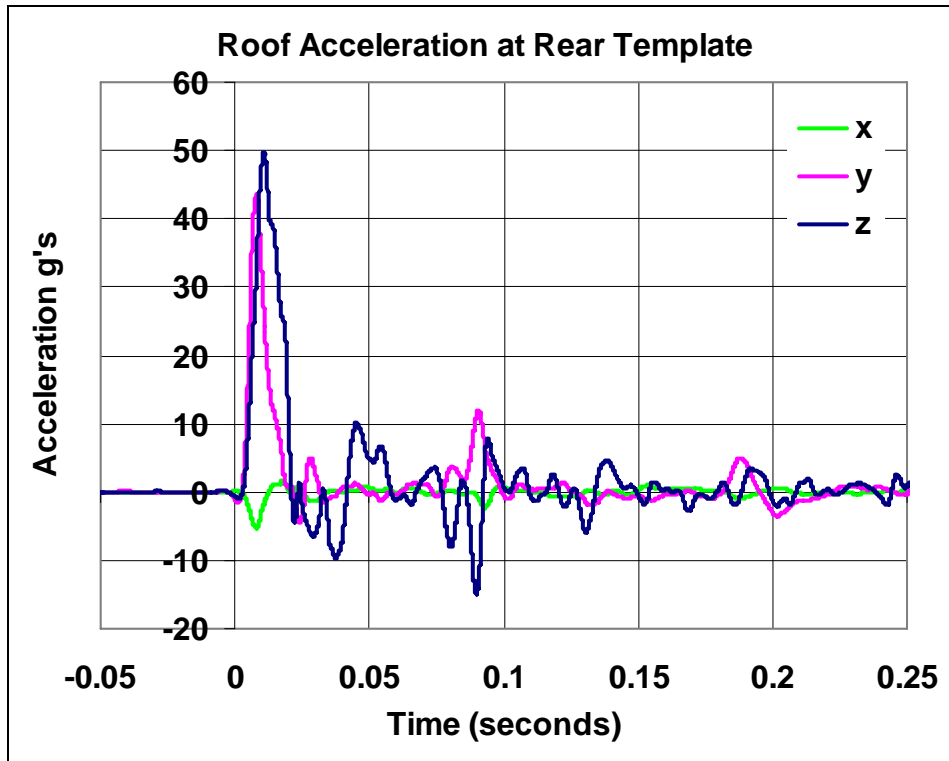
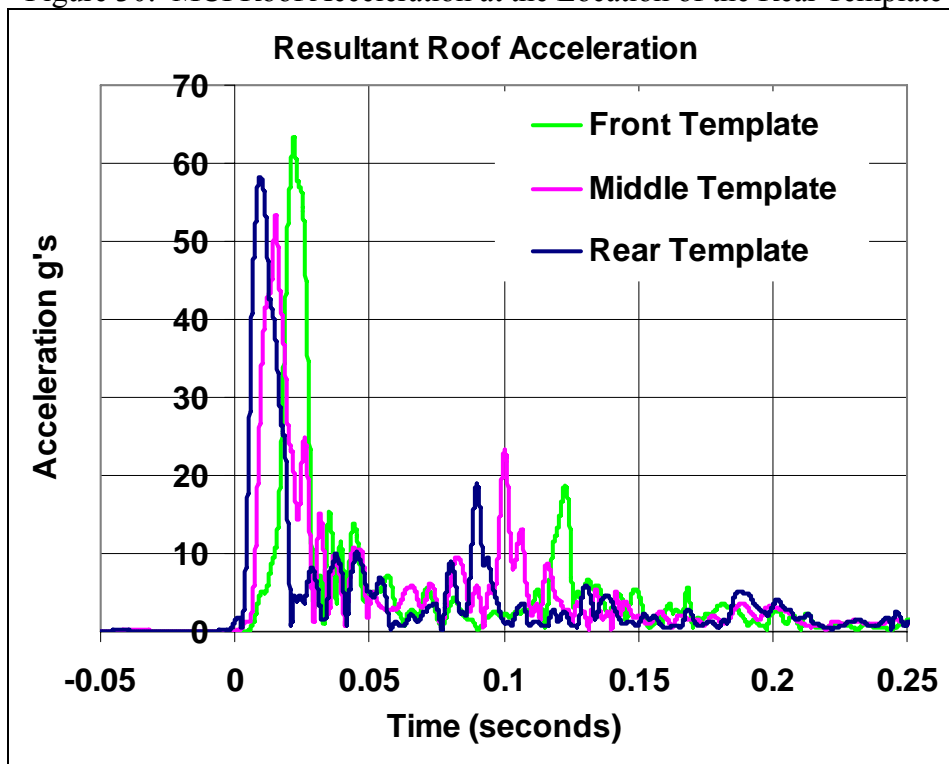
The data from the three tri-axial accelerometers that were mounted on the impact-side interior corner of the roof were filtered using a channel frequency class (CFC) 60 (100 Hz) digital filter. Figure 27 and Table 10 present the location of the accelerometers on the vehicle. Data plots of the X, Y and Z acceleration at each roof accelerometer location are presented in figures 28, 29 and 30. Figure 31 presents a data plot of the resultant roof accelerations at each template location. The peak accelerations for the Y and Z axis, the peak resultant acceleration, and average accelerations were calculated and are presented in Table 11. The average acceleration is the area under the resultant acceleration time history (from the start of deceleration until the resultant acceleration is effectively zero) divided by the associated time duration. The average acceleration along the top of the bus roof when the bus struck the ground surface is 7.59 g's (computed as the average of the average acceleration at each template location). The peak resultant roof acceleration is at the

foremost template and is equal to 63.5 g's. The average of the peak accelerations at the three templates is 58.3 g's.

Figure 28: MCI Roof Acceleration at the Location of the Front Template

Figure 29: MCI Roof Acceleration at the Location of the Middle Template

Figure 30: MCI Roof Acceleration at the Location of the Rear Template

Figure 31: MCI Resultant Roof Accelerations at Front, Middle, and Rear Templates.

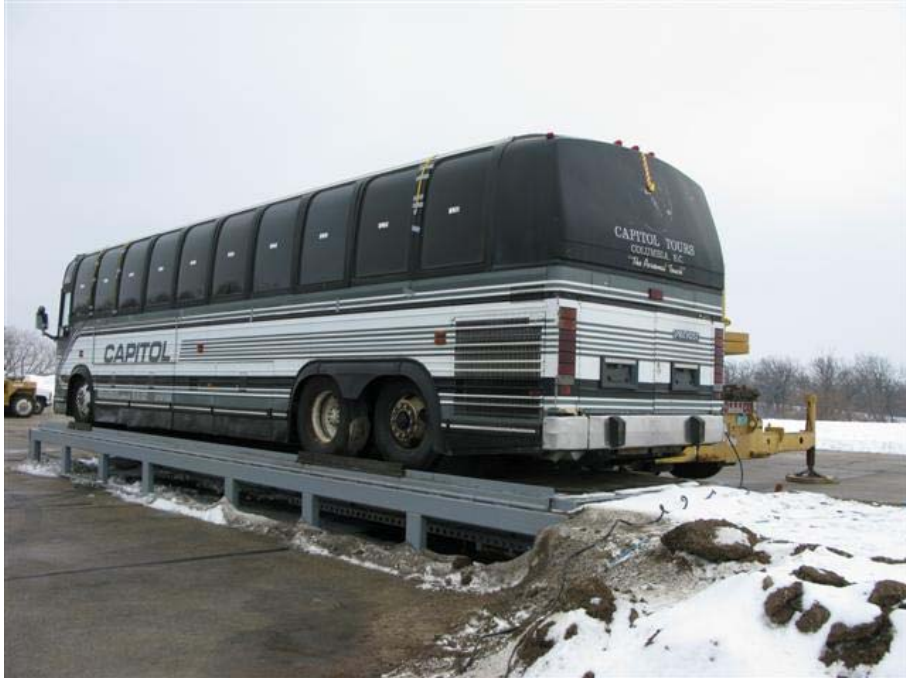
Figure 32: Prevost Pretest photograph

The motorcoach was positioned on the rollover platform with the driver's side (left) adjacent to the platform's hinge. The platform was raised at a steady rate of not more than 5 degrees/second until the vehicle reached its unstable equilibrium when the platform was approximately 51 degrees from the horizontal and it commenced its roll. The bus then struck the ground near the left upper edge of the vehicle. After the bus impacted the ground both sides of the windshield lost retention and fell from its supporting structure. Transfer marks showed that the front template struck the sidewall beneath the left side window and the left side window (L1). During impact the emergency exit windows on the side opposite impact came unlatched and the windows on the impact side remained intact but cracked. However, the emergency roof exits came open during the impact event. The bus had two emergency roof exits both of which came open during the impact event. Most of the seats on the right side of the bus detached from their wall mounts. Figure 32 presents a photograph of the bus on the tilting platform. Post-test photographs of the bus are provided in Figures 33, 34 and 35. The test results are summarized in Table 12.

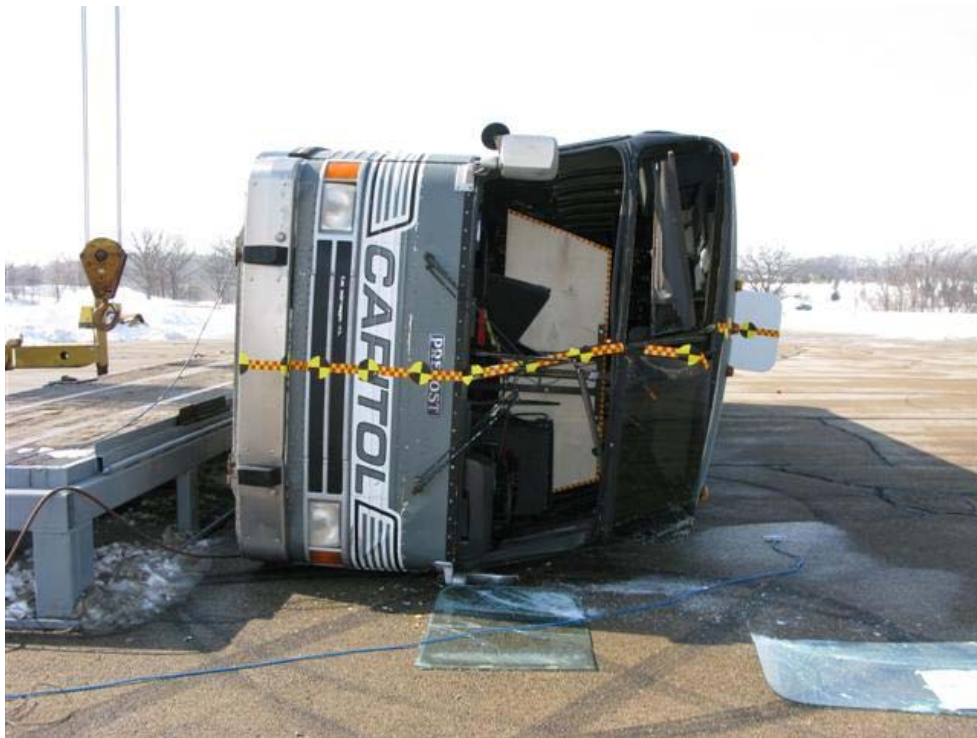
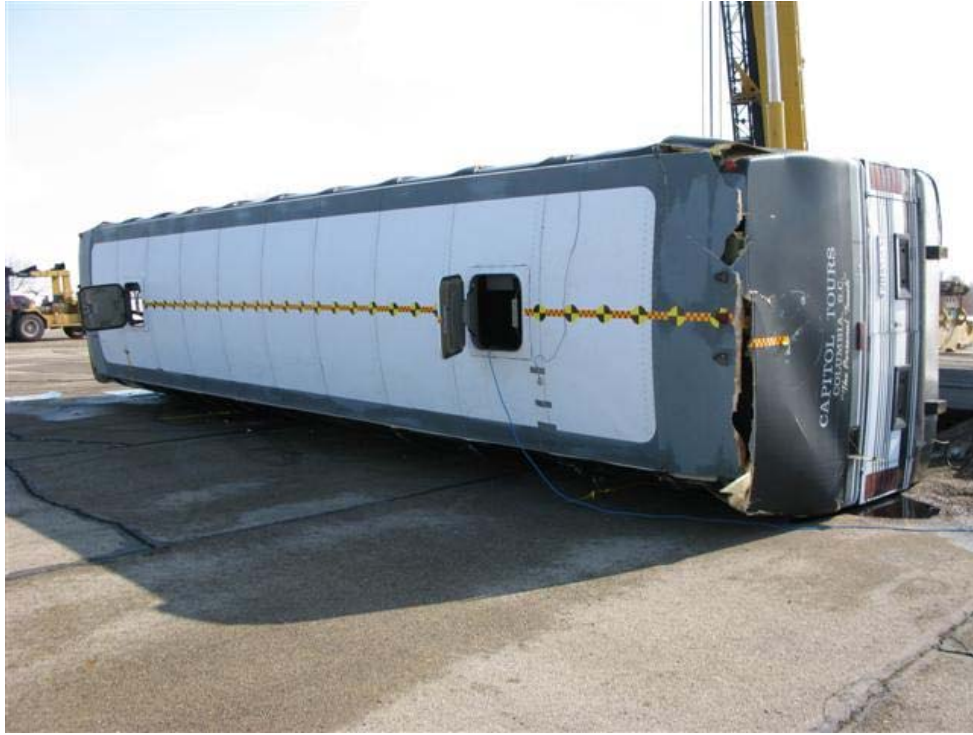
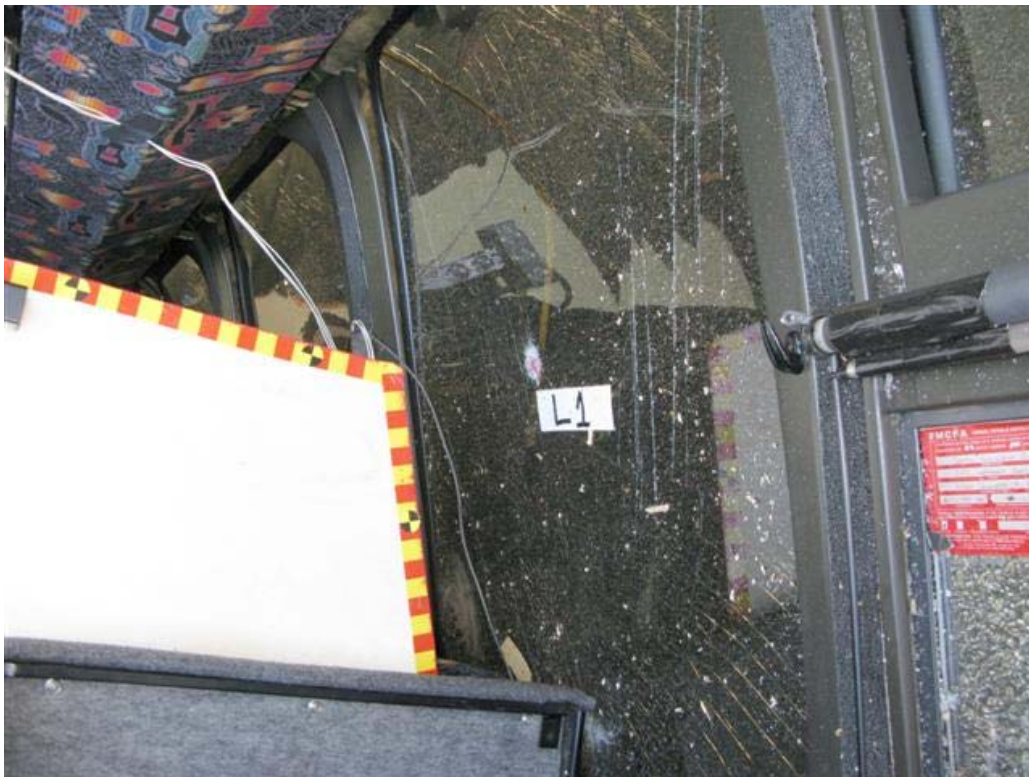
Figure 33: Prevost Post-test photograph front view

Figure 34: PrevoSt Post-test photograph side view

Figure 35: PrevoSt Post-test photograph front template transfer mark

| Impact Location: | Left side of bus. |
|---|--|
| Residual Space Template Contact: | <p>The left interior sidewall made contact with the front residual space template (T₁) leaving a transfer mark and cracks on window L1 and a transfer mark on the sidewall beneath window L1.</p> <p>There was no evidence of the interior contacting either the middle (T₂) or rear (T₃) residual space templates.</p> |

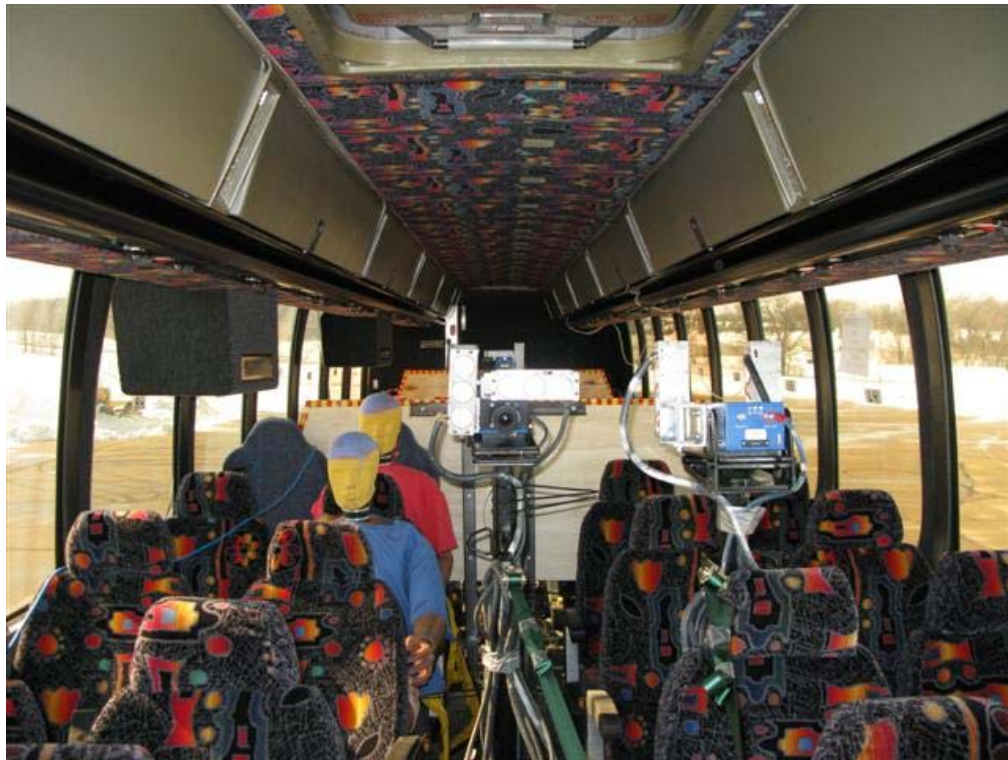
Figure 36: Prevost pretest ATD placement

Figure 36 presents a pretest photograph of the ATDs positioned in the bus. Figures 37 and 38 present photographs of the ATDs in their final resting position. Table 13 presents observations of the ATD performance and Table 14 presents a summary of the IAVs for the ATDs.

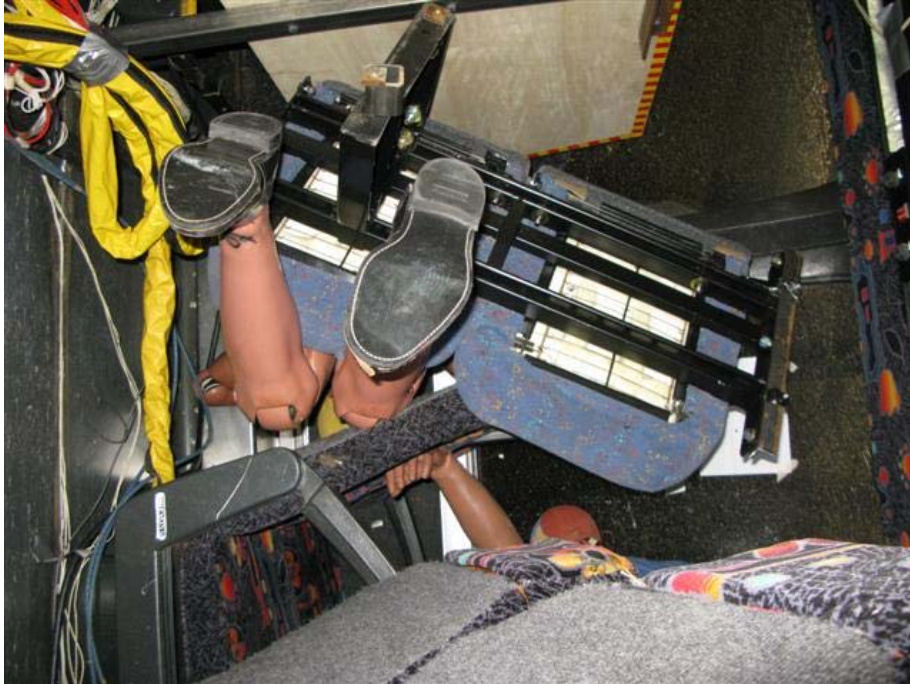
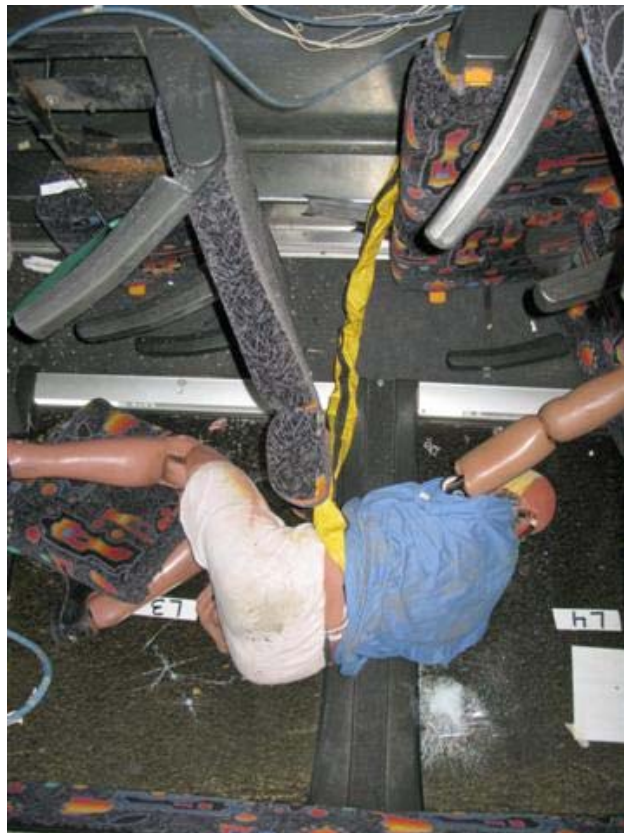
Figure 37: Prevost post-test restrained ATD

Figure 38: Prevost post-test unrestrained ATD

- Head injury criterion (4,132)
- Neck axial compressive force (-17,732 N)
- Nij compression-flexion (2.85)
- Nij compression-extension (2.93)

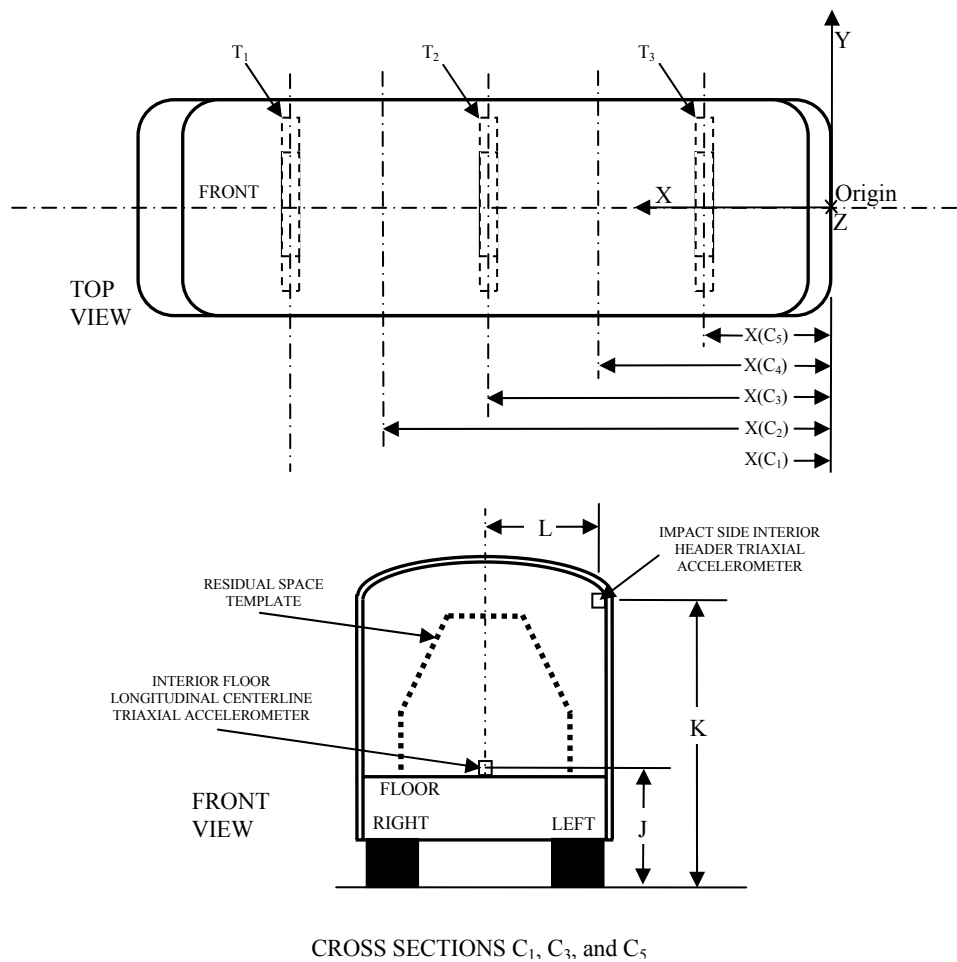
The data from the three tri-axial accelerometers that were mounted on the impact-side interior corner of the roof were filtered using a CFC 60 (100 Hz) digital filter. Figure 39 and Table 15 present the location of the accelerometers on the vehicle. Data plots of the X, Y and Z acceleration at each roof accelerometer location are presented in figures 40, 41 and 42. Figure 43

Figure 39: Prevost Accelerometer Locations

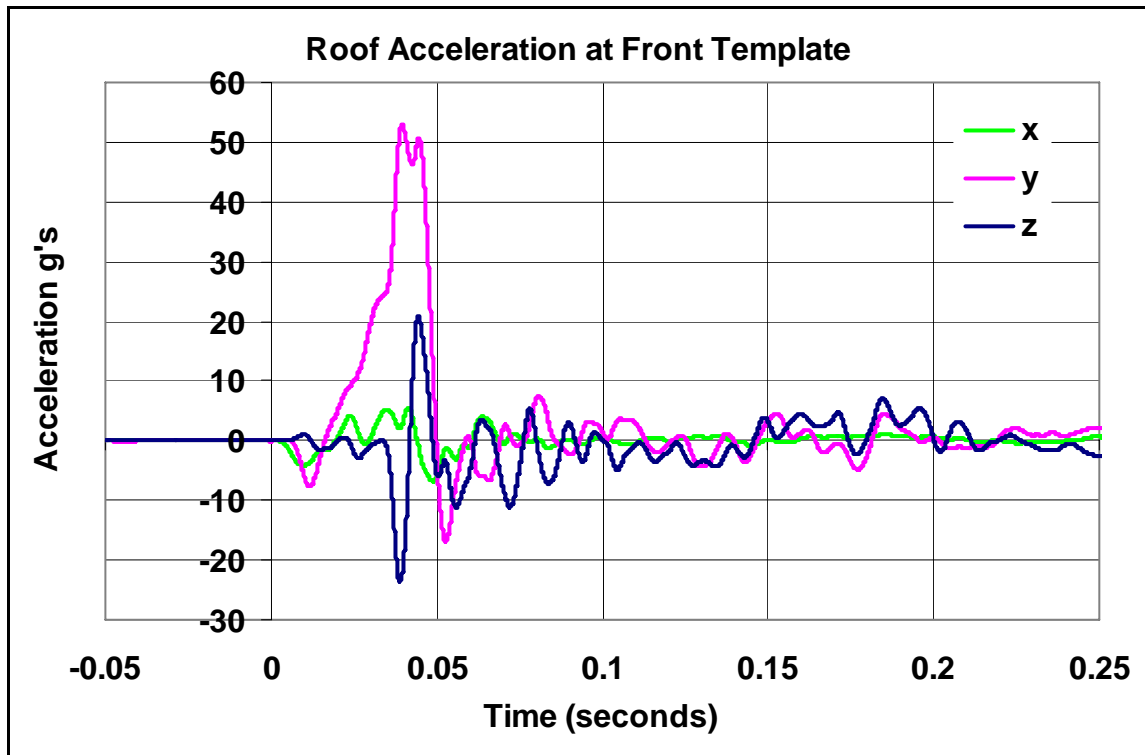
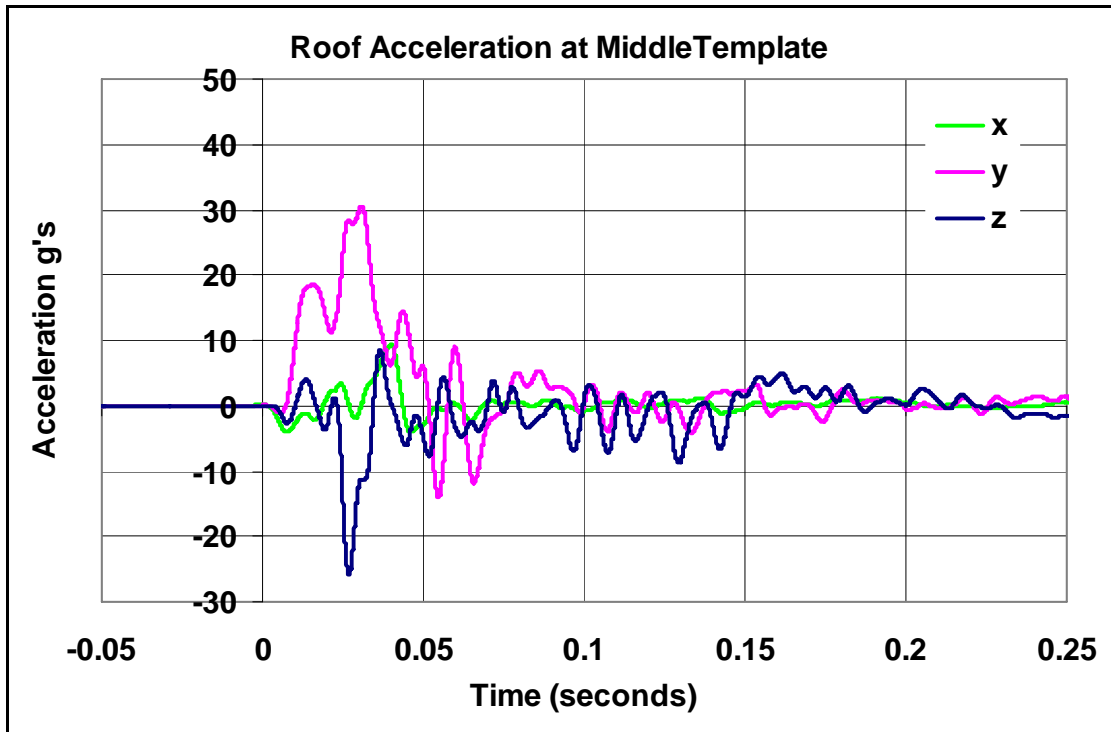
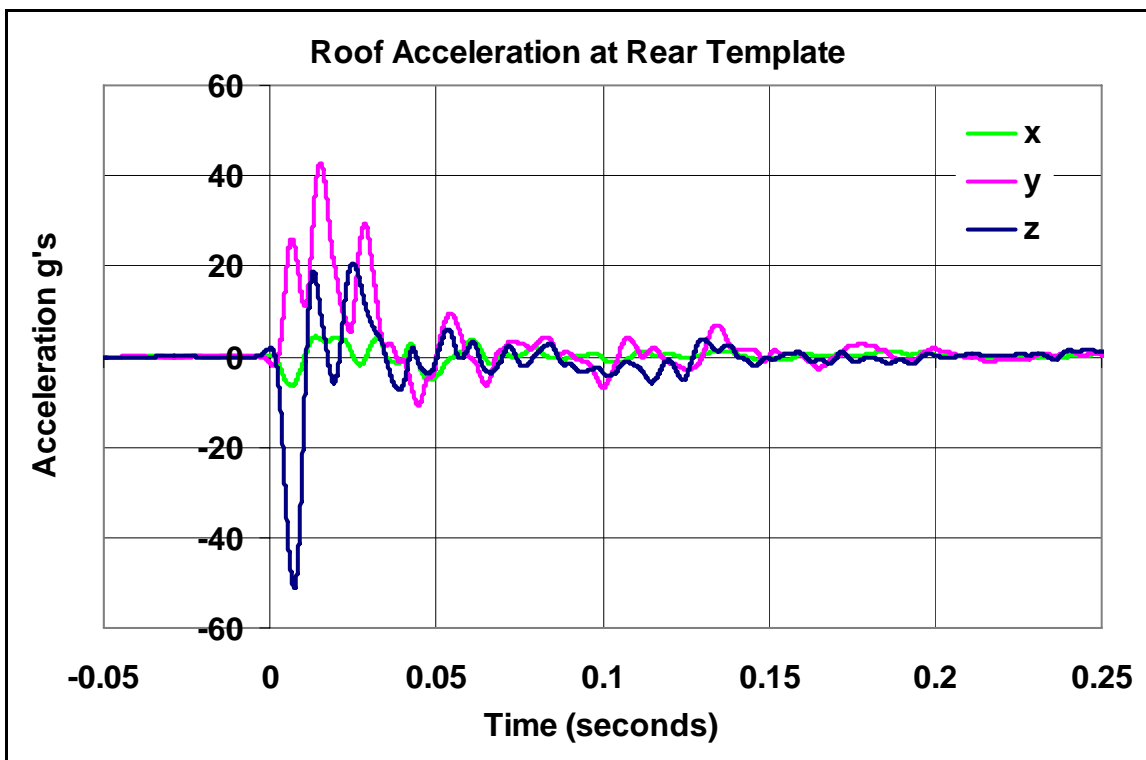
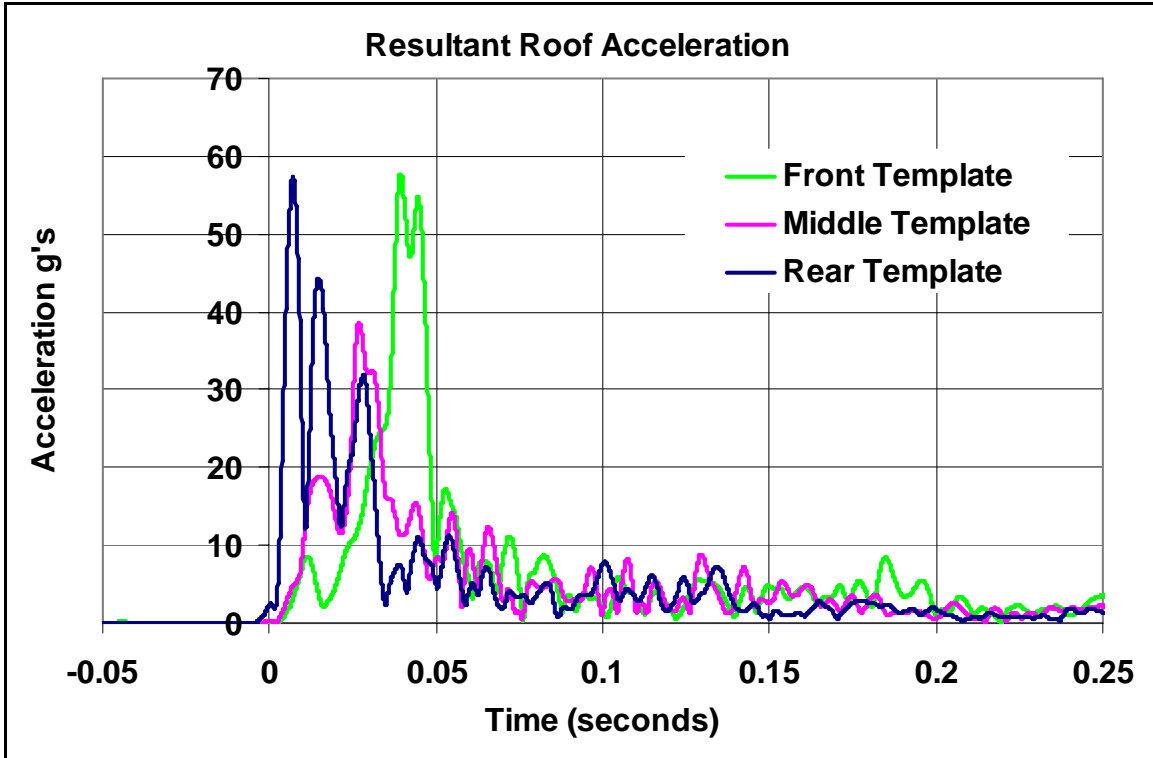
presents a data plot of the resultant roof accelerations at each template location. The peak accelerations for the Y and Z axis, the peak resultant acceleration, and average accelerations were calculated and are presented in Table 16. The average acceleration is the area under the resultant acceleration time history (from the start of deceleration until the resultant acceleration is effectively zero) divided by the associated time duration. The average acceleration along the top of the bus roof when the bus struck the ground surface is 8.20 g's (computed as the average of the average acceleration at each template location). The peak resultant roof acceleration is at the foremost template and is equal to 57.7 g's. The average of the peak accelerations at the three templates is 51.2 g's.

Figure 40: Prevost Roof Acceleration at Location of the Front Template

Figure 41: Prevost Roof Acceleration at Location of the Middle Template

Figure 42: Prevost Roof Acceleration at Location of the Rear Template

Figure 43: Prevost Resultant Roof Accelerations at the Front, Middle, and Rear Templates.

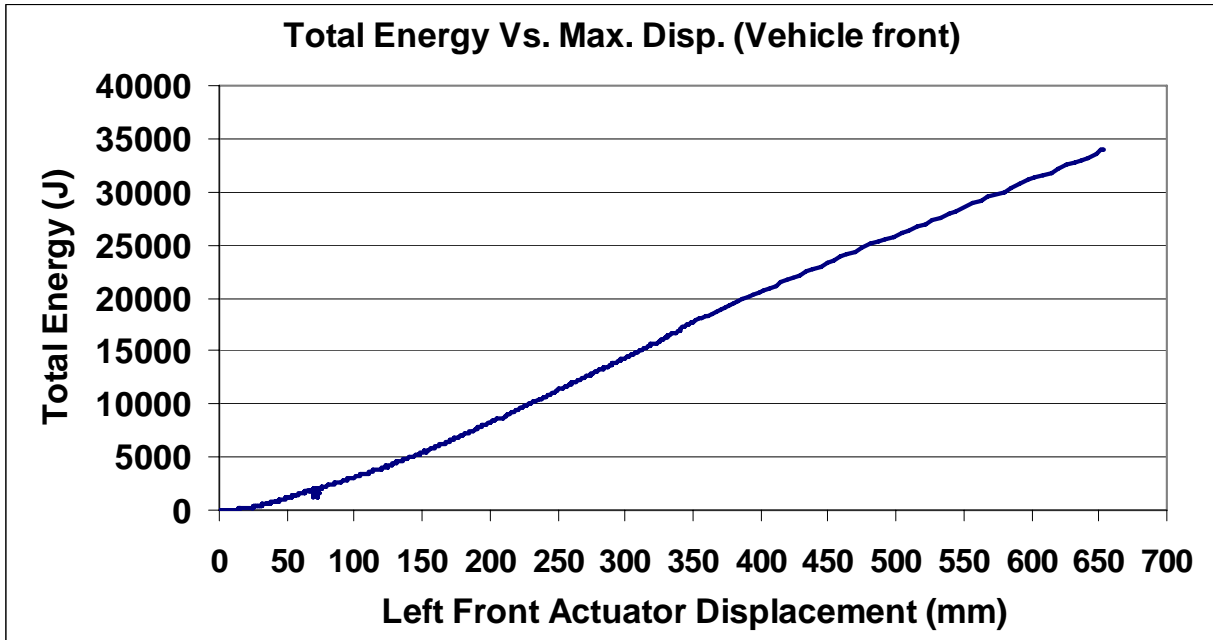
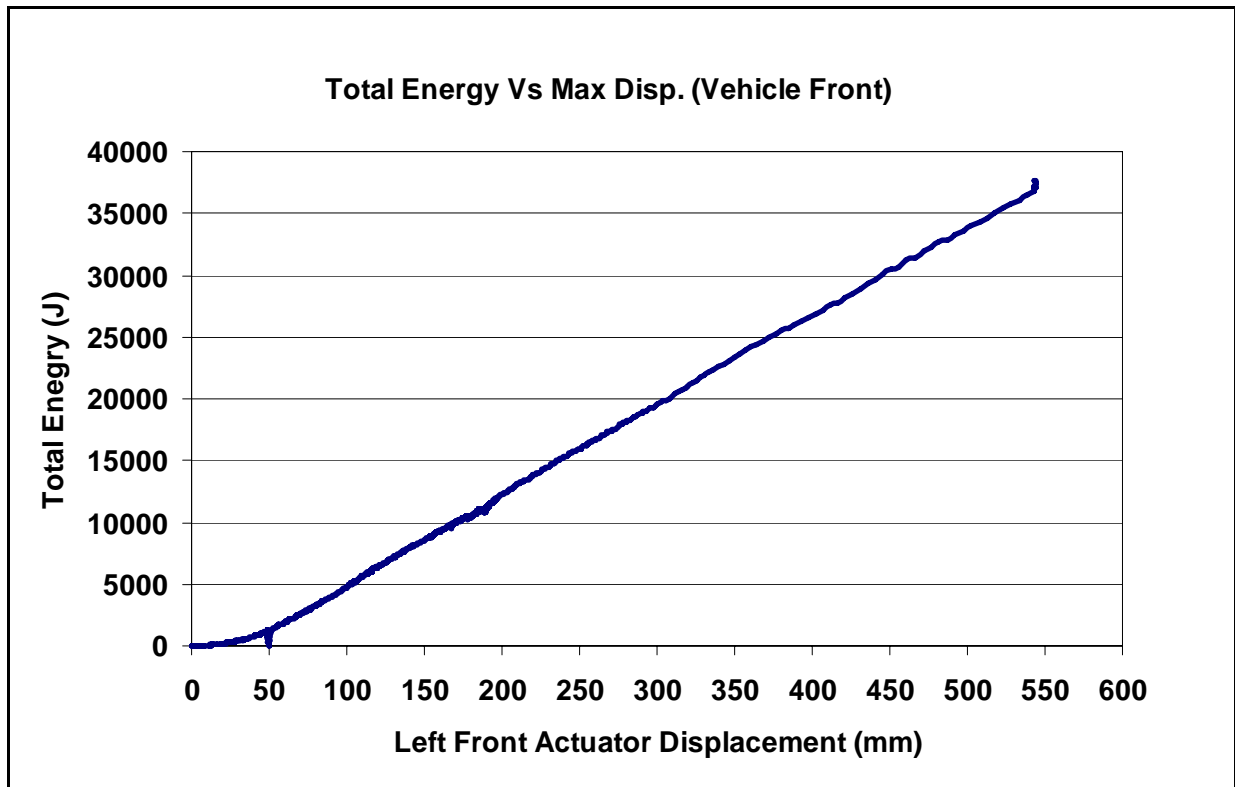
Figure 44: Energy Absorbed in FMVSS No. 220 Test with MCI Bus

Figure 45: Energy Absorbed in FMVSS No. 220 Test with Prevost Bus
