STURAA TEST

500,000 MILE BUS

PREVOST, a division of Volvo Group Canada Inc.

MODEL X3-45 COMMUTER

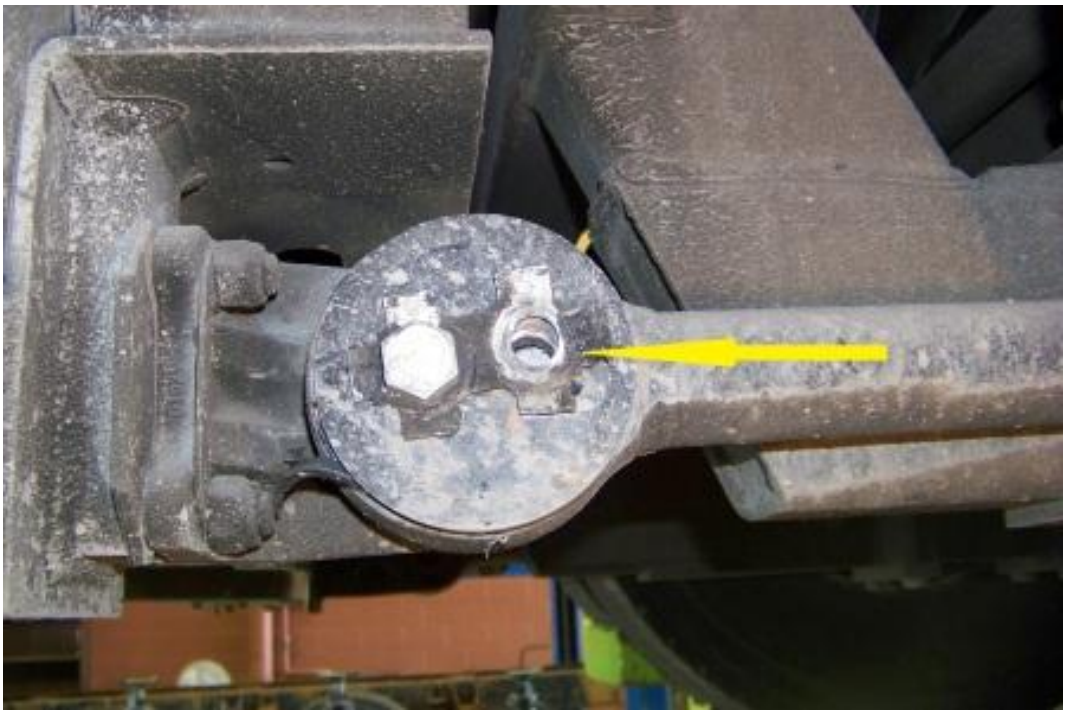
BROKEN RETAINING PLATE BOLT: LOWER, LEFT RADIUS ROD DRIVE AXLE (7,729 TEST MILES)

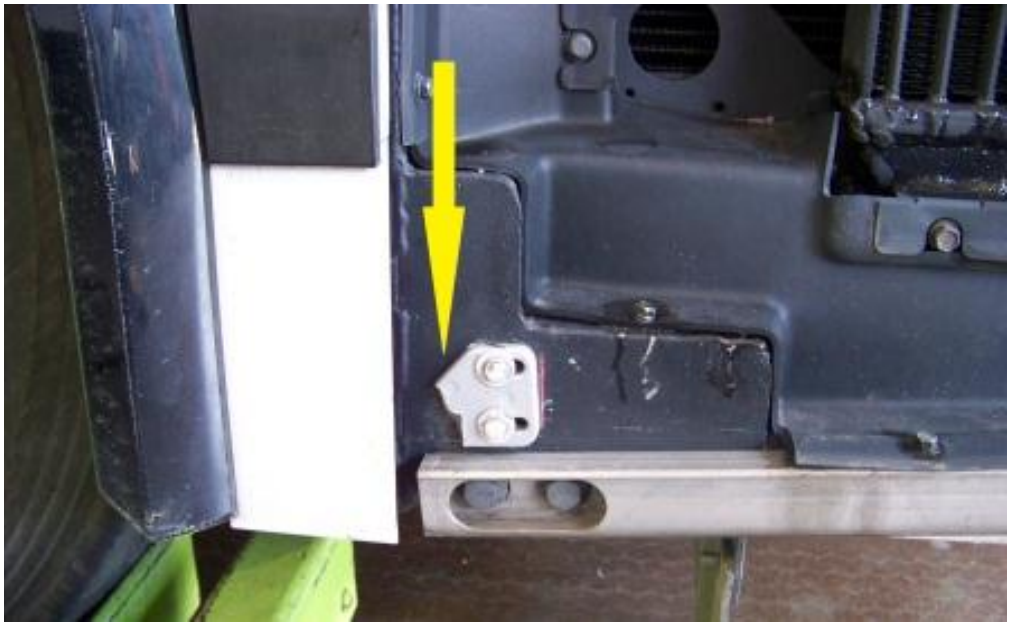
BROKEN LOWER HINGE, RADIATOR ACCESS DOOR
(9,132 TEST MILES)

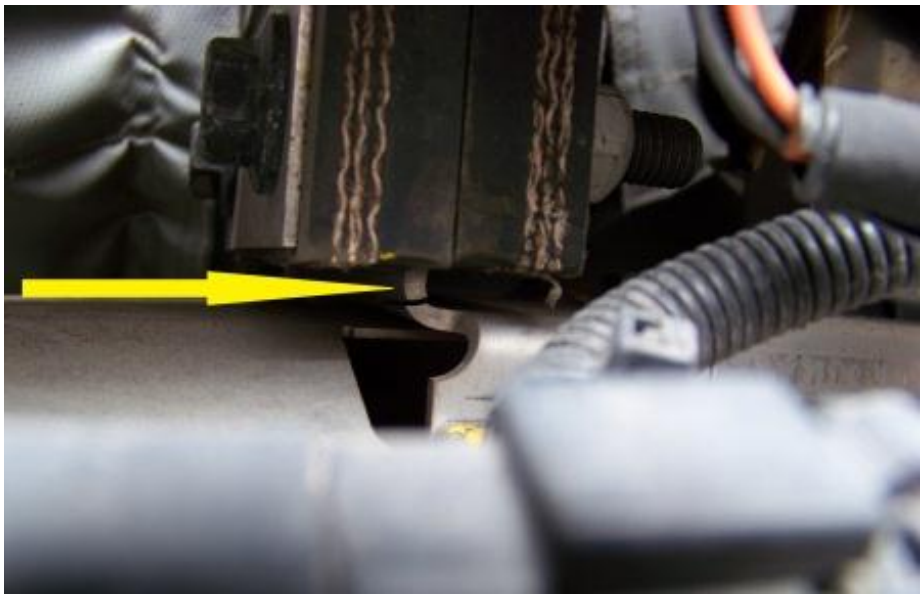
BROKEN FLEX EXHAUST PIPE
(11,902 TEST MILES)

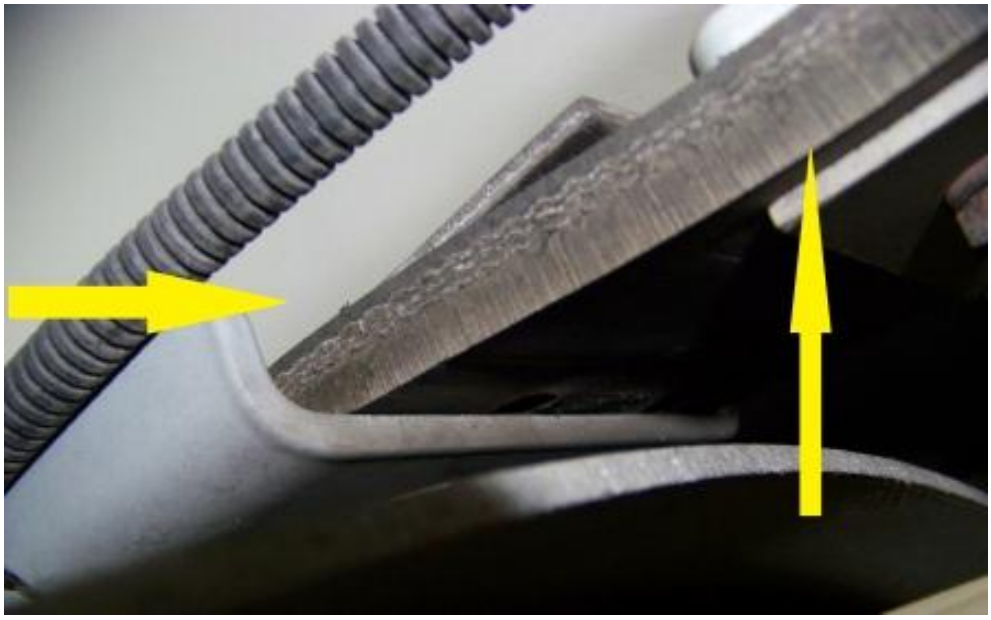
WORN UPPER ISOLATOR ON FAN DRIVE SUPPORT BRACKET (11,902 TEST MILES)

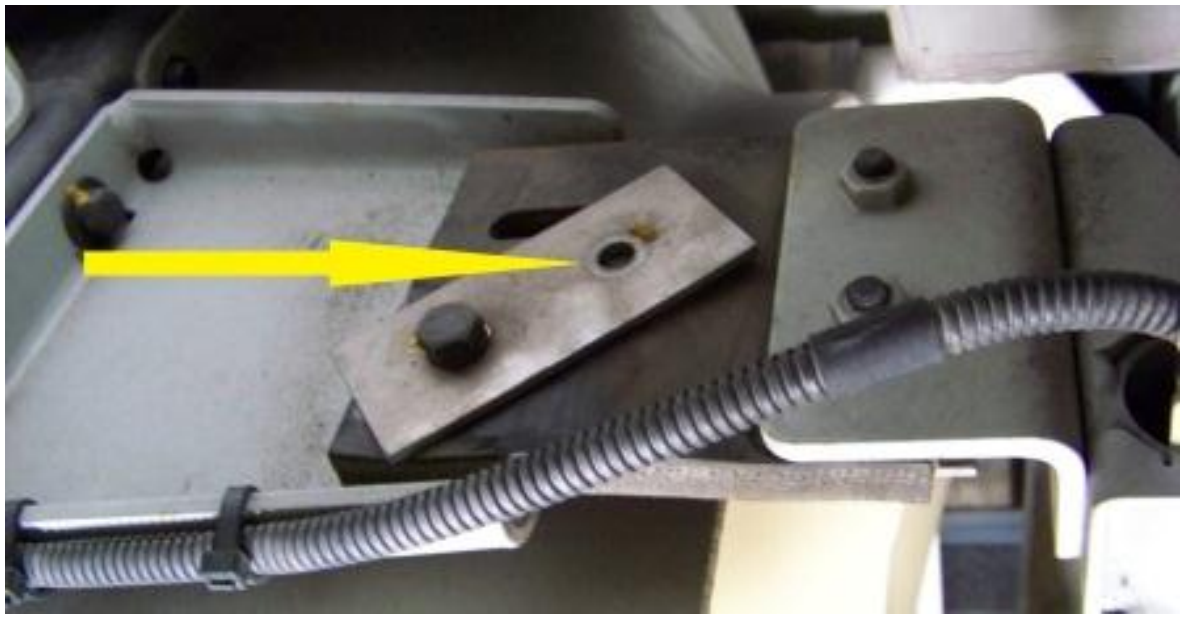
MISSING BOLT; COOLANT PIPE SUPPORT BRACKET
(11,902 TEST MILES)
