FIRE INVESTIGATIONS

WHY MOTORCOACHES MAY BURN

(A MECHANICAL ANALYSIS)

A CVSA SPECIAL REPORT

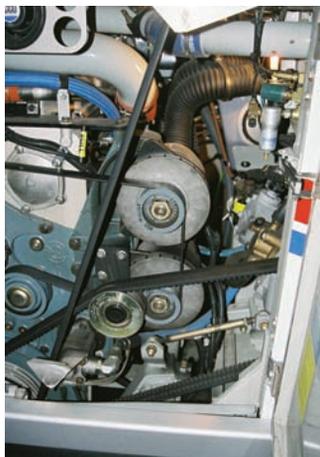
Photo 3B: Bosch T1, Series 60

nator similar to an automotive application; but larger. The typical varieties are a Delco 50-DN (Photo 3a) or an air cooled dual Bosch T1 (Photo 3b) configuration. The author must stress that these manufacturers are not being singled out for any particular reason; however, they are the most commonly found units within this type of vehicle. For most applications, the charging system for the motorcoach produces 275 amperes or more — as much amperage as a typical single family home may have. With this, the alternator (and system) carries great potential as an ignition source.

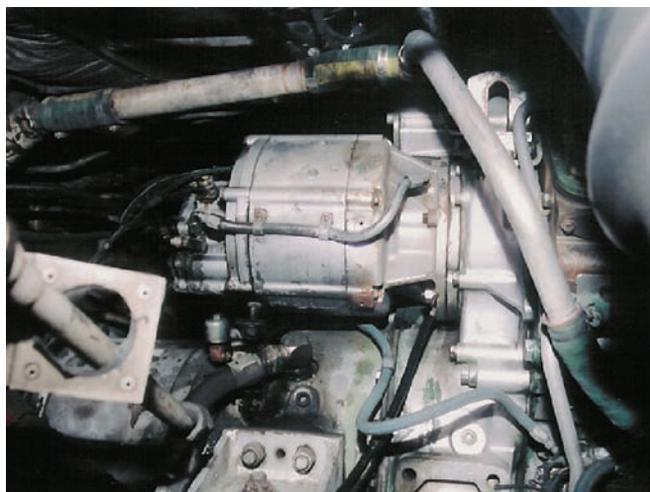
Photo 3C: 50-DN, Series 92

Typically with a 50-DN installation (Photos 3a & 3c), the B+ (direct battery feed) cable is routed to a large stud on the back of the alternator. This in turn is held in place with a nut (to the stud) along with various clamping methods to secure the cable end from any movement (Photo 4).

These connections must be quality checked after the alternator has been installed and inspected periodically as well as to ensure there is no movement. *It is noteworthy to point out that with some applications, these cables may need to be temporarily removed to facilitate other non-alternator related repairs. The same care and vigilance should be used whether alternator or other repairs are being made. If the B+ cable is loose, it can, by its own weight either fail the plastic insu-*

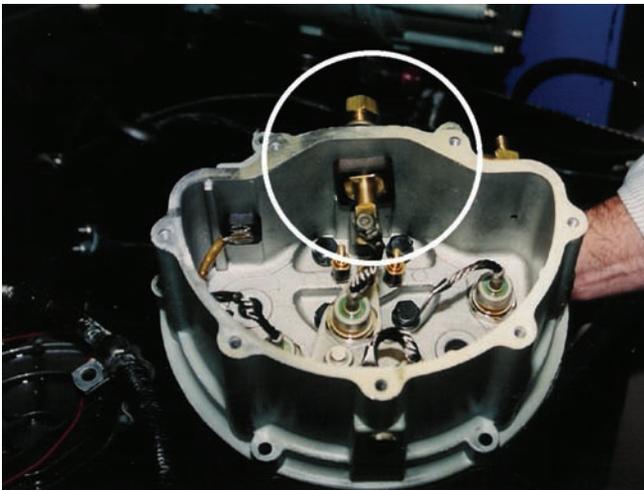
Photo 6A: 50-DN, B+ Stud Insulator

In addition to the cable and its' mounting system there is another potential fire hazard. When installing the B+ cable to the stud (50-DN) the proper torque must be used to ensure that the plastic material (internal insulator) is not broken or compromised in any way (Photo 6a). If this nut is over-torqued, or otherwise installed incorrectly, it could lead to a loose stud subsequently leading to an ignition source and fire (Photo 6b).

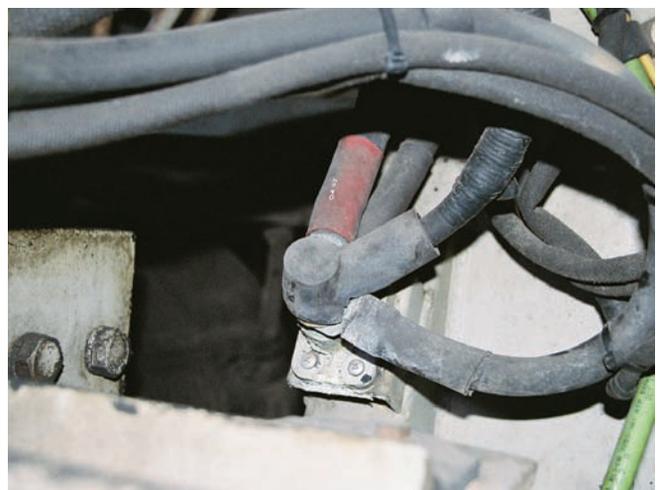
Photo 8A: Bulkhead Connection 50-DN

motor. However, this is initially routed to a bulkhead junction (Fig. 3; Photos 8a & 8b); again this is a heavy cable and must be properly connected and supported in its mounting.

Care must be given to the cable condition, cable to starter connections, as well as its' routing so that this B+ cable is not making unwanted contact and potentially coming in contact with ground as a result of an insulation breach.

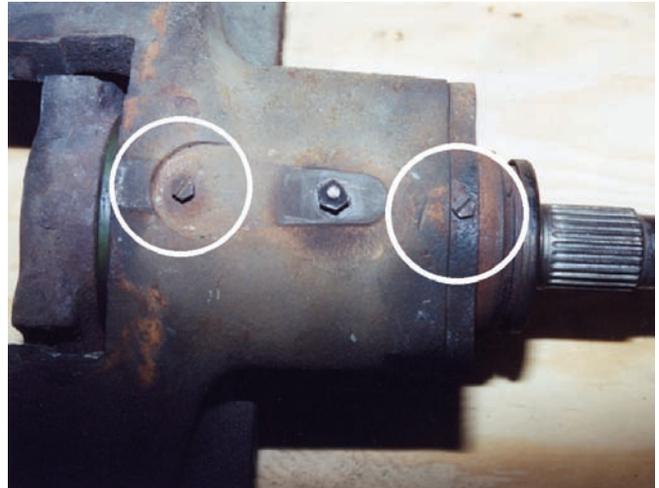
Photo 11: Rockwell Caliper ADB-1560

Disc Brakes: A “frozen” disc brake caliper can generate enough heat to ignite the surrounding combustible materials and sustain a fire. Proper inspection and lubrication intervals should be adhered to along with a periodic activation and release sequence confirming that the calipers are releasing and allowing the rotor to turn freely. This scenario applies to both air and hydraulic disc brakes. A simple method to determine the proper action of the calipers is to insert a feeler gauge (.002” - .004”) between the brake pad and rotor. By applying the service brakes a technician can feel if the gauge goes into this space, remains there upon brake application and is then released upon release of the service brakes. In some early applications, Rockwell disc brakes were used which in some instances were not supplied with grease fittings in the calipers* (Photo 11, Fig. 5). This very point leads to a “frozen” caliper scenario which, in the author’s direct experience, results in a fire at that wheel end.

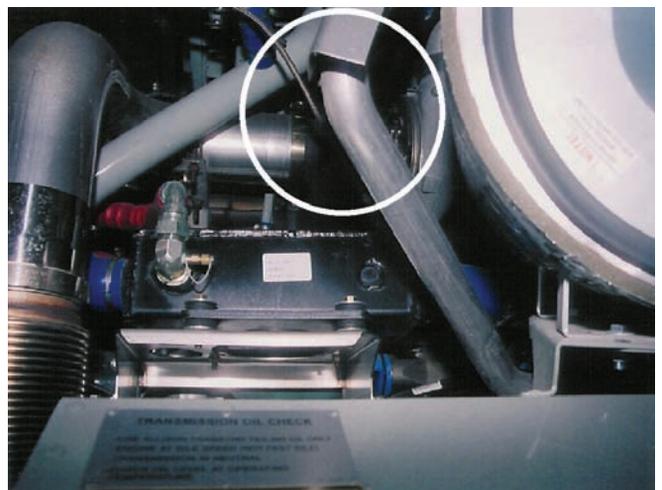
Photo 20: Auxiliary Heater Exhaust Pipe

Auxiliary Heaters: Also known as diesel furnaces, auxiliary heaters heat the onboard coolant when the engine is not running. However since it is a furnace which burns diesel as fuel it must be periodically inspected for function, control and integrity. Specifically, its cycle time and control must be verified to assure it is functioning when it should be, as well as, turning off when commanded. Additionally, the fuel lines must be inspected to confirm there are no leaks. In fact, in the summer months it is good practice to disconnect the heater function power supply and loop the supply and return fuel lines together (Photo 19). This will assure that fuel does not leak from the furnace itself when not in service. It should be pointed out that the heaters' exhaust pipe (Photo 20), within minutes of heater activation, reaches 375°F and continues to climb approaching the auto-ignition temperature of most of the vehicles fluids. Therefore, it is vital that

any leak, of any fluid in this area, be immediately repaired to minimize high temperature contact and subsequent fire.
