## F · R · A · C · T · U · R · E F · E · A · T · U · R · E · S by N.W. Sachs, P.E.

# Understanding the Surface Features of Fatigue Fractures: How They Describe the Failure Cause and the Failure History

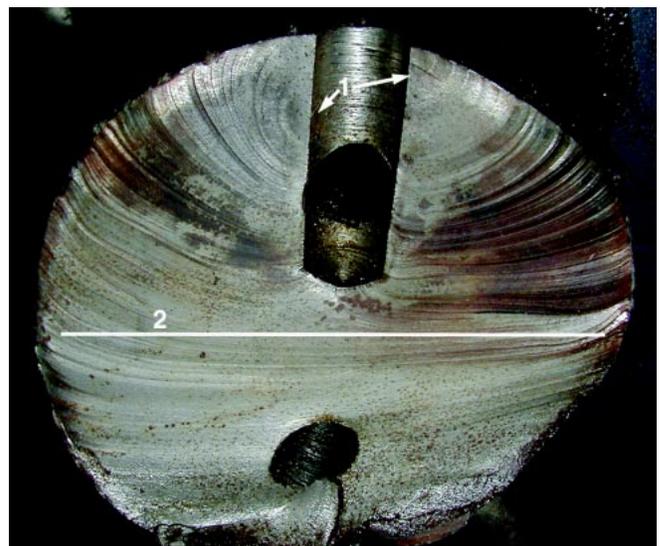
*Photo 1* A basic fatigue failure complicated by several holes. Two origins are seen at (1). The progression marks work across the fracture face. At (2) the growth of the fracture face is essentially straight across the face. (With high magnification, fatigue striations may be seen between the progression marks.)

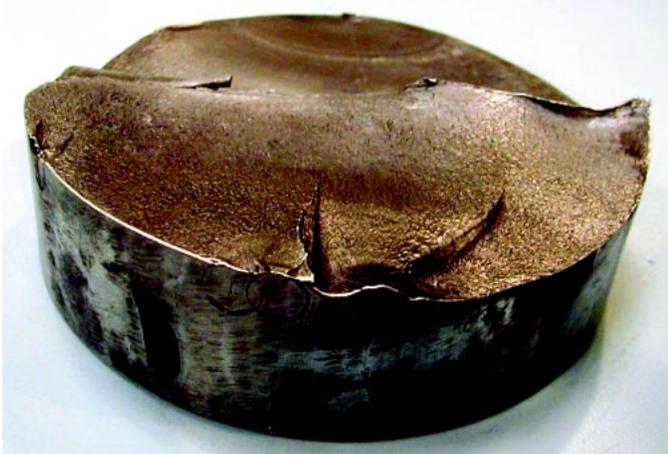
*Photo 2 A view of an agitator shaft showing two ratchet marks separating the three failure origins. Note that the origins are not on the same plane and that the ratchet marks are in effect boundaries between the fracture planes. (There is yet another origin on the other side of the failure face.)*

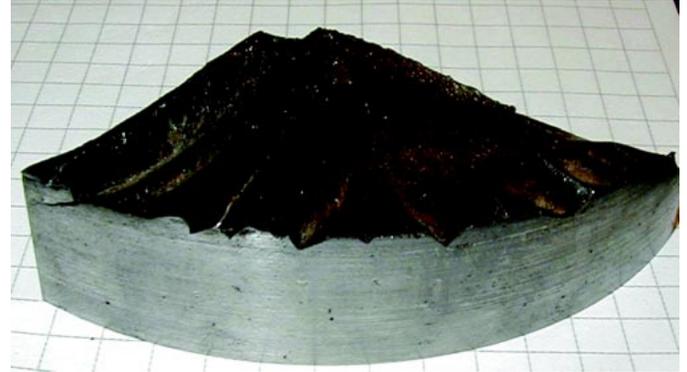
*Photo 3 This section of a crankshaft shows the ratchet marks that result when a torsional fatigue failure has multiple origins. Note that the sides are at approximately a 45° angle, whereas the sides of the ratchet marks shown in Photo 2 are essentially axial.*

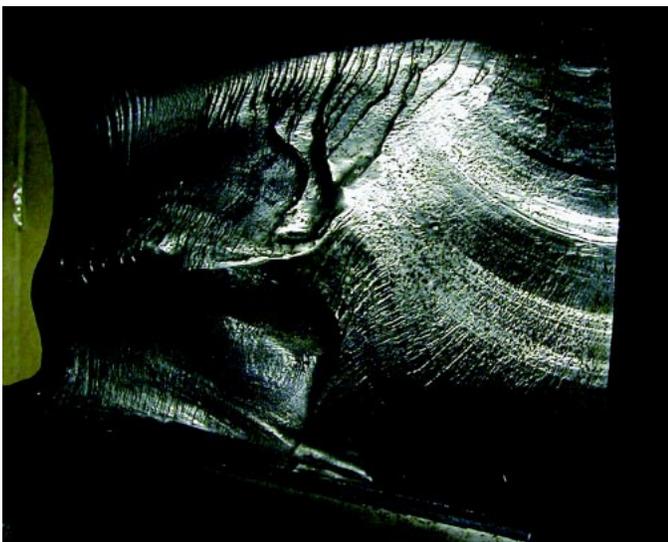
*Photo 6 These are "river marks" in a case hardened gear used in a 3500 hp pump drive. Like rivers flowing downstream, they indicate the direction in which the crack progressed and show the crack grew from top to bottom. However, the pressure side of the teeth is toward the bottom, that is, the gear is being driven in an upward direction, indicating a serious torsional problem.*
